KAMAN Rotor Top

Volume III, Number 10

August-September, 1964

UH-2 BAROMETRIC ALTITUDE CONTROL

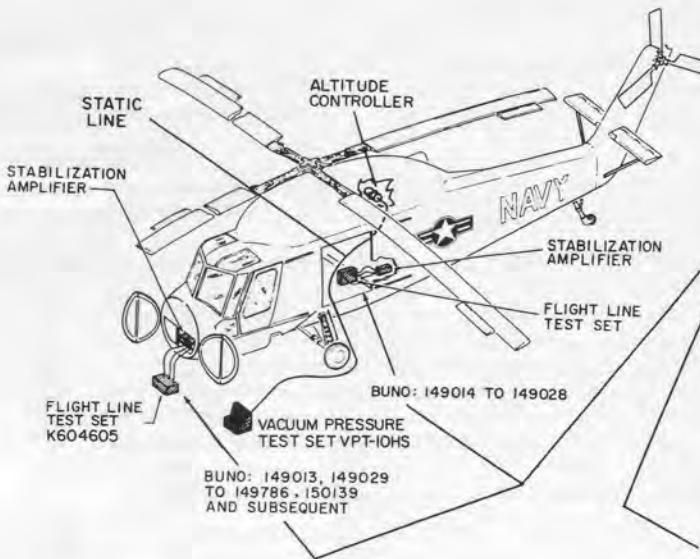
FIGURE 1

A. Collective Servo Valve Check: (1) Connect the ASE Flight Line Test Set, P/N K604605, to the ASE amplifier as shown in figure 1. (2) Disconnect the collective bungee. (3) With electrical and hydraulic power applied to the helicopter, engage the ASE and BAR/ALT switches on the radio console between the pilot and copilot seats. (Before the ASE can be engaged, the hydraulic boost switch, located on the heat and miscellaneous panel in the overhead console, must be cycled and placed in the ON position and the 60-second time delay must be completed. The time delay is complete when the OFF flag on the copilot's remote attitude indicator disappears.) (4) Place the DEMODULATOR OUTPUT switch on the test set in the COLLECTIVE position. The two milliammeters on the test set are now monitoring the differential current being transmitted from the ASE amplifier to the collective servo valve. (5) Pull collective up midway of its full travel. (6) Observe the two demodulator meters, M1 and M2, while engaging the collective control button on the collective stick. The annunciator window should indicate ON. There should not be any drift or jump in the collective stick. If the collective stick does drift and the two demodulator meters are at their quiescent current—a condition where both M1 and M2 are indicating the same amount of current—either the servo valve is not properly adjusted or is malfunctioning. If the collective stick drifts or jumps upon engagement and the demodulator meters M1 and M2 do not indicate their quiescent current, proceed with the electrical trouble shooting procedures.

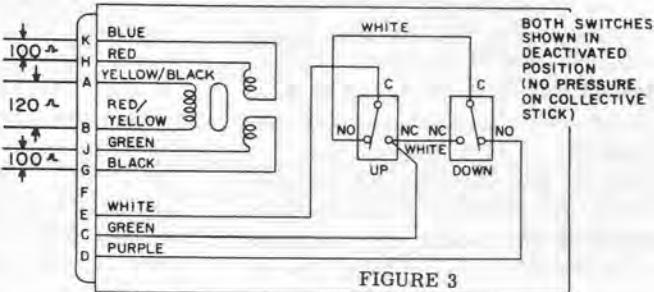
FIGURE 3

To test the collective force link for continuity remove the electrical connector on the collective force link and perform a continuity check on the force link in the following manner: Place one probe of an ohmmeter on pin D and the other on pin E (see figure 3). When no pressure is applied to the collective stick, continuity should exist.

When the stick is moved either up or down, the meter should indicate an open circuit or lack of continuity. Remove the probe from pin D and place on pin C. When no pressure is applied to the collective stick, the ohmmeter should indicate an open circuit. When the stick is either pulled up or pushed down, the meter should indicate continuity. Place one probe of the meter on pin A and the other probe on pin B. The resistance between the two pins should be approximately 120 ohms. Place one probe of the meter on pin G and the other probe on pin J. The resistance between the two pins should be approximately 100 ohms. Place one probe of the meter on pin H and the other probe on pin K. The resistance between these pins should be approximately 100 ohms. If the proper indications are observed during testing in sections A and B, the electrical portion of the system is functioning properly and no further checks are required.

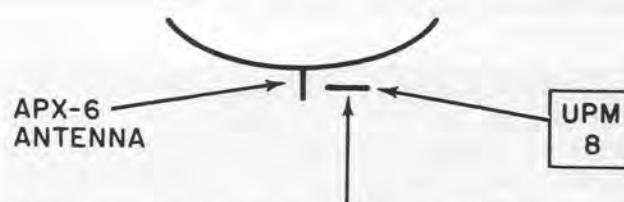
Use a "spare" antenna when giving the APX-6 an operational check and it won't be necessary to remove the floor plate to gain access to the Rec/Trans. Since the Tacan and APX-6 use the same type antenna, one of these antennas may be ordered for a shop rotating spare. This antenna can be connected to the UPM-8 tester and placed adjacent to the aircraft's APX-6 antenna. With both the UPM-8 and the APX-6 operating, radiation between the two antennas will be sufficient to make the necessary operational checks. The antenna attached to the UPM-8 may have to be varied in position in respect to the APX-6 antenna to find the position of maximum coupling. See drawing.

Spare antenna is held at 90 degrees to APX-6 antenna. Move antenna up or down to find point of maximum coupling.

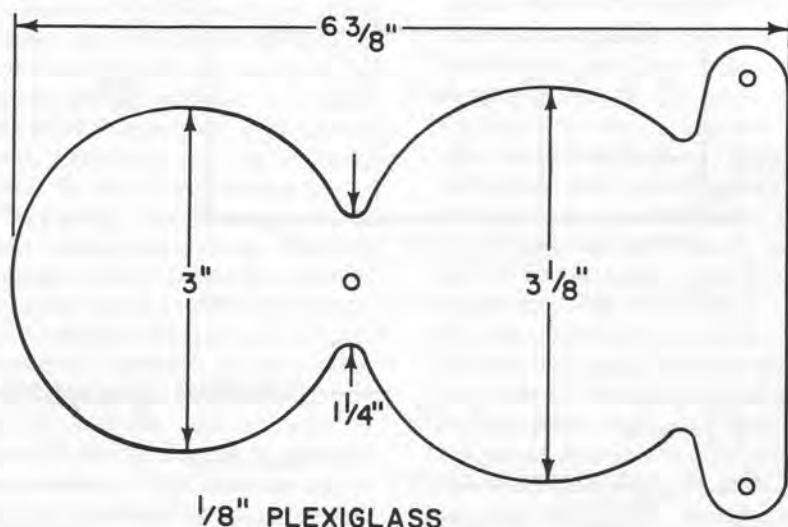
Extra protection in the form of cut-out (see drawing) plexiglass plates have solved the problem of broken glass in the ASA-13A computer control reported in the June-July issue of Kaman Rotor Tips. Whenever a computer is installed in the helicopter, the protective plate is installed on the computer. When the computer is removed from the aircraft for repair, the plate is removed before the unit is sent to AMD.

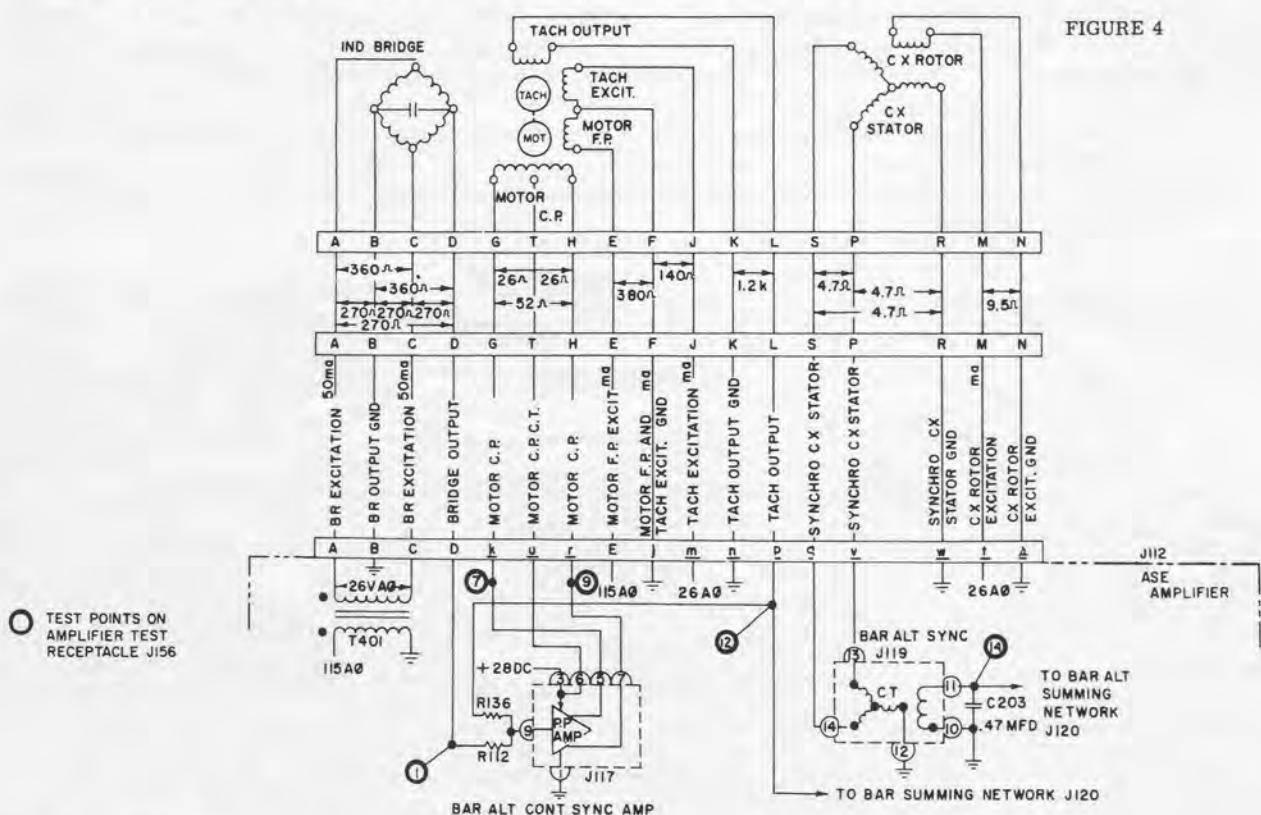
FIGURE 4

To test the altitude controller's inductive bridge output: (See figure 4) (1) Simulate an altitude of 500 feet with the VPT-10HS test set. (2) Increase the simulated altitude to 1000 feet. The voltmeter should indicate approximately minus 6.8 volts. (3) Decrease the simulated altitude to zero feet. The voltmeter should indicate approximately plus 6.8 volts. As the altitude controller reaches the simulated altitude, the voltmeter indication should decay to a null. If the signal increases or decreases to the 6.8 volt value but fails to null after it is known that the simulated change in altitude has been reached, either the ASE amplifier or the altitude controller is malfunctioning. If the voltmeter does not indicate any change in voltage when a change in altitude occurs, the problem can be assumed to be with the altitude controller. When the controller is suspected of having a malfunction in this or any other test, a resistance check should be made (see figure 4).
