OCTOBER-NOVEMBER
1965

KAMAN Rotor Tips

Timely Tips

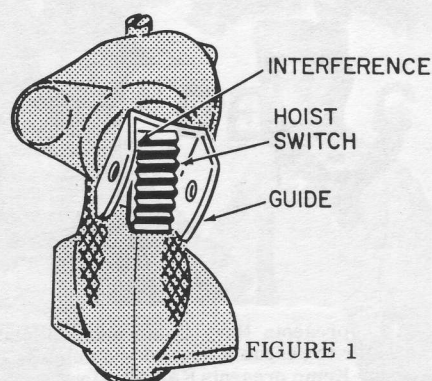
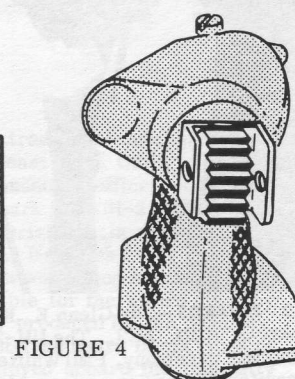
Hoist Control Grip (UH-2)

If on the hoist control grip, P/N 21490-1, this type of interference is encountered, see fig. 1, it is probably because this, see fig. 2, has happened to the switch guide, P/N 21399-1. To prevent guide-to-switch misalignment which can cause binding of the hoist switch, make sure the guide tab looks like this, see fig. 3, so that the adjacent guide and switch surfaces remain parallel, see fig. 4.

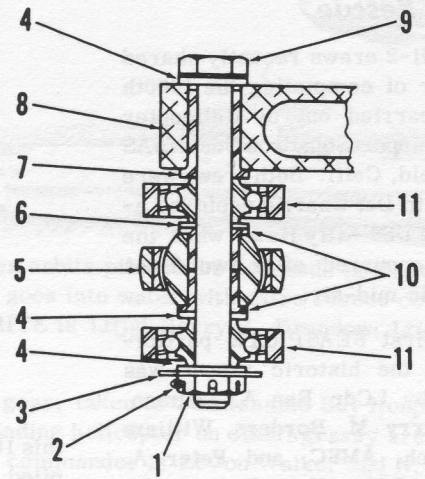
A. Proper spacing is important to ensure that the fail-safe washer (3), P/N KS1411-C1-04-14, will not rub the underside of the link (11). The resultant bind could cause an out-of-track condition. See NAVWEPS 01-260HCA-2-5, Installation of main rotor controls, for proper spacing.

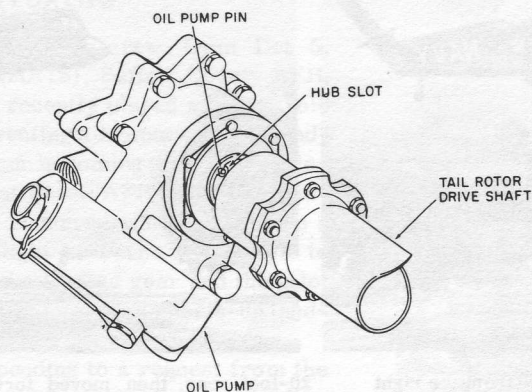
A. The pin, see drawing, was incorporated in the oil pump design to guarantee installation of the proper coupling at this location. Of the two types of couplings used in the tail rotor drive, only the PD854-2 has an accommodating slot milled in its hub. All pumps have these pins — be conscious of them and prevent damage by properly aligning slot with pin during coupling installation.

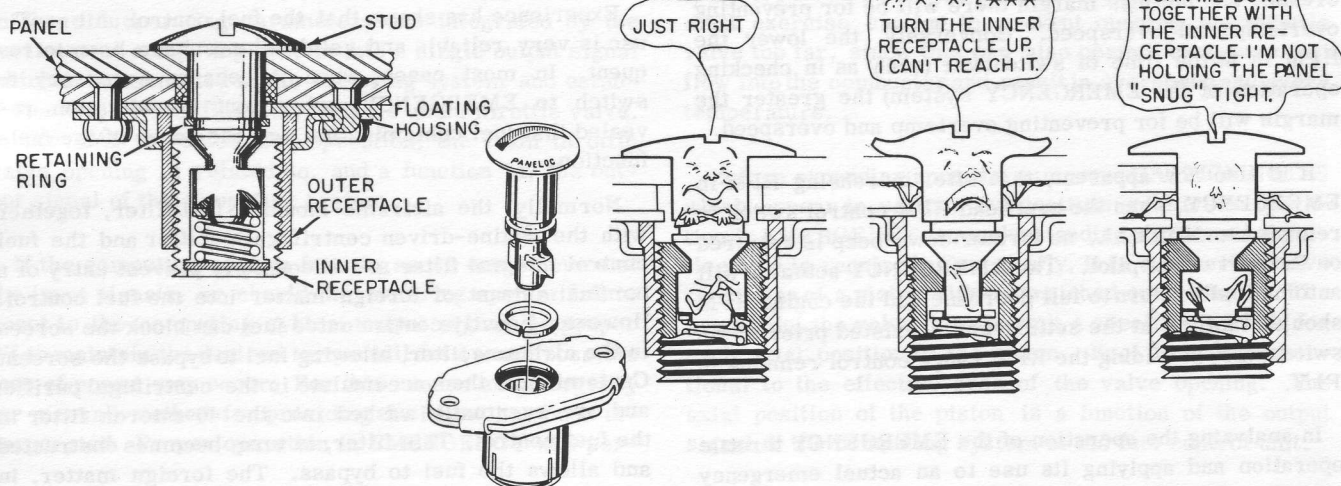
Paneloc Fasteners

Adjustment, not removal or repair, is usually the answer if the Paneloc 1/4-turn fasteners fail to engage and achieve the proper degree of snugness. These fasteners are used on the cockpit floor panels and the access cover over the shackle release on the auxiliary tank support. If the stud turns freely and won't engage when securing a panel or cover, it is an indication that the threaded inner receptacle (see drawings) is too far down. In this case, turn the stud to the left several times. This will raise the inner receptacle and bring it within reach of the engaging end of the stud. Next, turn the stud to the right to engage and lock it in the inner receptacle. Continue turning to the right to turn the inner receptacle down lower, thus tightening the fastener. (This part of the procedure should be used, of course, if it is found that the stud will engage when turned with a screwdriver but fails to snug the panel or cover down properly.) To avoid damaging the tangs on the shank of the stud, turn to the right only enough to seat the stud properly; do not overtorque. When engaged and snugged down, the fastener will neither loosen nor inadvertently open. Using the proper size screwdriver on these fasteners is a MUST if damage, and consequent difficulty in turning, is to be avoided.
