# *Rotor Tip*

NOVEMBER-DECEMBER, 1967

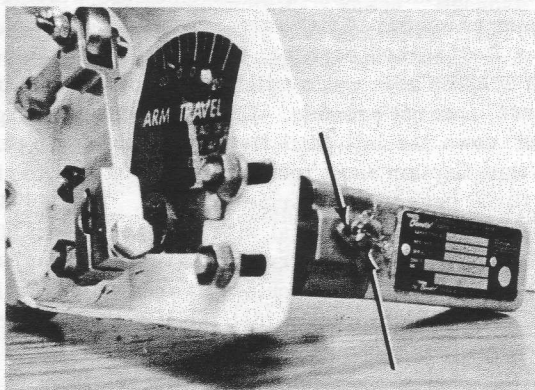
Whenever a new fuel control or emergency actuator is installed, or the relationship between the two is disturbed, the actuator must be rigged or re-rigged to the fuel control. In either case, if the actuator is improperly rigged, the resultant stoppage or binding will cause an electrical or mechanical failure in the actuator or limit throttle movement. The actuator produces rotary movement which, through linkage, is converted to linear movement. Because the available rotary movement is greater than the available linear movement, the actuator must be properly rigged to the fuel control.

Rigging procedures are detailed in the HMI - NAVAIR 01-260HCA-2-3, however, as a quick reference, the following general instructions are submitted: See photo.

1. Viewing the actuator in its installed position, the upper adjusting screw controls the forward or closed position stop. The lower adjusting screw controls the aft or open position stop. 2. One complete turn of the adjusting screw is equal to a change of 3° to 4°. Clockwise rotation of the screws will increase the actuator travel; counter-clockwise rotation will decrease the travel. 3. Adjustments should be accomplished in equal increments at both ends of the actuator travel. If, for example, a 4° change is required, make a 2° change at each adjusting screw. 4. Always make adjustments with the actuator at or near its midpoint of travel. If the actuator is against a stop, damage to the stop arm assembly could result if the adjusting screw is turned. 5. To assist in adjusting the actuator travel to equal the rack travel, measure the rack travel and convert the linear measurement to degrees by reference to the following table:

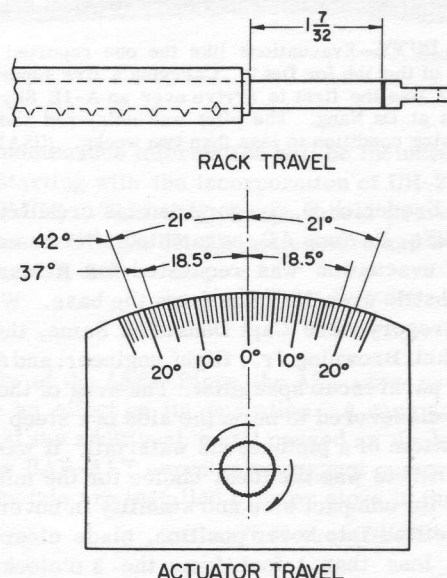
6. New and overhauled actuators, as received, will usually be set for 43° to 45° travel. The fuel control emergency throttle rack travel will generally be between 1-1/8" to 1-9/32" (34° - 39°). When installing a new actuator and before connecting the linkage, it will therefore be necessary to decrease the actuator travel as shown in the drawing.

In this example, the rack travels 1-7/32" or 37°. The actuator travels 42° and if connected would attempt to move the rack 1-3/8". Set the actuator at midpoint in its travel and adjust both actuator screws counter-clockwise approximately 3/4 of a turn. Before attaching the linkage to the rack, check the actuator movement to be sure it is a total of 37°. 7. After adjusting, place the actuator and rack in corresponding positions (both units in full open or full closed) gap fill and connect linkage. Check operation.

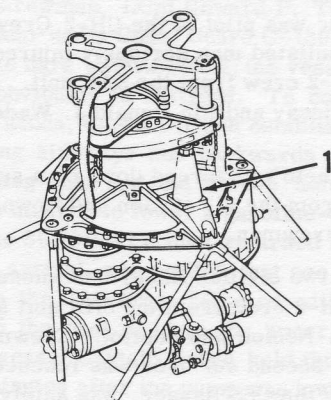
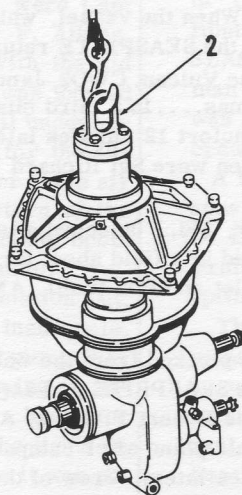
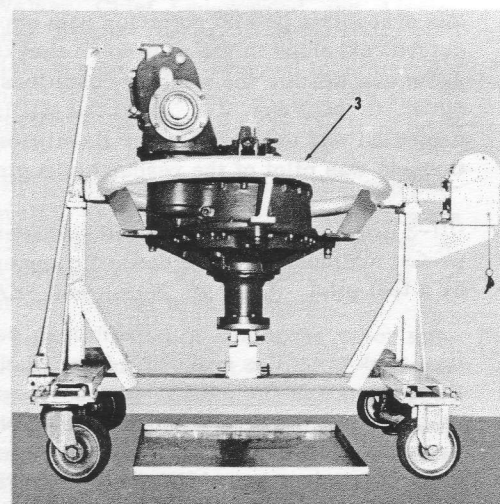
Prior to replacing the lower seal in the main gearbox, be certain the proper support or supports are utilized as shown in the illustrations. If the main rotor hub is installed on the gearbox, make sure the hub is securely supported by a hoist or by jackscrews (1, View A), P/N K604215-101. Install the jackscrews according to the instructions listed in the MIM NAVAIR 01-260HCA-2-4. If the main rotor hub is not installed on the gearbox, support the rotor shaft with a suitable hoist and lifting adapter (2, View B). When the gearbox is installed in transport dolly assembly (View C), P/N K604504-201, use swivel assembly (3), P/N K604201-5, for support. Invert the gearbox assembly before removing the oil seal from the main rotor shaft. **DO NOT** attempt to replace this seal without the main rotor shaft being properly supported. The gearbox assembly must also be in the inverted position on the transport dolly during seal replacement. If the rotor shaft or the hub is not supported prior to removal of the bearing seal plate retainer bolt, internal components may shift or fall out of the gearbox and cause subsequent gearbox damage.

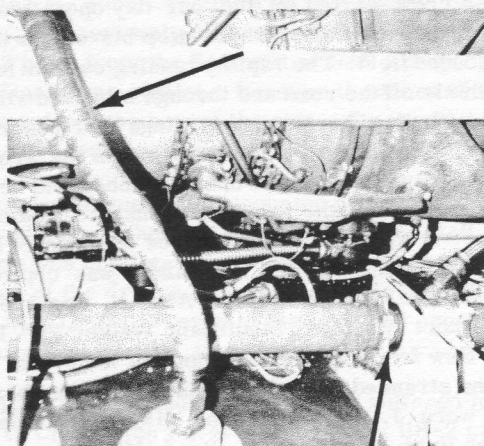
**Q.** (Applies UH-2A/B) WHEN THE HEAT-SENSITIVE TEMPERATURE PLATE ON THE TAIL ROTOR SHAFT COUPLING AT STATION 229 INDICATES AN OVER-TEMP CONDITION, WHAT SHOULD THE MECHANIC LOOK FOR?

**A.** When the heat-sensitive plate turns black, indicating an overtemp condition, check the coupling, the bearing and the cabin heater hose. If the coupling and bearing do not appear damaged and the coupling grease is not contaminated, change the heat-sensitive plate. Check the cabin heater flexible hose from the engine combustion section for a hot air leak or a rupture. The air flowing through the hose is very hot and if it escapes and circulates around the coupling, the heat sensitive temperature plate will probably turn black. The arrows in the illustration point to the hose and the coupling.

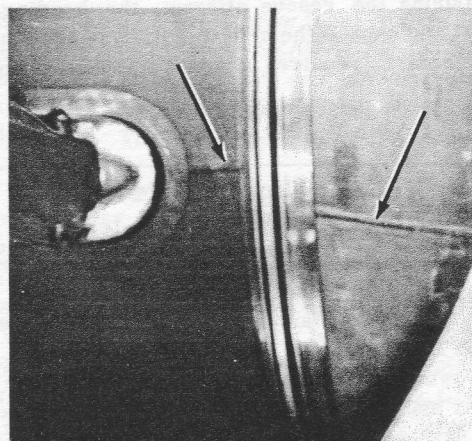
**Q.** (Applies UH-2A/B) WHAT CAN BE USED AS AN AID IN ENGINE EXHAUST DUCT ALIGNMENT?

**A.** The seam welds on the exhaust duct and the exhaust case may be used as reference points when positioning or checking the position of the duct. The duct is properly positioned when its seam weld is about one inch above the short seam weld on the engine exhaust case. The photo was taken from the RH work platform. The arrows point to the two welds; on the left is the exhaust duct and on the right is the exhaust case. This alignment can be very important as improper positioning could deflect hot exhaust gases toward the fuselage instead of away and into the slipstream. If the hot gases are allowed to strike the fuselage, discoloration or even skin buckling could occur. The exhaust case is not keyed nor slotted so the alignment can easily be accomplished.

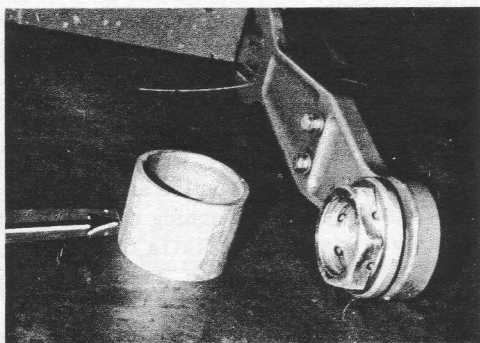
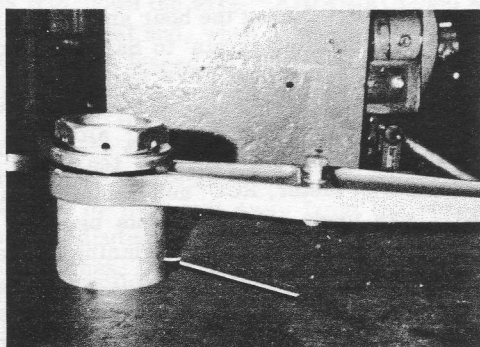
**Q.** (Applies UH-2) WHAT PROCEDURE SHOULD BE USED TO REMOVE A SEIZED CONE LOADING BUSHING FROM THE LOWER LOCKING ARM ON THE MAIN ROTOR BLADE?

**A.** Remove the arm from the blade and check the bushing to make sure it is not in a cocked position. If the bushing is cocked, place the arm in an arbor and press against the nut end of the bushing until square. Usually only a slight pressure will be necessary to align the bushing. When squaring up the bushing in the arbor, be sure to support the arm around the seized bushing to prevent bending the arm. The arrow in the photos points to a piece of steel pipe which is being used for support. Squirt light oil on the seized joint and let it soak in. If a rivet gun is available, place an aluminum block on the end of the bushing, a flat set in the gun, and drive the bushing out of the arm. An aluminum drift and a hammer may be used to drive out the bushing if a rivet gun is not available.

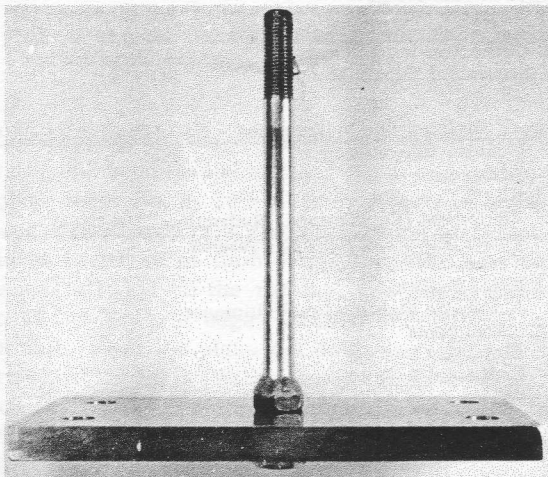
PHOTO ONE

Occasionally, due to torque and corrosion, the engine end yoke fitting, P/N K774681-13, binds and resists normal removal efforts. The tool shown in Photo 1 will supply the required force to overcome this resistance. It's a relatively simple tool, consisting of a steel plate, a 3/8 inch nut, and a 3/8-24 bolt — all may be salvaged from scrap. The plate must measure at least 3 by 5-3/4 inches and, preferably, should be 1/2 inch thick because of the bending stresses which may be imposed.

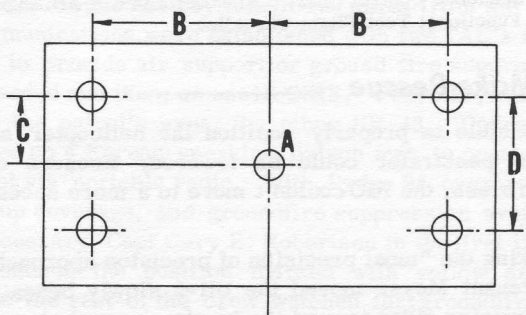
Begin fabrication by locating the exact center of the plate. Mark and drill five 7/16 inch diameter holes according to the dimensions listed beside the drawing. Drill out the threads in the 3/8 inch nut and extend the bolt threads to at least 1 inch.

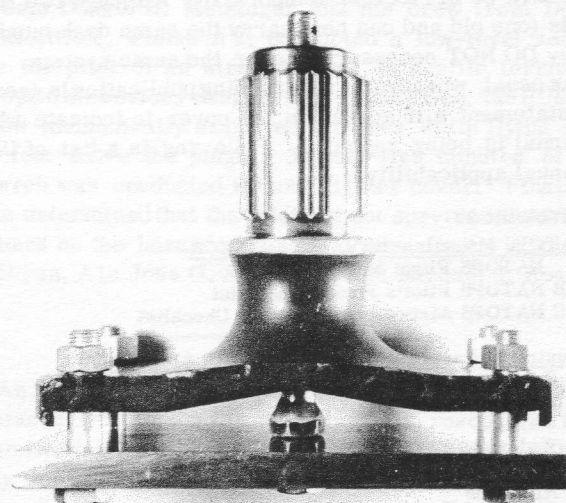
PHOTO TWO

Assemble the tool by inserting the bolt through the center hole in the plate and slide the nut up the shank of the bolt. Position the nut close to the plate and leave enough clearance so that the plate may rotate freely between the bolthead and the drilled nut. Maintain this clearance and weld the nut to the bolt.
