# KAMAN

## Rotor Tips

# Rotor Tips

Volume VI Number 7

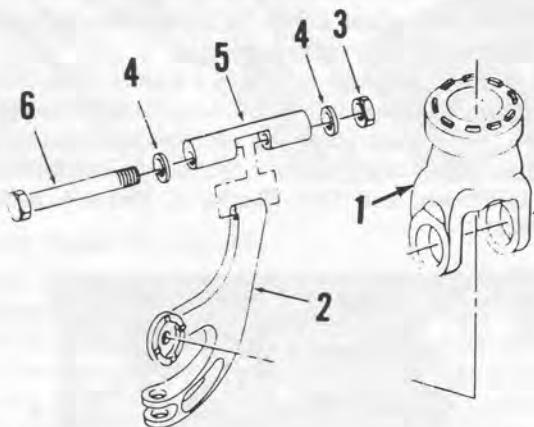
Tail rotor blade, P/N K614701-1, MUST be used on HH (4 bladed tail rotor) aircraft only. Tail rotor blades, P/N K614001-203; -205; -207, MUST be installed on UH-2 aircraft only. The reason for the restriction is a difference in pitch arm flyweights, made necessary by the addition of the fourth tail rotor blade on HH aircraft. In the event of a directional control failure, the pitch arm flyweights will position the blades in an optimum pitch angle, thereby aiding the pilot in effecting a safe landing. Illustration 1 shows an exploded view of the area under discussion.

- 1. Tail rotor blade hub
- 2. Pitch arm
- 3. Nut
- 4. Washer
- 5. Flyweight
- 6. Bolt

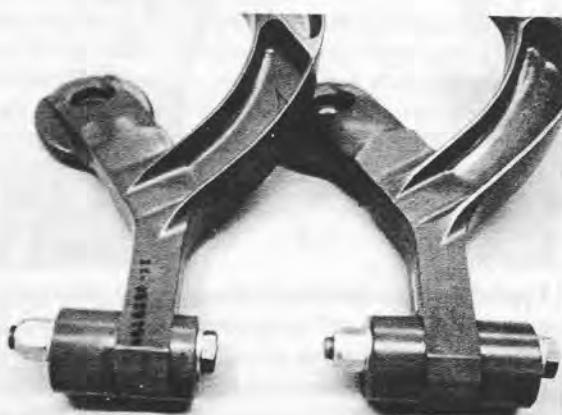
Photo A

K616709-11  
Flyweight

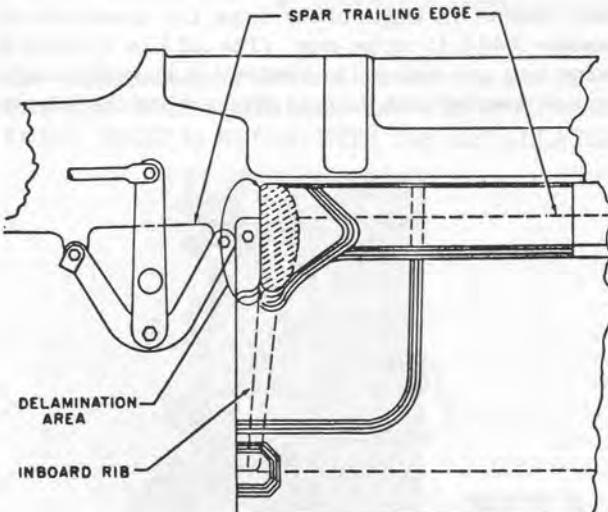
The following information reflects the latest in delamination repair. The information will be incorporated into applicable handbooks by a future Change.

1. Use a feeler gage to check for delamination. Up to 1/3 of the area covered by the aluminum doubler, shown in accompanying illustration, can be repaired as follows:

2. Clean up faying surfaces. Remove corrosion by abrading with No. 180 emery paper (or finer). Using a clean, oil-free cloth, solvent-wipe with Methyl-Ethyl-Ketone (Federal Specification TT-M-261). Dry with clean, filtered compressed air.

5. Apply a thin, even coat between the surfaces and press doublers down into position; tape in place.
6. Cover area with plastic film (such as PVA) to prevent adhesive squeeze-out from sticking to the pressure device which will be used in step 7. Using a suitable tool, squeeze the excess adhesive out from under the doubler. (Start at the secure end and work toward the loose end.) A fillet of adhesive should be evident around the edges of the delamination.

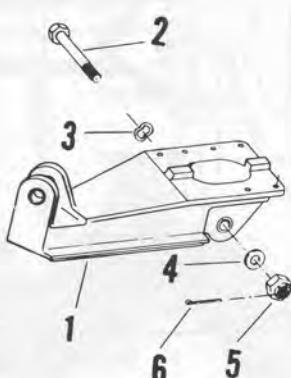
also be installed with the head inboard. (This will make it a bit easier to install, torque and align the nut.) If improper hardware stackup or installation of the wrong bolt is suspected, perform the following check:

In the event the preceding check indicates an incorrect installation, the jawbone must be removed and inspected for evidence of clamp-up damage to the ears. If necessary, the jawbone should be replaced. For information purposes, the dimension between the jawbone ears should be 1.455-1.465 inches.

1. Jawbone, K672730-1
2. Bolt, K672770-11
3. Wave washer, WW519-S18
4. Flat washer, AN960-1016L
5. Nut, AN310-10
6. Cotterpin, MS24665-355

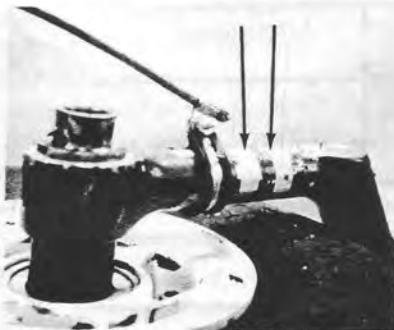
Photo B

**A.** In closeup, Photo B, notice how the static ground wire is attached to the tail wheel fork. *Under no circumstances should insulated clamps be used to attach a grounding connection.* Paint on the fork under the clamps should be removed before attaching the bare metal clamps. (The arrows point to where the two original clamps were installed.) The recommended installation, which is shown in Figure 3, NAVAIR 01-260HCA-4-4 and Figure 3, NAVAIR 01-260HCB-4-8, calls out a K683094-3 wire assembly to be used as a static ground. (See Photo C.)

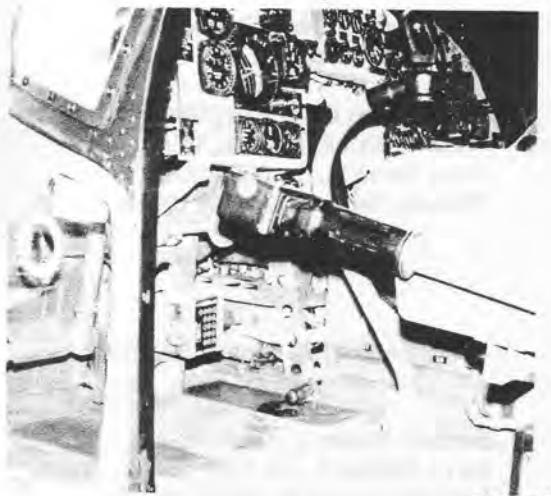
PHOTO A

This particular tool was wedged in rather forcefully and considerable effort was required to remove it; however, the screwdriver still could have come loose in flight. The necessity to occasionally lay a tool down while work-

*Before closing or sealing a component, whether it be a fuse box or gearbox, practice DARFO! Detect and Remove Foreign Objects. Before leaving your shift or aircraft, inform your superiors or your relief of open areas and loose materials. Take the time to "take one last look around," remember, if we all do our part and practice DARFO, everyone will benefit.*
