Rotor Tips

MARCH-APRIL, 1977

Volume VII Number 3

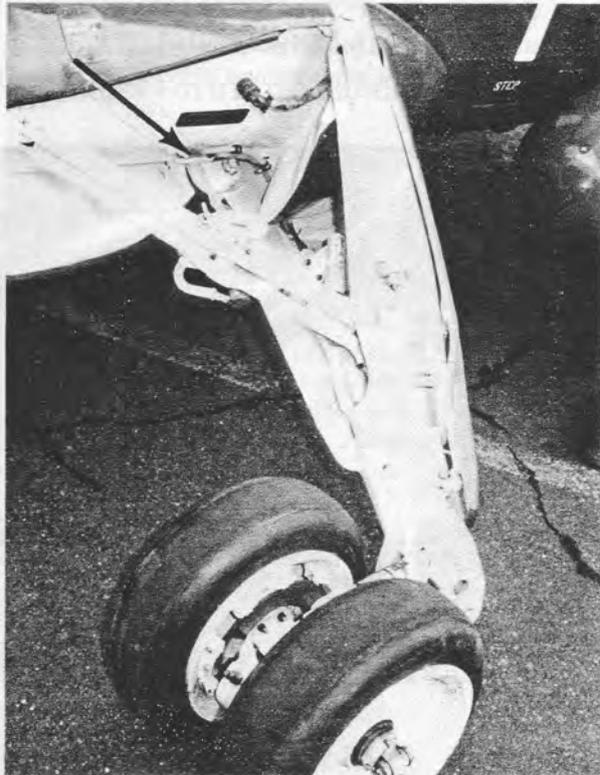
Photo A

The wheel brake system and the landing gear retraction system lines run from the landing gear, up to the strut and to the fuselage within the wheel wells, arrow Photo A. Aluminum elbows carry the lines through the fuselage as shown in Photo B (two elbows for the retraction system and one for the wheel brake system in each wheel well). Some elbows have reportedly cracked and since replacement necessitates fuel tank removal, steel elbows have re-

cently been authorized.* The steel elbows will be installed on an attrition basis. (Be sure to use the steel nut with the steel elbows.) Callouts: Number 1 in Photo B are wheel retraction lines; Number 2 is the wheel brake system line. The authorized substitutions are as follows:

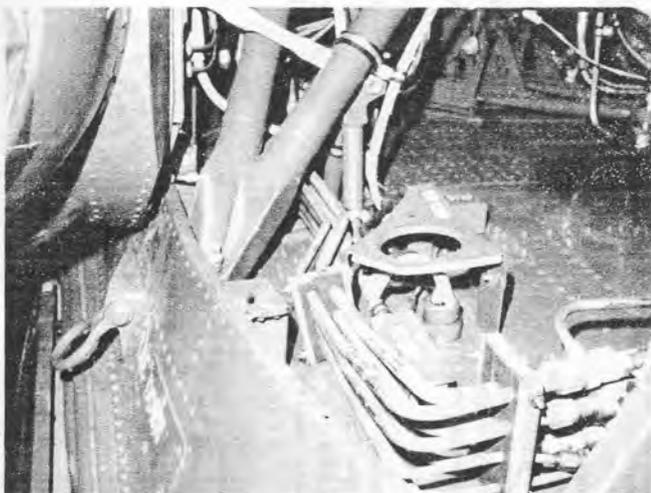
Photo A. The camera is aimed at the roof section, immediately above the pilot's door. A Foreign Object is visible; can you see it?

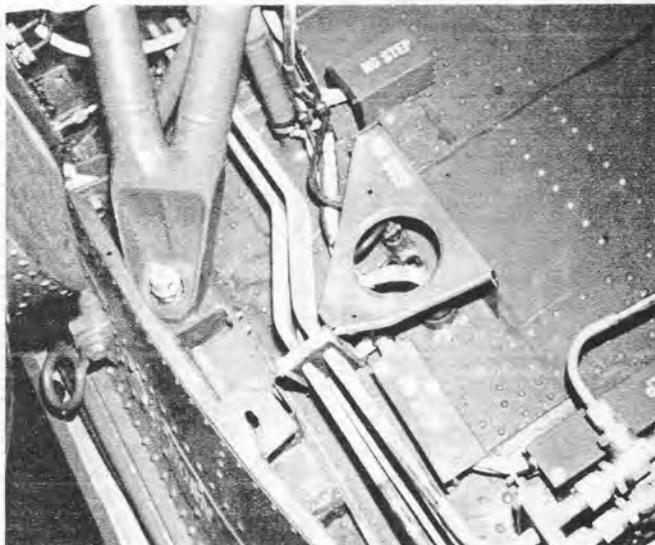
Photo B. A closer look at the same area and the Foreign Object is closer but perhaps not more visible.

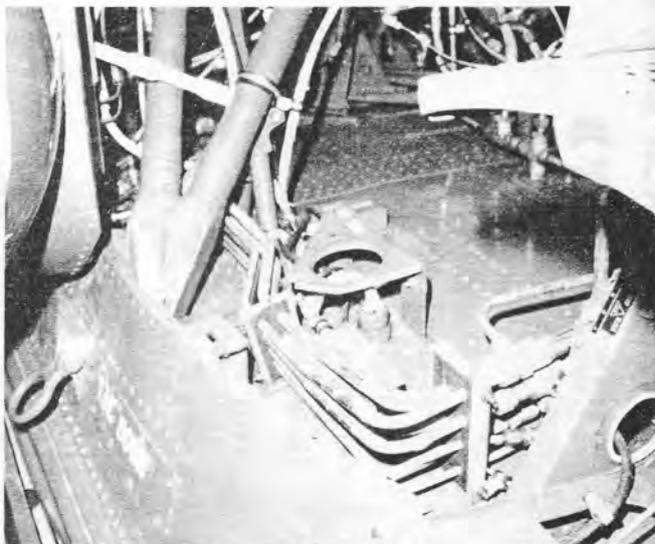
Photo C. From this angle, the Object seems to jump out of the photo.

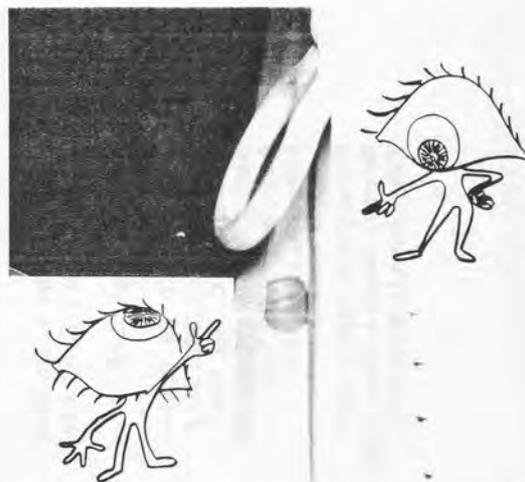
Photo D. For those who have not found the CD-10 Caplug, our eyeballers again point the way. Most mechs are accustomed to seeing door rollers in the door tracks and this round item might have gone unnoticed except for that "last look around."
