RAMMEN Rotor Tips

JANUARY-FEBRUARY, 1973

Volume VII No 1

TECHNICAL SECTION

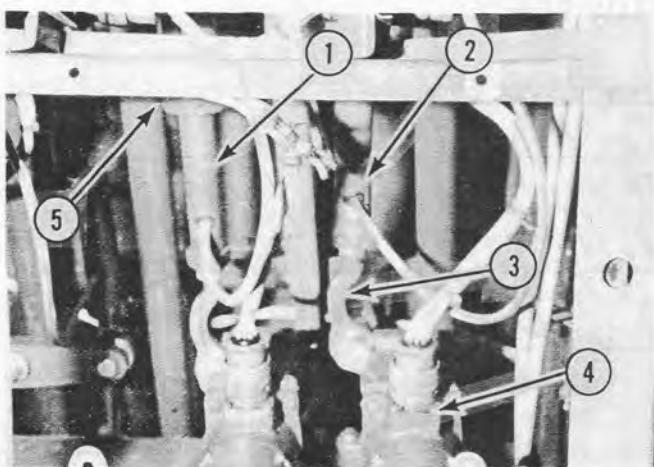
Photo A

1. Longitudinal trim strut
2. Lateral trim strut
3. Rodend, P/N K654054-1

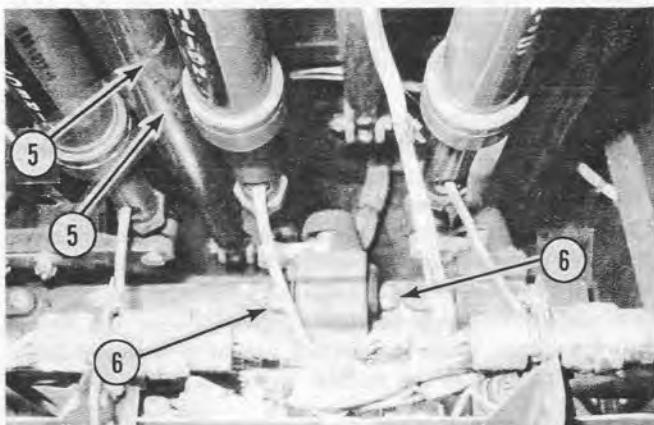
Photo B

Also, be sure the rods are free to move without touching other rods. (An example of interference is shown in Photo B, item 5.) If an interference is discovered, reposition the trim motors. Trim motor bolt holes are slightly oversize to provide movement if required. Loosen the hold-down bolts (6), relocate the motors and lockwire the bolts after achieving the proper position.

5. Interference areas

6. Bolts (trim motor)

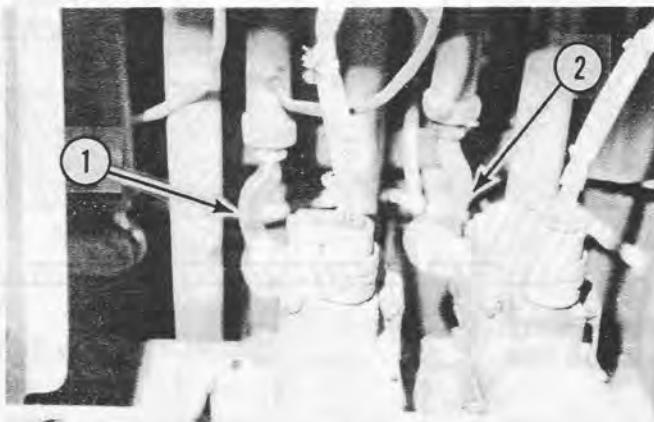
Photo C

1. Correct installation 2. Incorrect installation

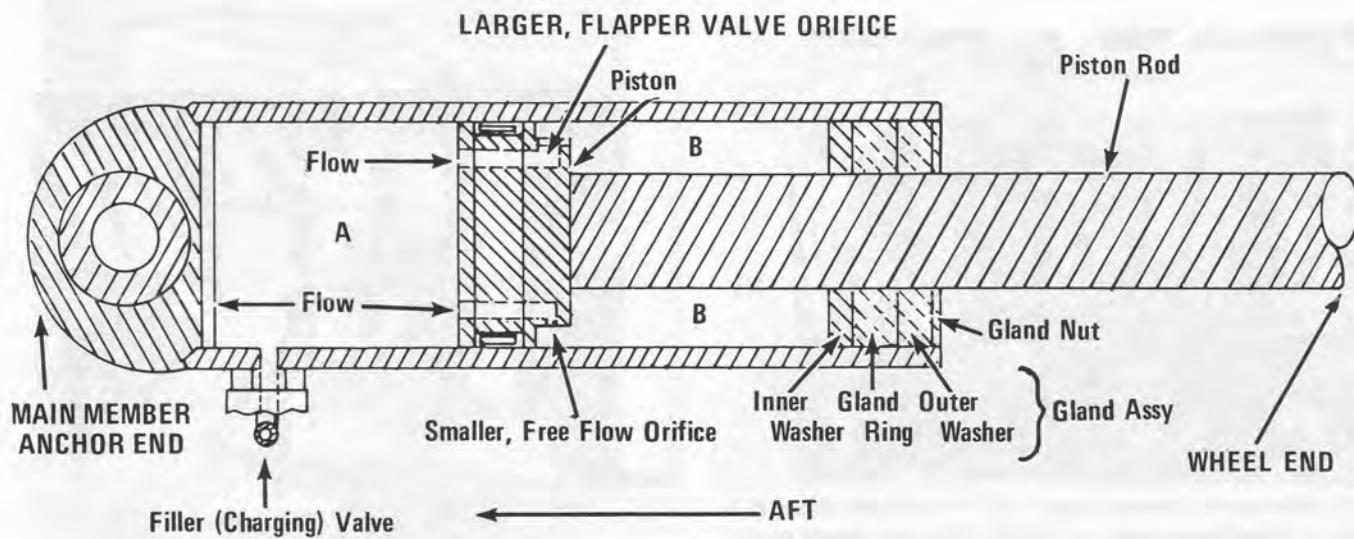
ILLUSTRATION 1

It is therefore suggested that daily observations for proper liquid spring extension be accomplished under similar or approximately similar conditions of OAT (Outside Air Temperature) and aircraft weight. Consistent piston rod extension of less than 1/2 inch or greater than 1-1/4 inches

is an indication that reserving is required in accordance with NAVAIR 01-260HCA-2-1. Another feature which contributes to proper liquid spring performance is the gland assembly, incorporated to minimize leakage and piston rod binding.

Attention to piston cleanliness is as important to liquid springs as it is on any conventional air-oil shock strut. Abrasive particles adhering to the piston rod can cut and abrade the piston rod chamfer ring (3) causing leakage and a "flat strut." Flat or underextended liquid springs should not be automatically replaced; first determine that replacement is actually required. Leakage can usually be confirmed by the presence of hydraulic fluid. If it appears to be leaking from around the piston rod, replacement is required. If it appears to be leaking at the charging valve, remove the valve per NA 01-260HCA-2-2, replace the O-ring, P/N 011-1DSA9250 (01-260HCB-4-2, 1 September 1972, Fig. 83, Index 37), and recharge the spring per NA 01-260HCA-2-1. If leakage at the charging valve recurs, replace the complete valve assembly, P/N 3283327-1.

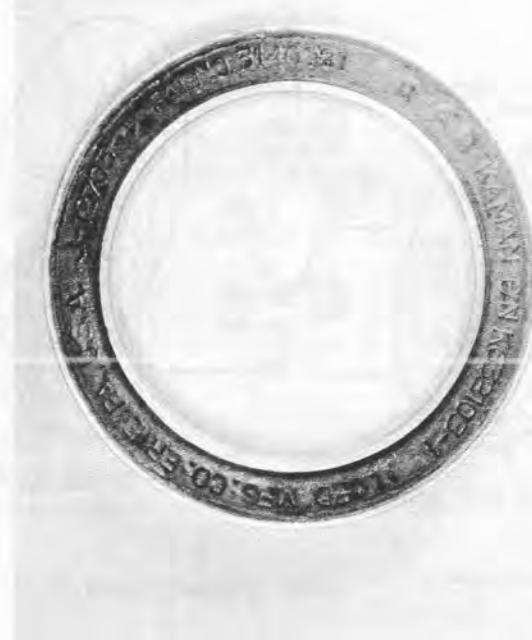
Airframe Change 126 replaced the tail rotor pylon stabilizer spar tube ball bearings, P/N KP37BS, with vibration-absorbing resilient mounts, P/N K632103-1, shown in Photo A and the accompanying illustration. The mounts are constructed of a rubber core bonded to an inner and an outer aluminum alloy ring. To protect against corrosion, rubber deterioration, and to provide maximum resistance to wear, the components have been treated as follows:

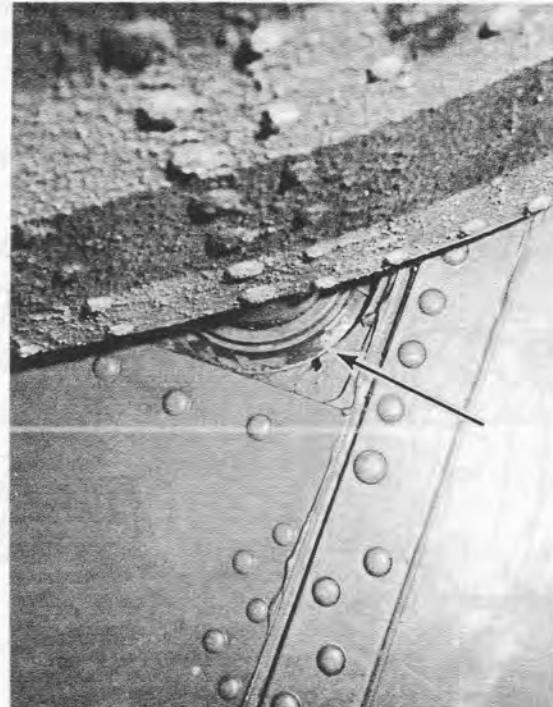
Resilient mounts which have the appearance of surface deterioration (cracks in the urethane coating, discolored, etc.) such as that shown in Photo B are still serviceable. All resilient mounts are replaced at each PDLM (Periodic Depot Level Maintenance).

Replace resilient mounts, K632103-1, if they are discovered with any of the following conditions:

- Missing chunks of rubber deeper than 1/8-inch.
- Rubber deformed to the point of protruding beyond the width of the ring.
- Rubber which has separated or cracked (completely through) at edge of either ring for a total of 90° or more. (Crack depth may be determined by using a probe.)

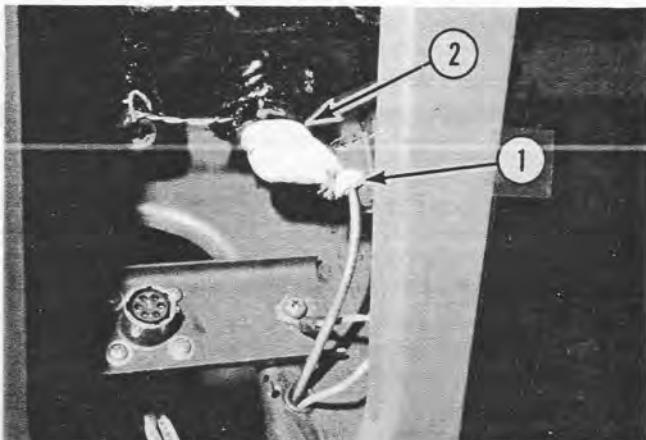
A recent report from the field referred to a flickering chip detector light. During trouble shooting, one of the rubber boots covering the stud and terminal of a chip detector was found to contain water. Since further investigation did not reveal a gearbox failure or contamination, it was apparent that the flickering light was caused by the water trapped in the boot. Photo A typifies what occurred. The boot was lace-tied at the wire end (1) and left untied at the terminal end (2). Water found its way into the boot (during washdown or heavy rains) and was trapped by the tied end. It is accepted practice to tie both ends of a boot to ensure proper installation; tying only the lower end is almost a guarantee of water entrapment and subsequent problems.
