*Rotor Tips*

JULY-AUGUST, 1973

Volume VII No. 11

## TECHNICAL SECTION

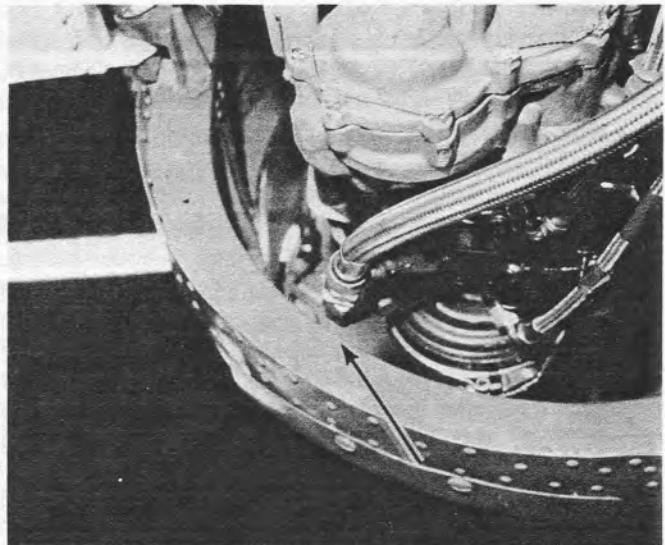
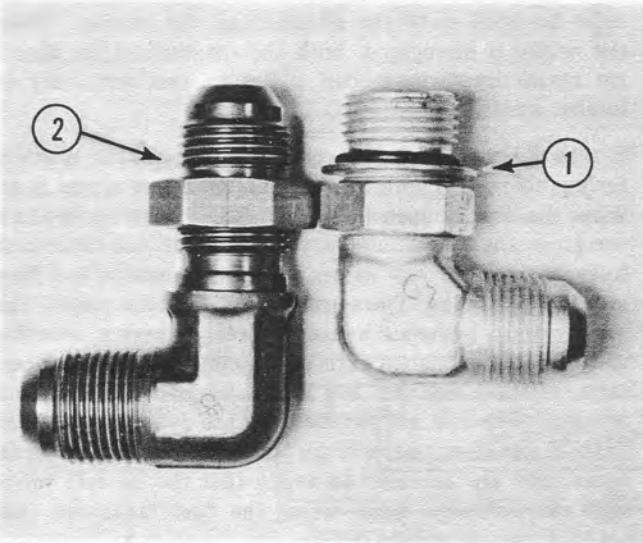
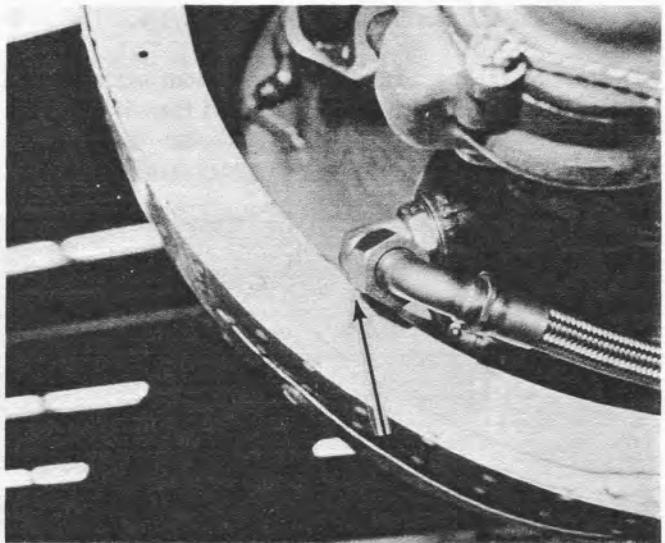
A recent report indicated an unauthorized substitution in the fuel inlet line at the centrifugal purifier, was causing interference with the nose cowl frame member. Subsequent investigation revealed that the elbow, P/N 10C50X-S, called out in the IPB had been replaced with a standard AN833 elbow. (Refer to NAVAIR 01-260HCB-4-5, dated 1 May 1969, Changed 1 February 1973, Figure 7A, index number 30.) The result of such incorrect substitution can be seen by comparing Photos 1 and 2. Photo 1 shows the correct elbow installed; note the clearance (arrow). The arrow in Photo 2 shows the interference between the engine cowl and the elbow when an incorrect elbow is used.

Since engine location within the fixed position cowl can vary as a function of engine alignment, the clearance between the cowl and the fitting will vary. The normal clearance, using the correct elbow fitting is 0.25-0.50-inch. The standard AN elbow is approximately 5/8-inch longer than the correct elbow as shown in Photo 3. MORAL: Do not make unauthorized substitutions.

1. Elbow, 10C50X-S
2. Elbow, AN833

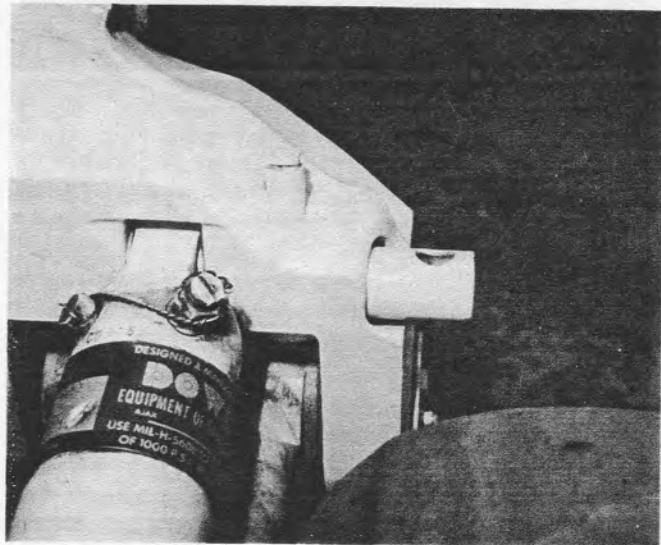
Photo 1

The corrosive action of salt spray from overwater flights and/or shipboard operations can ultimately cause the liquid spring upper shaft, P/N 3283129-3, to seize. A review of the situation has resulted in a design change to facilitate shaft removal.

As shown in the accompanying illustration and Photo 1, the new retaining pin protrudes above the landing gear main member 1/2-inch and is designed with integral wrenching flats. The new shaft protrudes beyond the side of the

New Installation Consisting of:  
Shaft-3283096-1  
Retainer Pin 3283097-1  
Bolt, Self-Lock MS21295-56  
Washer-AN960-C416

main member approximately 1-inch and is provided with wrenching holes (Photo 1). To remove the shaft, after removal of the retaining pin, insert a rod through the wrenching holes, rotate and remove the shaft.

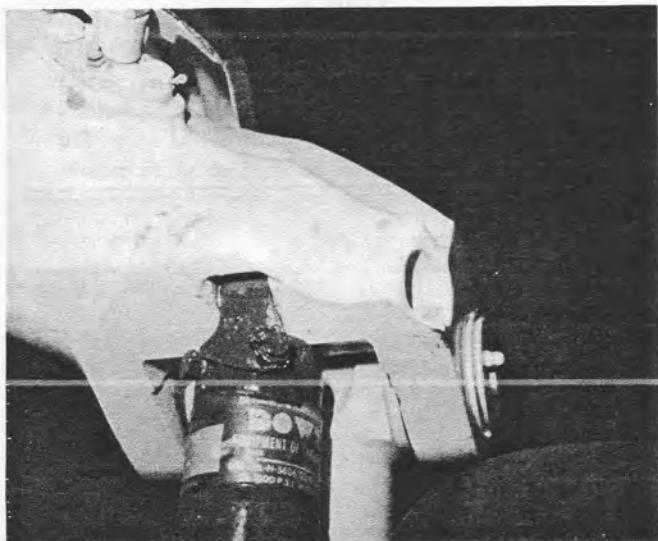
The following removal procedure for the present shaft, shown in Photo 2 (P/N 3283129-3), is recommended when changing a liquid spring:

It is possible that after prolonged exposure to a corrosive environment, the shaft may be so tightly seized that the preceding removal efforts will not be successful. Rather than replace the complete main landing gear, the following procedure is recommended:

Shaft-3283129-3  
Retainer Pin-3283134-1  
Bolt-MS21094-4008  
Washer-AN960-C416

Pending conversion to the new shaft and retaining pin, a Special 245-day removal, cleaning, and lubrication requirement has been established for the present installation in accordance with NAVAIR 01-260HCB-6-3, 1 October 1971, Maintenance Requirement Cards (MRC) Number 35, item 4.

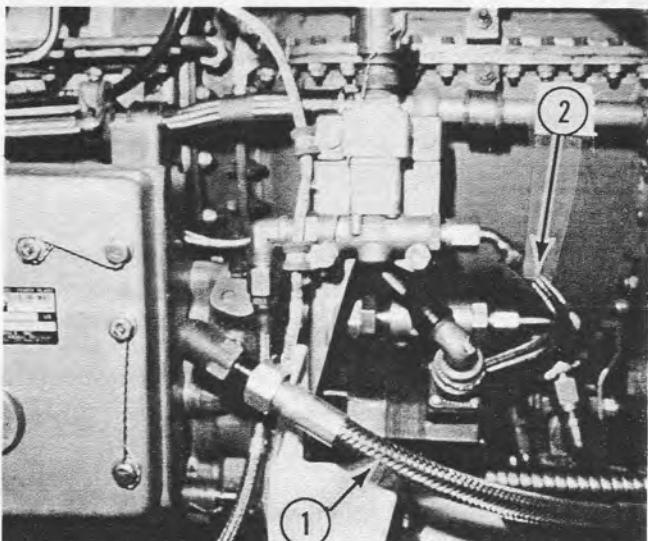
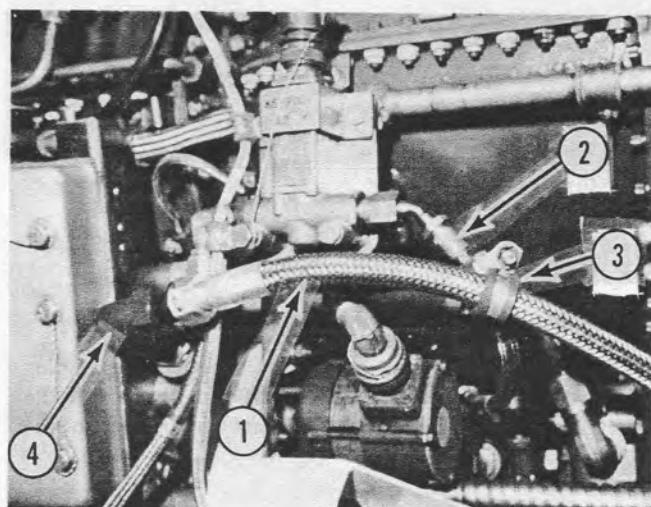
1. Remote topping cable
2. Battery start fuel line

3. Clamp-up
4. Right angle driver assy.

MS21919H8 clamp on the topping cable. Secure the clamps with an MS27039-1-08 screw, two AN960PD10L washers (under head and nut) and an NAS679A3 nut. It is suggested that detachments inspect the LH engine remote topping cable for evidence of chafing. If damage is evident, replace the assembly and add the clamps. If no damage is found, add the clamps to prevent damage from occurring.
