Rotor Tips

Volume VIII No. 6

Table of Contents

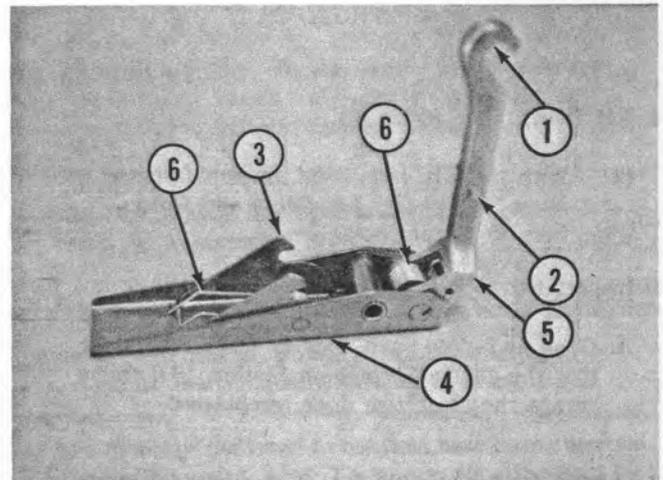
PHOTO 1

Investigation of recent nose door Hartwell Fastener malfunctions revealed that nose door misalignment results in a preload on the fasteners, causing distortion, premature wear, loss of toggle hook tension and ultimately, fastener dis-engagement. In some instances, the preload has been severe enough to cause material failure. Unless lower door replacement hinges are installed in the EXACT position as the original hinges, door misalignment will occur. Whenever door misalignment is evident and whenever fastener latching integrity is in doubt, the following actions should be accomplished.

- A. Toggle hook (1) for wear and distortion.
- B. Toggle hook pins (2) for distortion.
- C. Base of toggle hook (5) for distortion and cracks.
- D. Toggle hook detents (3) for wear and distortion.
- E. Handle (4) for cracks and distortion.

1. Toggle hook	4. Handle
2. Pin	5. Base
3. Hook detent	6. Springs (2)

1. Inspect the Fasteners. (See Photo 1.) Any discrepancy is cause for fastener replacement.

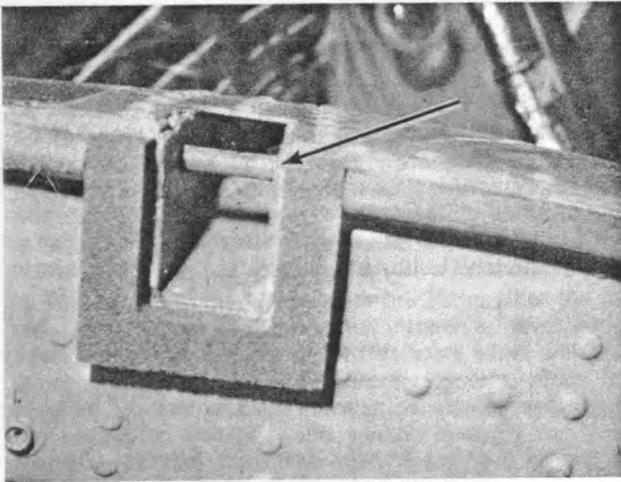
PHOTO 2

LH Door - toggle hook engaging pin
(arrow)

- (1) Inspect the engaging pin for wear and corrosion.
- (2) With the door open, inspect the pin support bracket for pin hole elongation and/or cracks.

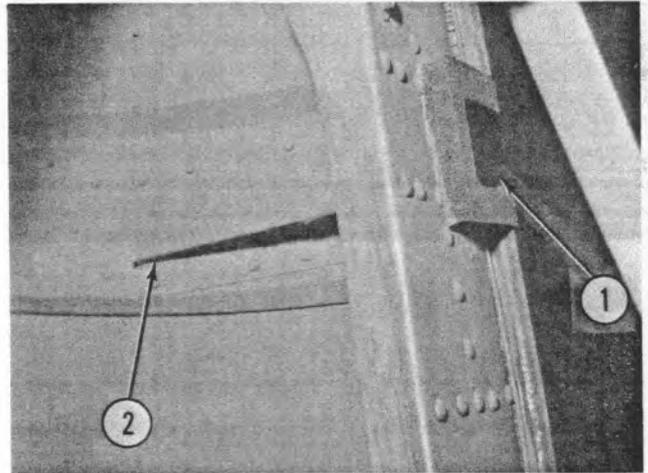
PHOTO 3. Inside LH Door

1. Pin support bracket
2. Cutout for engaging pin
(Photo 2)

Hold doors in closed position and check for alignment of the fastener cut-outs. If alignment is satisfactory, proceed to Step 5. If fastener cut-outs are misaligned to the extent that one door must be "sprung" in order to engage the alignment pins and to latch the fastener, the "low" door should be shimmed to obtain alignment. (Nose door shimming will be defined as a repair function in the next revision of the Structural Repair Manual, NAVAIR 01-260HCA-3, and is within Organizational Level capability.)

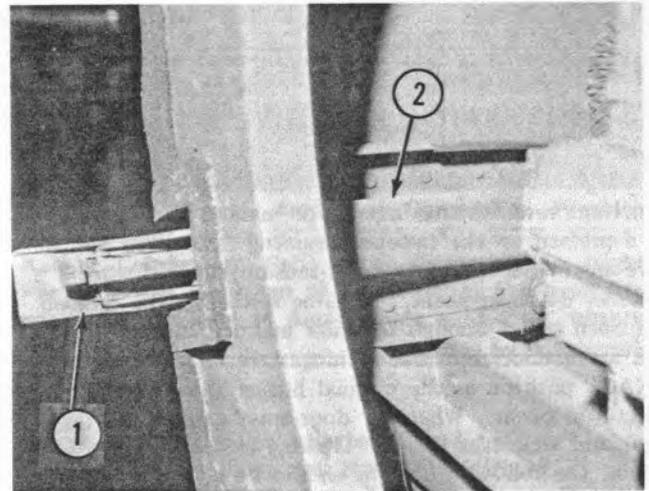
PHOTO 4. RH Door (inside)

1. Toggle hook
2. Fastener hinge pin support bracket

- (1) With the RH door open, inspect fastener hinge pin bracket for cracks and elongation of the pin holes.

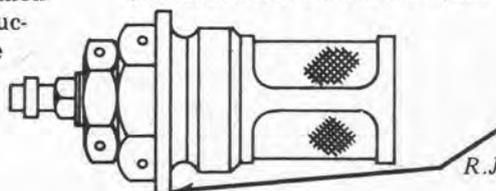
REWORK FLAT
AREA 360°

A. A main gearbox oil monitor could fail to operate when dirt or corrosion builds up on the surface which mates with the grounding tab, P/N K678773-11. The foreign material would inhibit continuity between the center post of the monitor and ground, rendering the monitor electrically inoperative. To assure electrical conductivity, the dirt or corrosion must be removed from the surface as shown in the illustration. To remove the material, remove the monitor from the aircraft and use aluminum oxide cloth, Specification PC451, fine grit, or an equivalent. After cleaning, apply al-

A few monitors delivered to the field have been anodized in the mating surface area. The anodize coating must be removed in order to provide proper electrical ground. Remove the anodize coating in the same manner as described above for corrosion/dirt.

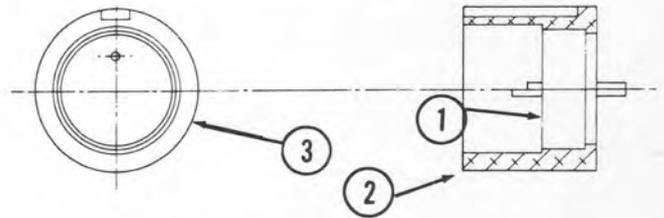
FIGURE No. 4

The adapter assembly, Figure 4, can be very difficult to remove due to close tolerances and/or corrosion. If the adapter assembly cannot be eased from the cyclic stick, the connector will most likely be damaged and a new one will be required.

1. Connector, M8601-19/32
2. Adapter, K651064-1

3. NOTE: Number 8 pin on M8601-19/32 must be located on centerline of groove within $1/2$ degree. Bond M8601-19/32 in place.

3. If necessary, break the bond between the adapter/connector by pushing the connector up into the stick. Remove the adapter ring with a small gear puller. If the connector is to be replaced, cut the wiring as close to connector pins as possible.

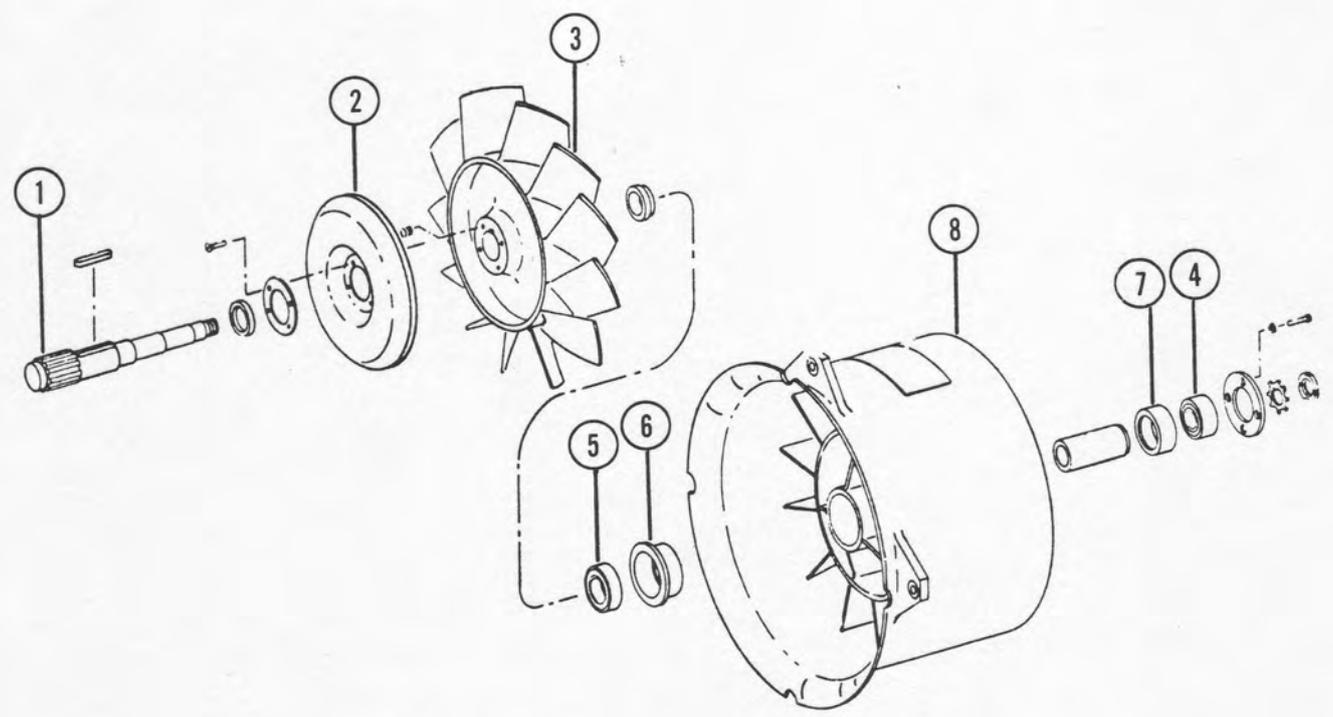
OIL COOLER BLOWER ASSEMBLY - EXPLODED VIEW
HH-2D, SH-2D/F

Trouble	Probable Cause	Remedy
Scraping noise.	Fan rotor blades contacting casing inlet bore.	Remove fan rotor and inspect, repair, or replace in accordance with Table 2 and the accompanying illustration.
Vibration or noisy operation.	Bent shaft.	Replace blower assembly.
	Defective bearings.	Replace bearings.
	Rotor out of balance.	Replace blower assembly.

Component	Inspection	Repair Action
Shaft, item 1	Inspect spline stub for wear. Dimension over 0.1200-inch diameter inspection pins shall not be less than 1.6801 inch.	Replace blower assembly.
	Inspect keyway for wear. Width shall not exceed 0.252-inch.	
	Inspect bearing journals for evidence of bearing slippage and scoring.	
	Inspect threads for cross-threading and stripping.	
Spun nose, item 2	Inspect for cracks and breaks.	Replace blower assembly.
Rotor, item 3	Inspect rotor blades for nicks, burrs, cracks and breaks.	Remove nicks and burrs from blades max depth 0.050-inch.
	Inspect hub bore and keyway for damage. Bore shall not exceed 1.189 inches. Keyway shall not exceed 0.252-inch width.	Replace blower assembly.
Bearings, items 4 and 5	Conditional/Visual	Replace as required.
Casing assembly, items 6, 7 and 8	Inspect inlet bore of casing (8) for evidence of rotor contact, nicks and burrs.	Remove nicks and burrs max depth 0.080-inch.

Inspect bearing retainer (6) and bearing insert (7) for evidence of bearing slippage and scoring.	Replace blower assembly.
	Inspect casing (8) for any physical damage, such as cracks and breaks.	Any physical damage is cause for replacement of blower assembly.
Bearing retainer, item 6	I.D. bore shall not exceed 2.027-inch.	Replace blower assembly.
Bearing insert, item 7	I.D. bore shall not exceed 1.830-inch.	Replace blower assembly.

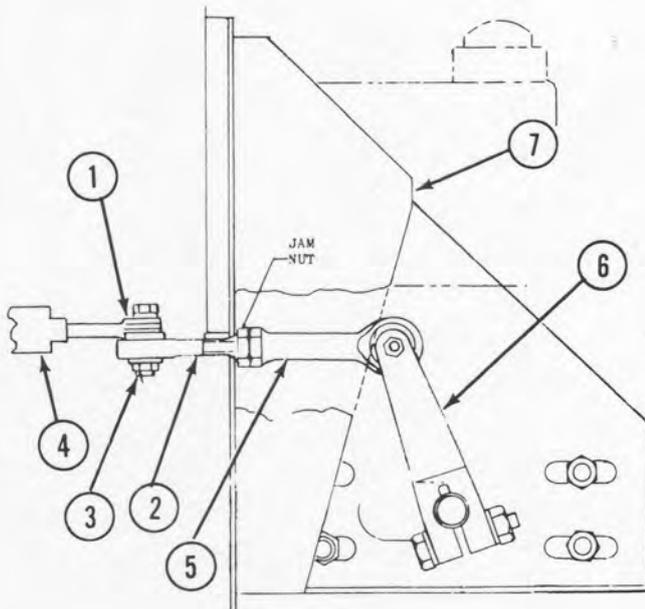
DIAGRAM A

In certain instances, the support bracket linkage hole may prove to be too small to allow adequate clearance for both the link assy and the link assy rodend bolt-stackup as shown by items 1, 2 and 3 of Diagram A. This is caused by variations in the amount of travel of the fuel control rack. If interference is encountered, it is permissible to enlarge the hole as necessary to provide adequate clearance in area shown by Arrow Number 4, Diagram B.

The support bracket, P/N K673059-3, can also be rotated a small degree in order to provide adequate clearance for the link assy, K673068-3. To ensure clearance, loosen the attaching bolts, rotate the support away from the interference, and re-tighten the bolts.

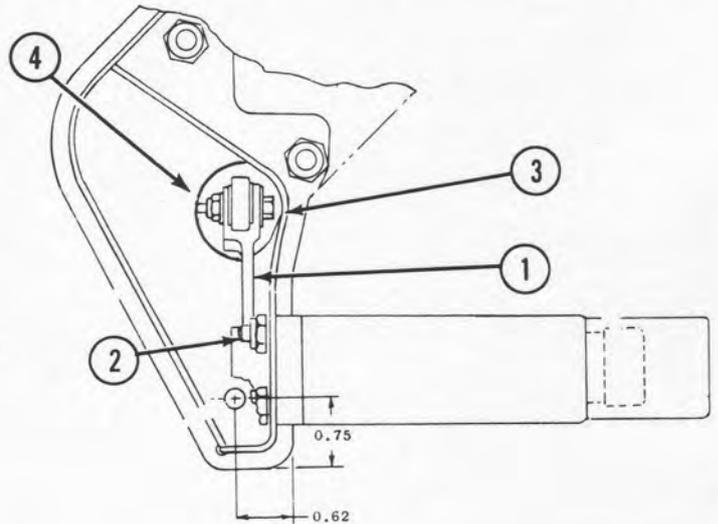
DIAGRAM B

Diagram B, is positioned with the offset side of the arm facing away from the actuator, and flush with the end of the spline shaft (2). This will prevent the link assy from rubbing against the support bracket assembly at position 3, Diagram B, and will center the link assembly so that it will pass through the support bracket linkage passage hole.

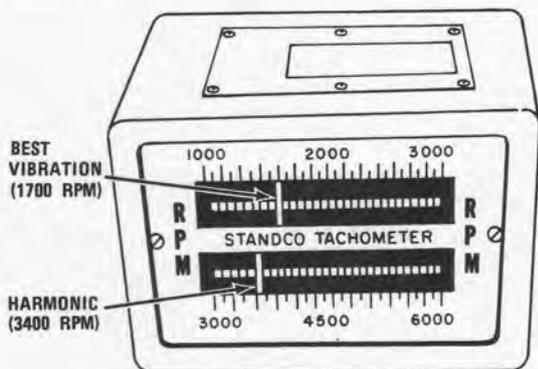
The illustration depicts a vibratach which is indicating a tail rotor vibration. Note that the 1700 reed is displaced full scale. This indicates that we have a one-per-rev of the tail rotor. Note also that the 1200 scale is static. Why check for main rotor four-per-rev, in this case, when the problem is in the tail rotor? Make Sense? Since you now know what to use for troubleshooting, we would be doing half a job if we didn't tell you where it can and cannot be used.
