Rotor Tips

JANUARY-FEBRUARY, 1975

Volume VIII No. 8

TECHNICAL SECTION

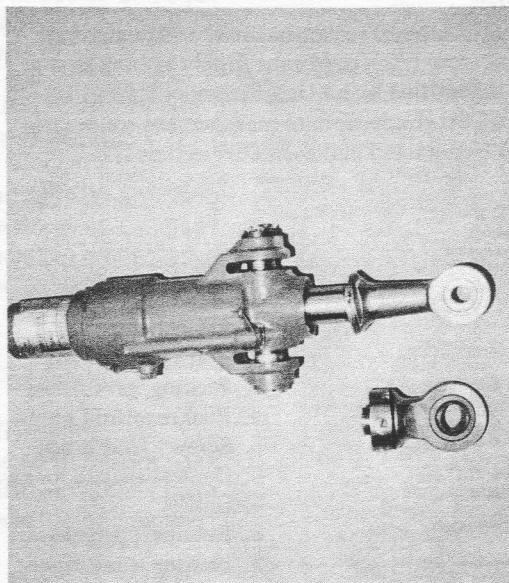
Photo A

1. 100934 Washer
2. 100899 Rodend

Damper rodends should be removed and installed in accordance with NAVAIR 01-260HCA-2-4.2.

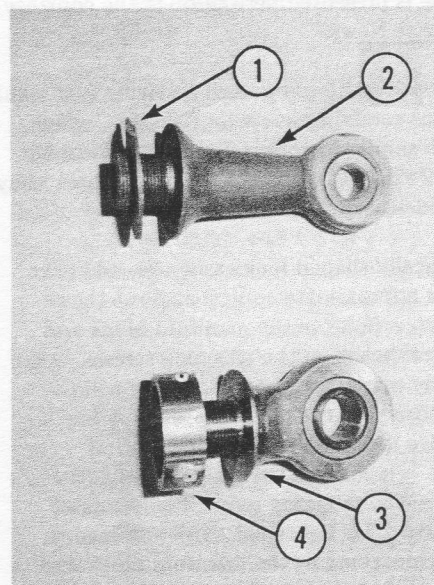
Photo B shows a closeup of both rodends and spacers. When Items 1 and 2 are installed on a damper, its part number is K610029-1 and/or 101264. When Items 1 and 2 are removed and Items 3 and 4 are substituted, the damper is re-identified as a K610100-1 assembly. If serviceable, (up to 0.006 radial play allowable on K610029-1 damper rodend and 0.010 radial play on K610100-1 rodend) a rodend may be removed from a failed damper and re-used on an RFI (Ready For Issue) damper assembly.

3. K610098-1 Rodend
4. K610108-1 Spacer

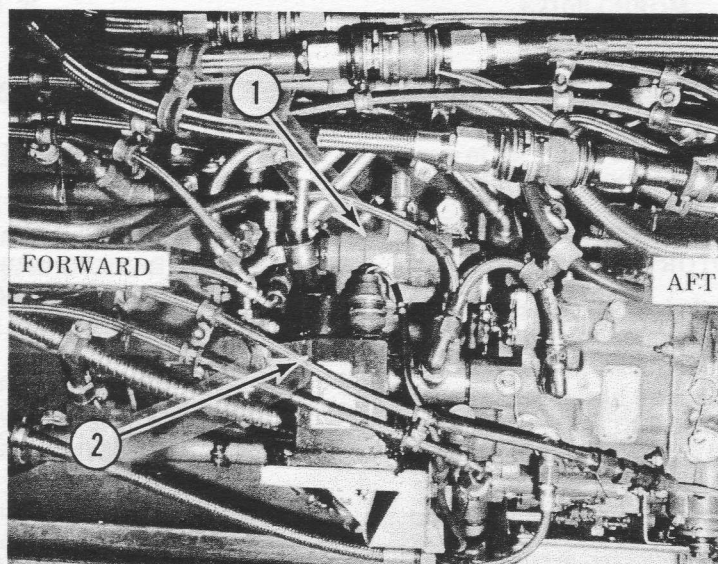
VIEW LOOKING UP AT BOTTOM OF ENGINE

Correction of fuel leakage at the flow divider, item 1 in the accompanying illustration, often involves removal of the fuel manifold block and replacement of the gasket, seals, packings and retainers. When re-installing the manifold block, it is most important that the proper conical-shaped lockwashers be installed under the head of the block retaining screws and that the torque callouts and tightening sequence per NA 02B-105AHD-6-1, Figure 4-17, be observed. The following excerpt from a GE News article is presented here through the courtesy of the GE Jet Service News.

The conically-shaped lockwashers should have the same approximate conical-angle as the recessed screw holes in the manifold block and the conical heads on the retaining screws. Also, a properly manufactured lockwasher will fit rather loosely on the retaining screw, while a defective lockwasher will fit tightly. If the angle is incorrect, the lockwasher will split when the retaining screw, Part Number AN510C10-20 is tightened. This will lead to eventual loosening of the manifold block and fuel leakage between the block and the flow divider.

1. Flow divider
2. Bolt - (12 point)
3. Packing, preformed
4. Fuel manifold block
5. Screw - (flat head)
6. Conical-shaped lockwasher
7. Gasket
8. Retainer, packing
9. Packing, preformed
10. Retainer, packing
11. Seal

If improperly manufactured lockwashers are detected, the cognizant supply agency should be notified by an Unsatisfactory Report or by other appropriate means so the source can be contacted and corrective action taken.
