Rotor Tips

MAY-JUNE, 1975

Volume VIII No. 10

TECHNICAL SECTION

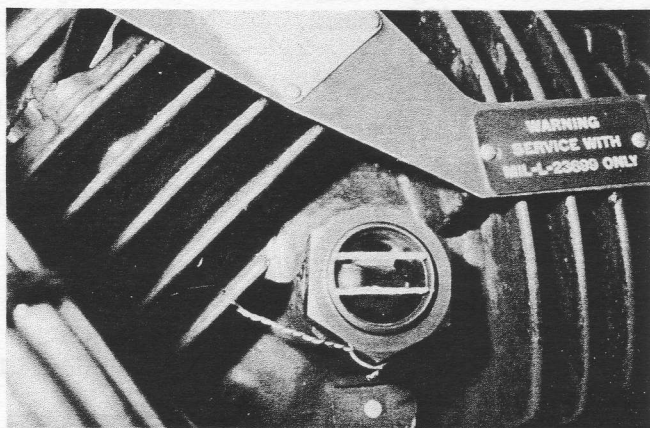
INTERMEDIATE AND TAIL ROTOR GEARBOX SIGHT GAGES

New oil level sight gages will soon be available for Fleet use. The P/N S51E gages replace the old gages, P/N K671433-1. The S51E gages, shown in the accompanying photo, will improve the ease and accuracy of visually checking oil levels in the tail rotor and intermediate gearboxes, thus reducing maintenance time. Note the aluminum ball which floats with the sump oil level. When the ball is raised to the top line, as shown, the oil level is adequate; when the ball is seen below the lower line, it indicates that the oil reservoir needs to be serviced.

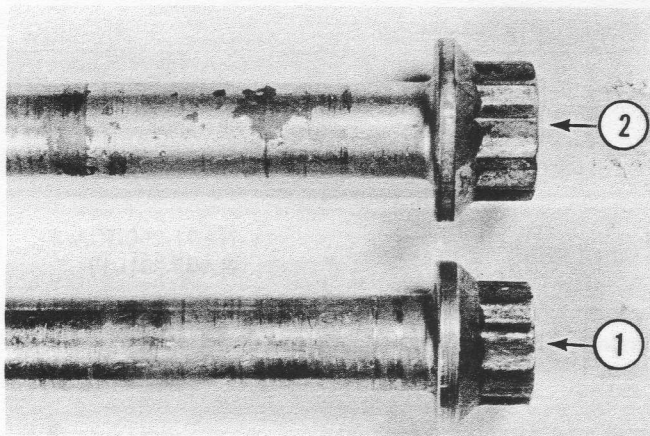
PHOTO 1

1. Bolt, P/N LWB-22-7-46 - NOT FOR SH-2F
2. Bolt, P/N K618769-11 - SH-2F APPROVED

Although the bolts shown in Photo 1 have the same shank diameter, they are not identical because one has a higher tensile strength and a larger bearing head as can be seen in Photo 2. The larger-head, higher-strength bolt, P/N K618769-11, is used on the SH-2F aircraft. While the stronger bolt may be used on all H-2 aircraft, in no case should the smaller-headed bolt, P/N LWB-22-7-46, be used on SH-2F aircraft. The bolt secures the main rotor hub to the main transmission as seen in Photo 3. When installing the bolts be sure to use new PLI washers, P/N PLI7-14.4.

The quickest method of determining if the proper bolt is installed is, the SH-2F bolt, P/N K618769-11, requires use of a 9/16-inch, 12-point socket or box end wrench and the LWB-22-7-46 bolt requires a 1/2-inch, 12-point wrench.

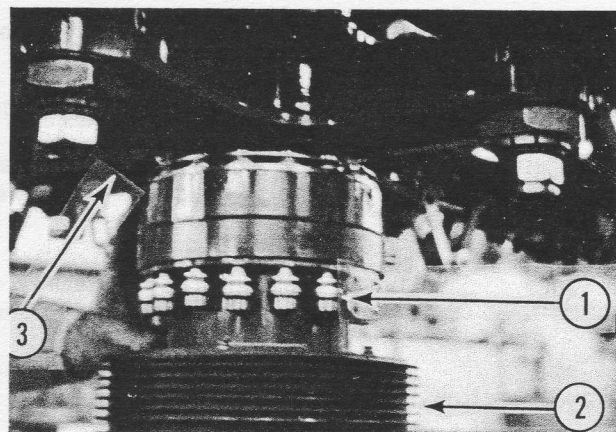
PHOTO 3

1. Bolts with PLI washers (untightened).
2. Transmission with slipring assembly.
3. Rotor hub.

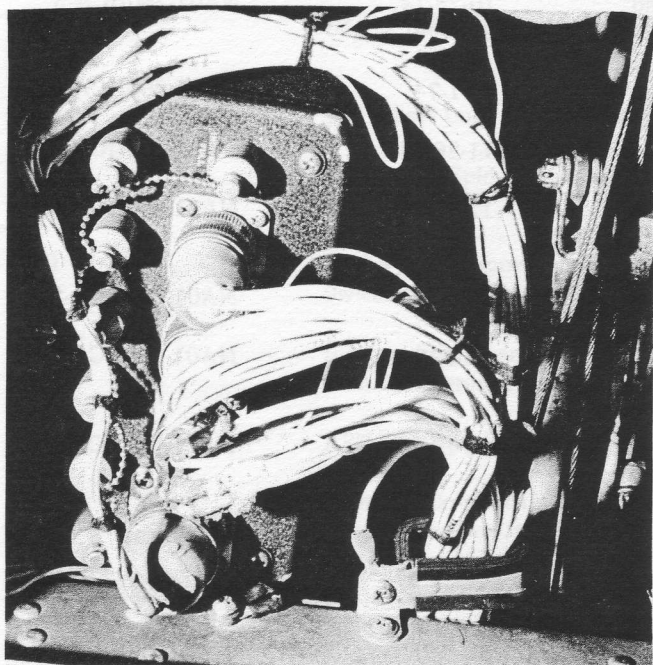
What's Wrong???????

A major maintenance error is visible in the accompanying photo. The area shown is the fuel quantity amplifier and related wiring located beneath floor, aft of pilot's seat. For the answer refer to page 14.

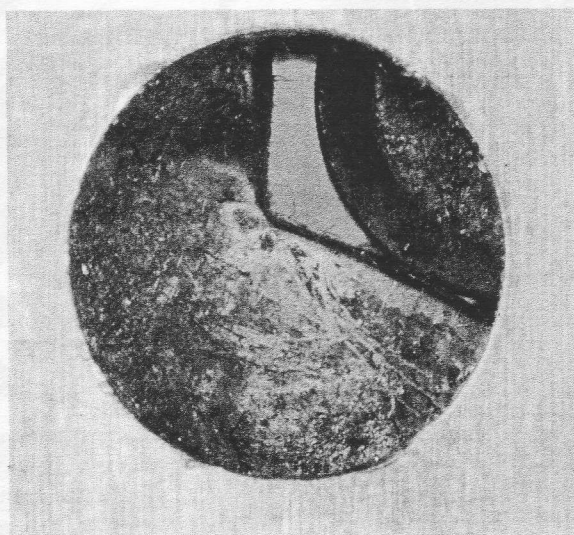
Correct View
PHOTO A

Several recent UR's report aux tanks dropping to the deck when the ground safety pins were removed. Review of information contained in the MMI, NAVAIR 01-260HCA-2-4, revealed that the procedures are correct and adequate to properly accomplish the rigging. Photo A shows a close-up of what should be observed when looking through the inspection hole. Before withdrawing the ground safety pin, be sure the cam-angle is as shown.

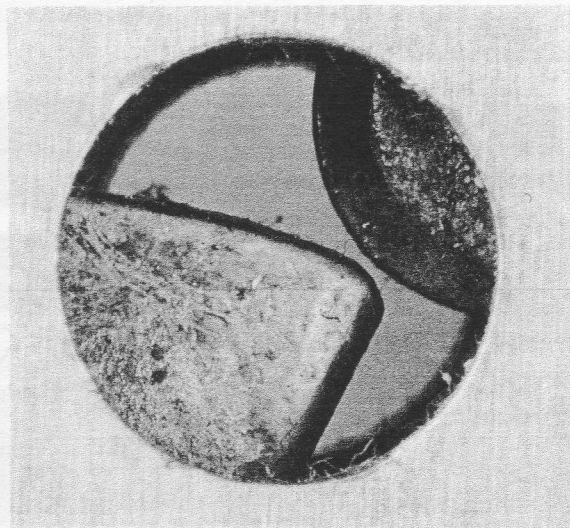
Photos B and C show unsafe conditions. If the cam/roller position resembles these photos, DO NOT remove the ground safety pin. Instead, remove the shackle access panel on top of the aux tank support and determine why the shackle release lever is not correctly positioned at the aft end of the lever slot as shown in PHOTO D.

- Release cables not rigged per the MMI (Cable Tension too tight).
- An interference exists somewhere in the release cable routing.
- The electrical jettison system had been activated.

Unsafe view . . .
suspect binding or improperly rigged cable.
PHOTO B

Any of the three possible causes will result in the visual indication of an unsafe shackle as shown in Photos B or C (when viewed through the inspection hole). Complete rigging instructions are included in a previous KRT article (September-October 1972 issue) and the MMI.

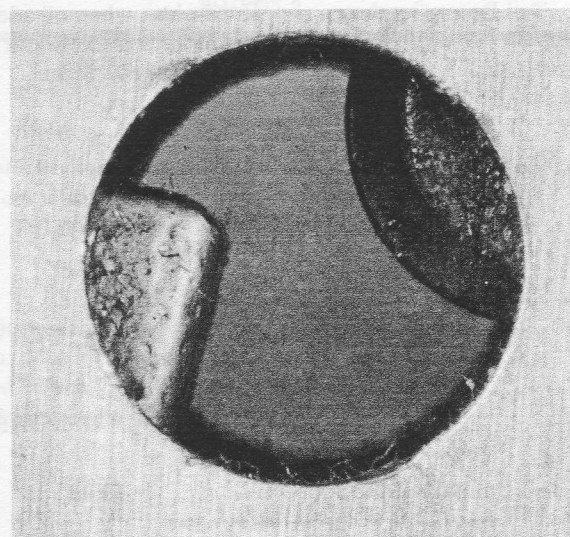
PHOTO C

Photo E applies to SH aircraft only because it deals with the aux tank electrical solenoid release mechanism. Note that the solenoid has been activated and is pressing against the shackle release lever, forcing it to the forward (release) position. If inspection reveals a condition as shown in Photo C, suspect that the solenoid has been activated. Do not remove the ground safety pin. If the condition shown in Photo E is discovered, recocking of the shackle and solenoid is required. The latched position for the solenoid is as shown in Photo D. Note that the solenoid plunger is retracted and the release lever is aft.

Unsafe view . . .
If inspection reveals this condition, suspect solenoid activated.

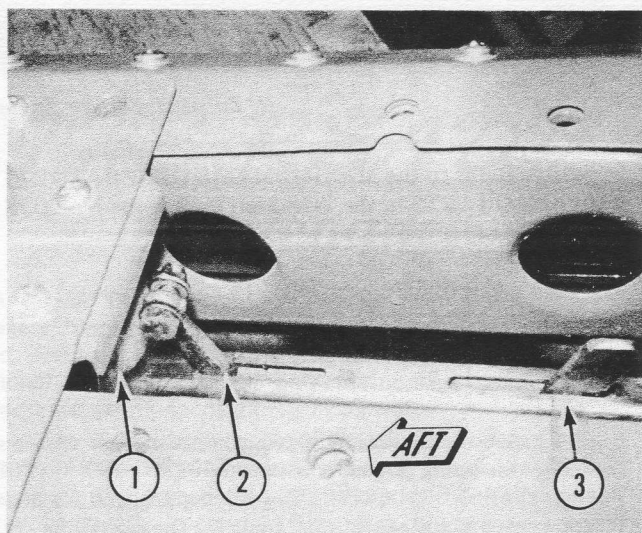
PHOTO D

Shackle release lever must be at aft end of lever slot as shown.

1. Electrical solenoid
2. Shackle release lever
3. Shackle cocking lever

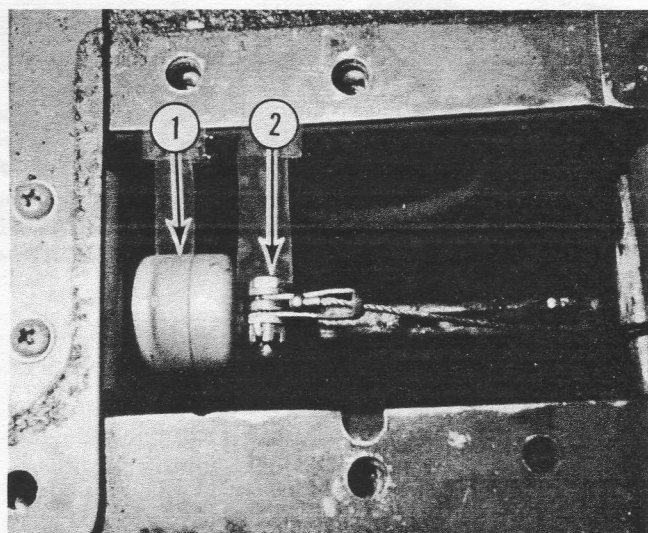
PHOTO E

Activated solenoid plunger, item 1, pressing against release lever, item 2. Unsafe view . . .

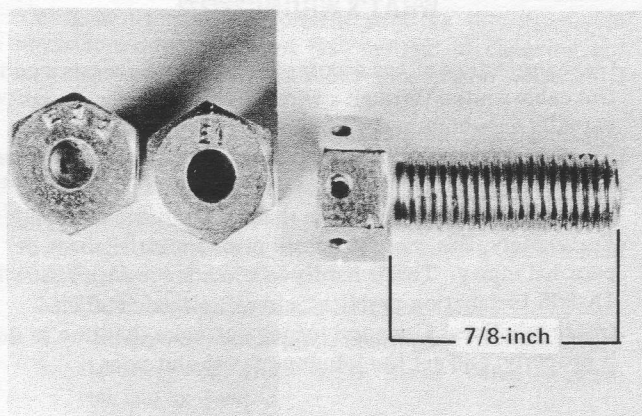
PHOTO 1

A recent inspection of the forward engine mount installation, P/N K672751-3, revealed the presence of unauthorized and, in some instances, unsafe mount bolts (too short). The correct bolt, P/N AN103912, shown in Photo 1, has a 7/8-inch threaded grip length, a recessed head with 6 lockwire holes, and the marking E11 or E1. (The E11 mark supersedes the E1 mark.) The markings identify the material specification and heat treat condition: IT DOES NOT INDICATE BOLT LENGTH! For example, Photo 2 shows a bolt with the E11 marking; however, note also that the head is solid, has only one lockwire hole, and only a 5/8-inch threaded grip. This bolt must not be used in the engine mount installation. Photo 3 shows the correct and incorrect bolts inserted in the engine mount fitting. Note the difference in threads available for engagement.

To inspect for correct length of installed bolts, insert a thin three or four-inch long piece of wood or aluminum into the open end of the bolt holes from inside the engine air inlet. Bottom the "gage" against the end of the installed bolt and make a pencil mark, flush with the end of the bolt

hole. Withdraw the "gage" and measure the length from the pencil mark to the end which butted against the bolt. If dimension is more than 3/8-inch, the bolt is too short and should be replaced with an AN103912 bolt.

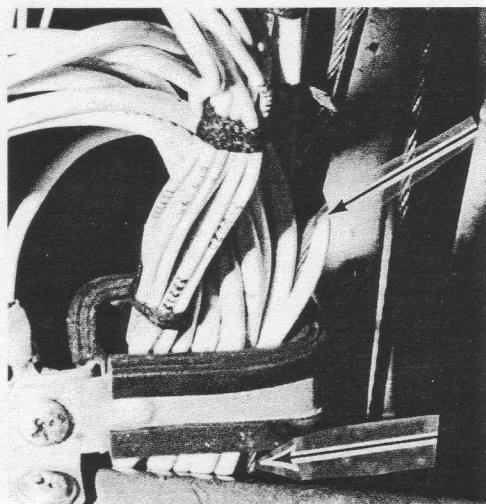
WHAT'S WRONG??????

Close inspection of the accompanying photo reveals a control cable routed through a wire harness cable clamp apparently accomplished subsequent to re-wiring/repair! Note the cable entering at upper arrow and leaving at lower arrow. This particular cable was...the aux tank jettison cable running from the bomb shackle up to the cockpit. Fortunately, this was discovered prior to fire, damage or personal injury. This is hardly in accordance with NA01-1A-505 Installation practices; aircraft electric and electronic practices. Use good judgement, take the time to do it properly, and get the job done faster and safer.

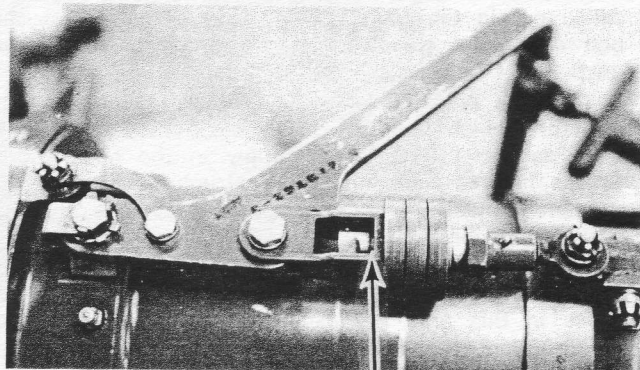
simple visual check for the required dimension is sufficient to insure proper adjustment as can be seen in the Photo. One final point on folding pin torques: any pin which continually loosens after repetitive retightening should be removed and checked for proper seating. Check the MMI for correct procedures.

Gap (0.068-0.088) must be visible at arrow.
Folding Lock Dimension

Folding pins and folding locks require proper seating and torque in order to minimize four-per-revs. It does not take much time to check each folding pin for proper torque (using a torque wrench), whenever the gripe is written up. Always check for correct torque in the tightening direction. If the nut breakaway is below 350 foot-pounds, continue tightening (up to 400) in order to achieve cotter pin alignment. If the torque wrench reaches 350 without the nut turning, the pin is properly torqued and no action is required other than installing a new cotter pin. Where the folding locks are concerned, a

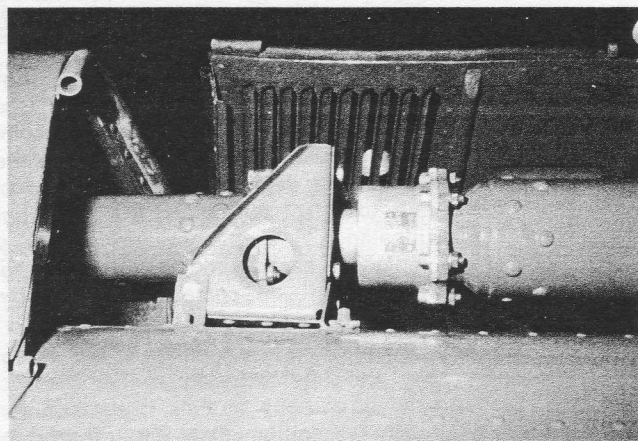
Tail Rotor Drive Shaft and Coupling

Troubleshooting pillow support bearing problems is generally straightforward and logical with one exception. A bearing malfunction will usually show up via a discolored temp plate; however, remember that the bearing is mounted in a universal housing of the "uniball" type in order to allow for self-centering during normal operation. Prolonged inoperation, particularly in humid weather, can allow fretting corrosion to form and the bearing mount to "take a set." When this happens, the self-aligning feature is defeated and troubleshooting can become difficult. For example, recently a temp tape on a drive shaft coupling turned black. The coupling was replaced and the new temp plate turned black while the temp plate on the bearing remained white. The mechanic assumed the drive shaft was at fault, and, it was the next item to be replaced, but again the temp plate turned black. Finally, the coupling was disassembled and a frozen uniball was discovered. Light oil was applied to the bearing area and it was "worked" with the hands until it loosened and pivoted freely, then it was re-installed. A subsequent 15-minute hover disclosed the coupling running cool to the point that the bare hand could be held on it immediately after aircraft shutdown. The point here is that whenever tail rotor drive shaft

components are disassembled, check the self-aligning feature on the support bearing. Apply light oil and check that each is free to pivot to any angle within its range. You might be saving some work you would otherwise be doing later. Another point to remember is to use the proper coupling in the proper location. According to the IPB, the PD 854 coupling is to be installed in the "A" location only, while the coupling used in other locations is the PD 832. (The PD 854 coupling can be identified by its longer hub which contains a slot.)
