# KAMAN *Rotor Tips*

Volume III Number 4

August-September, 1963

# MODIFIED FIRE SUPPRESSION KIT

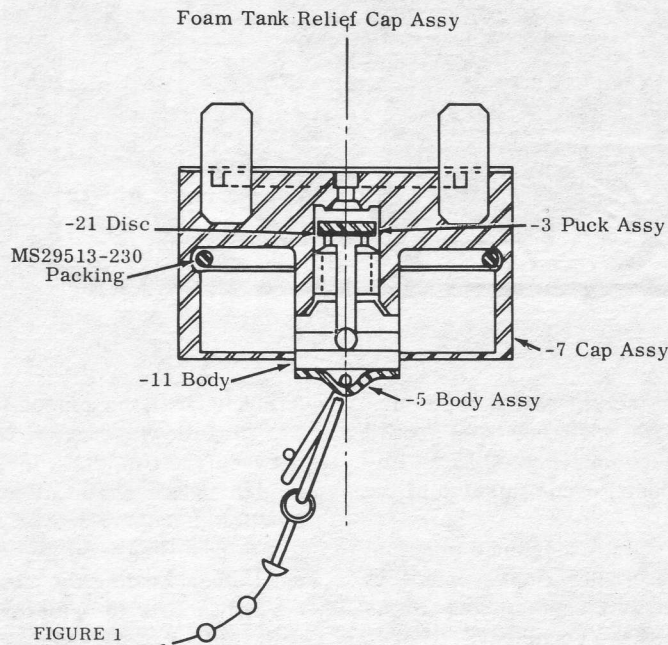
Description of Change - Combination foam-tank filler cap and relief valve incorporated to relieve internal pressure buildup which prevents rich foam mixture at discharge.

Special Maintenance Requirements - Following each FSK discharge, remove the -11 body (threaded) from the -7 cap assembly using caution not to lose the -3 puck assembly. Clean thoroughly with water and reinstall the -11. Make certain the rubber disc of the -3 puck assembly faces top of cap. (Ref. Fig. 1)

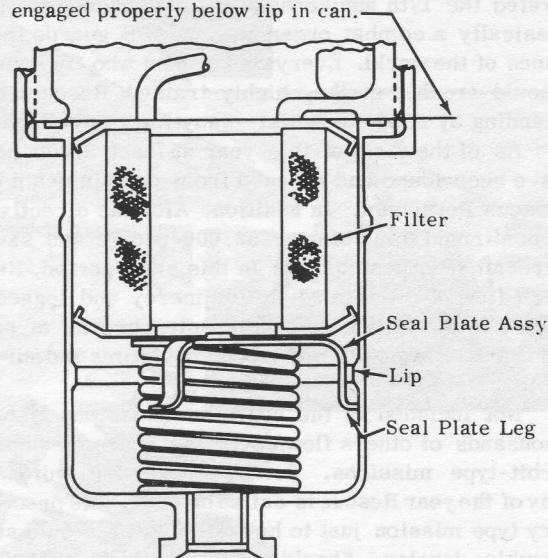
Top of filter must be able to compress below this surface by hand pressure. This will verify that seal plate leg is engaged properly below lip in can.

**Q.** (Applies UH-2A, UH-2B) WHEN ASSEMBLING THE MAIN FUEL FILTER, WHAT PROCEDURES SHOULD BE USED IN ORDER TO PREVENT CRUSHED STRAINERS?

**A.** Before installing filter can on the housing, the seal plate assembly and strainer should be inserted into the can. The three legs of the seal plate must be below the lip within the can. The strainer is then inserted on top of the seal plate. Slight pressure at the top of the strainer will allow the spring to compress and indicates correct assembly. The can is then assembled to the housing. NOTE the position of the seal plate legs below the lip of the can in the drawing.

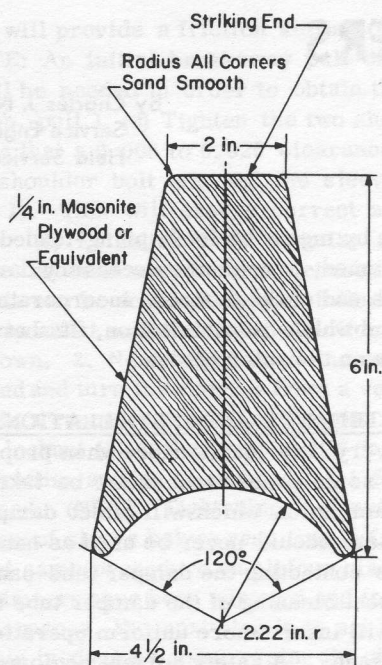
**Q.** (Applies UH-2A, UH-2B) DUE TO THE TIGHTNESS OF THE FIT BETWEEN THE RETENTION AND CROSS ASSEMBLY BUILDUP IN THE ROTOR AREA, MECHANICS MAY EXPERIENCE SOME DIFFICULTY WHEN ATTEMPTING TO POSITION THE K618415 BEARING RACE. WHAT SIMPLE TOOL CAN BE FASHIONED WHICH WILL AID THEM IN PERFORMING THIS TASK?

**A.** A tool with a concave cutout such as the one shown in the drawing can easily be made by mechanics and will aid in positioning the bearing race. First install the cross assembly buildup between the retention ears (assistance may be required to maintain the relative position of these parts), then place the tool cutout against the protruding race. Gently position the race by using the palm of the hand to strike firm blows on the end of the tool. If the tightness of the fit requires considerable force to position the race, it is suggested thinner shims be substituted, keeping in mind that the tolerances specified in the maintenance handbook must be maintained. With the race positioned in the approximate area, insert alignment tool P/N K604734-1 into the retention flapping bearing. Rotate the tool until the "pick-up" tooth centers all spacers and shims between the cross assembly and retention ears. Remove the

alignment tool and install the spindle. After the spindle has been secured, use the tool with the cutout to align the bearing race with adjacent component parts if necessary. (Never attempt to position the bearing race by tapping with a hammer or other hard object. This damages the outer surface of the bearing and can lead to shortened life of the component.)
