# *Rotor Tips*

## Rotor Tips

Volume VI Number 5

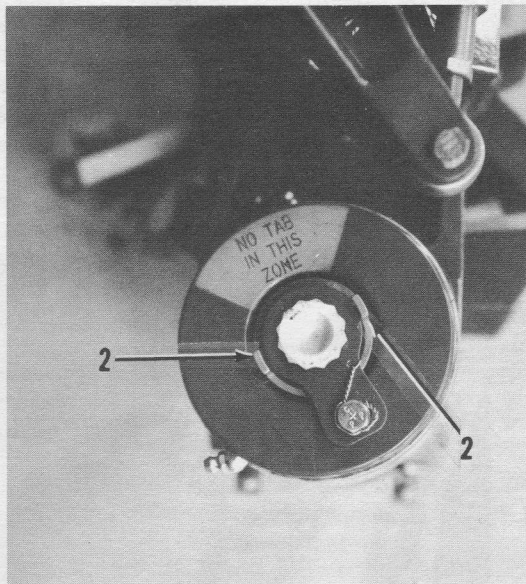
A

AFC 100 introduced new bolts and PLI washers to retain the main rotor blade retention assembly spindles. Move-

1. Screws
2. Tab ring
3. PLI washer

ment of the PLI washer tabs (item 2, Photo A), can indicate one of the following: Loss of torque on the spindle attaching bolt, P/N 65694-18H; or a looseness of the screws which attach the tabs to the lockwasher. Photo B shows the PLI washer assembly. The three screws (item 1, Photo B), secure the tab ring to the PLI washer. If one or more of the screws become loose, the tabs will move even though the washer is securely held in place by the bolt head. If the screws loosen while the PLI washer assembly is installed, tab movement will be slight. If a loss of torque were to occur, considerable rotational movement of the tabs will be evident when checked. This information will be incorporated into applicable handbooks by a future change.

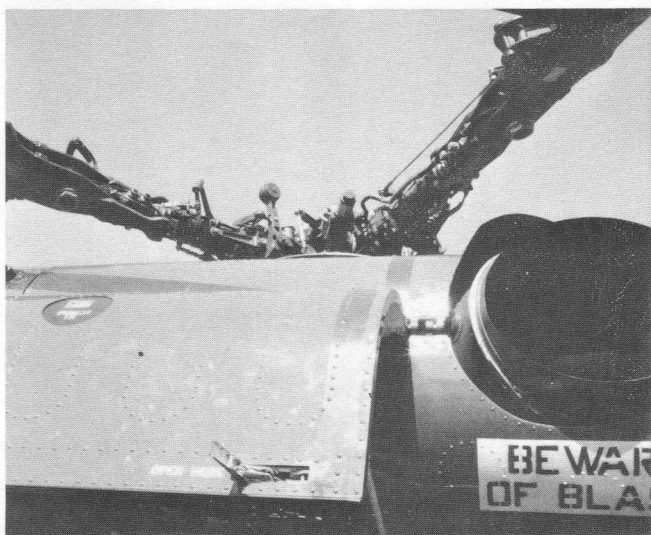
PHOTO A

Well--the object can easily be seen in the close-up Photo B. Obviously, the roll of lockwire was not intended as a per-

Before closing or sealing a component, whether it be a fuse box or gear box, practice DARFO! Detect And Remove Foreign Objects. Before leaving your shift or aircraft, inform your superiors or your relief of open areas and loose materials. If we all do our part and practice DARFO, everyone will benefit.

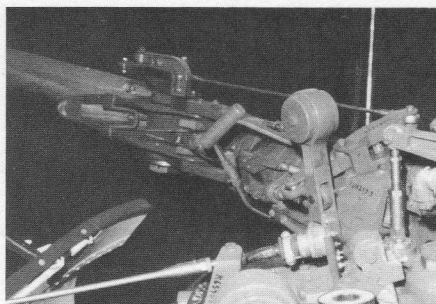
PHOTO B

manent part of the rotor head. This alert mechanic probably prevented mechanical damage from occurring to the aircraft. He may have even saved a life! HAVE YOU PRACTICED DARFO TODAY?
