Rotor Tips

NOVEMBER-DECEMBER 1972

Volume VII Number 7

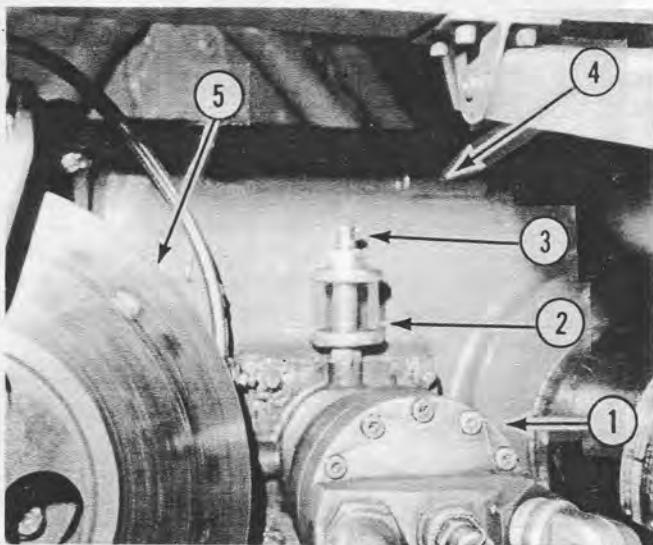
Photo A

H-2 Airframe Change (AFC) 199, Part 3, installs an oil cup, P/N K678771-11, onto the combining gearbox hydraulic pump as shown in Photo A. The oil cup is an interim action pending incorporation of AFC 199, Part 2,

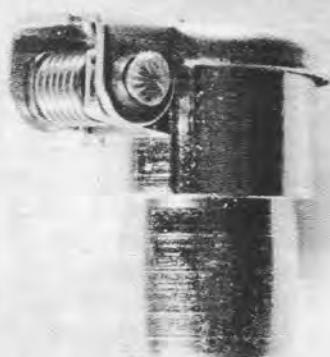
Photo B

The oil cup cap has reportedly cracked or has been dislodged by daily normal servicing and, since the oil cup was an interim measure, the cap was not provisioned as a spare. To preclude possible maintenance or supply problems in the fleet due to faulty or damaged oil filler caps, replacement oil filler caps (shown in Photo B) may be obtained from Kaman Field Service Representatives.

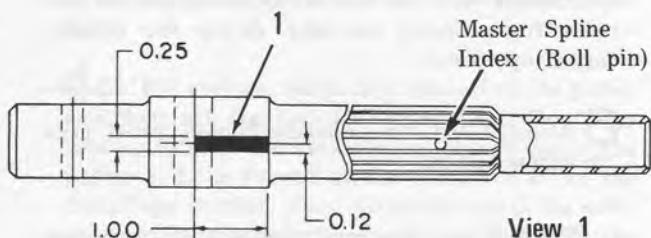
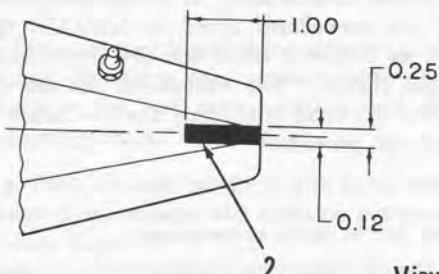
A recent flight control problem was traced to the azimuth assembly where, it was discovered, the master spline had been improperly installed, shearing the roll pin. In order for this to occur, someone had to force the components together, probably by attempting to lower a main gearbox onto an azimuth which was already installed into the aircraft. In the event the gearbox is lowered onto the installed azimuth, the two may appear to mate properly but due to the mass involved, no "feel" for possible interference will be evident. Consequently, damage can result, and as in the previously described incident, much maintenance time is expended attempting to correct the error.

The stripe on the spindle (item 1, View 1 and the accompanying photo), is in line with the master spline located inside the support. The photo shows an azimuth assembly with the azimuth spindle about to be inserted into the support. Notice the paint stripes indicated by the arrows. This information will be incorporated into applicable manuals by a future change.

A drawing change accomplished in early 1970, assists in aligning the two components. The change added a 1/4-inch wide by 1-inch long white paint stripe on the spindle support and on the spindle. Detachments may add these stripes in accordance with the dimensions listed on Views 1 and 2. Use paint color No. 17875, in accordance with MIL-L-19537.

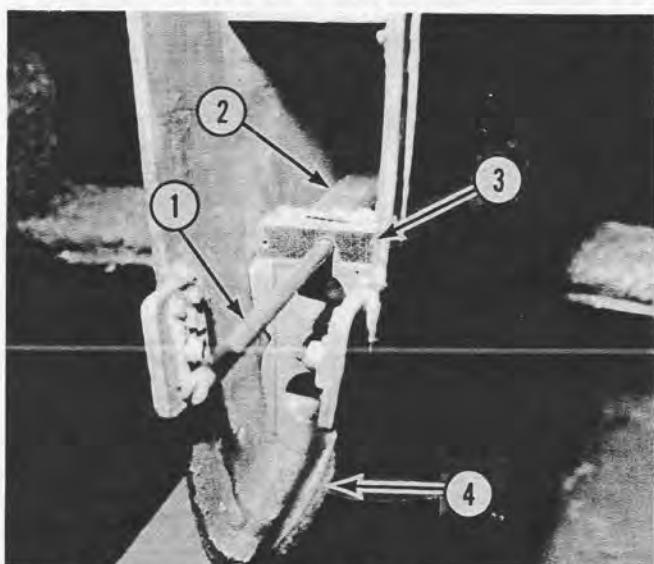
A. No. The main rotor blade tip cap failsafe indicator rod is a quick method of determining whether the blade ballast weight bond is intact. Blade ballast weights are bonded to the blade leading edge and the assembly built up as shown in the accompanying illustration. If the bond fails, centrifugal force will cause the weights to shift outward and crush the impact assembly core. The indicator rod, which is threaded into the impact assembly, will also shift outward and protrude from the tip cap. If the core has been crushed, the blade must be returned to an overhaul facility; occasionally, however, the rod may loosen and protrude from the tip cap.

To determine whether a blade change is necessary when an indicator rod is discovered protruding, remove the four screws and remove the tip cap. (Tip cap installation and removal instructions are contained in NAVAIR 01-260HCA-2-4.2.) Photo A shows the blade tip with the cap removed. Photo B shows the components removed from the blade (right-hand side of photo represents the outboard end). After removing the tip cap, use a mirror and light to check the impact assembly for evidence of having been crushed. If the impact assembly has been crushed, return the blade to Overhaul.

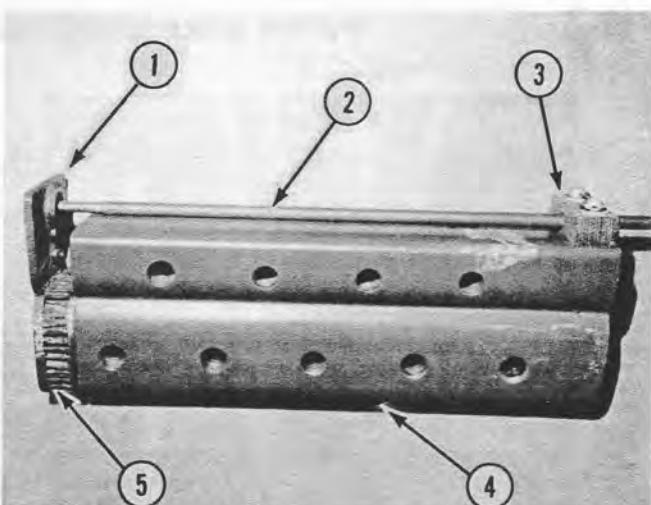
Photo B

1. Impact assembly
2. Indicator rod
3. Phenolic guide
4. Retention block assembly
5. Crushable core

If the impact assembly core has not been crushed, remove the rod, inspect the threads for damage; if necessary, replace the rod (P/N K611583-13). If the rod is not damaged, apply a drop or two of Locktite, Type C, on the threads, re-install into the impact assembly and replace the tip cap. Be sure to seal the screws.

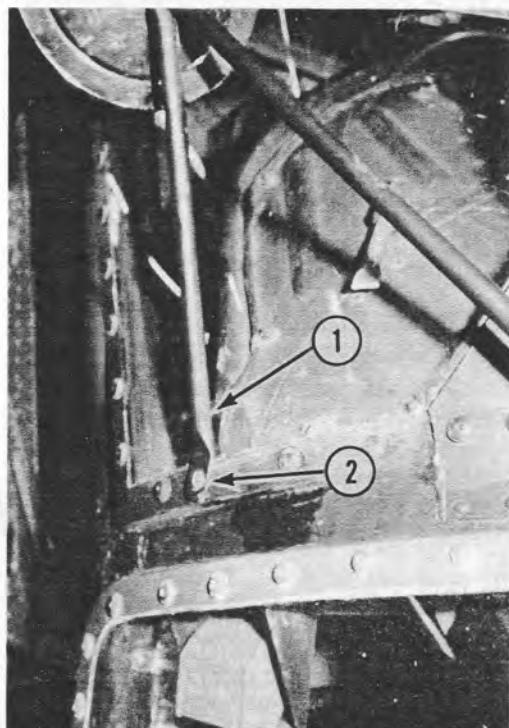
Photo A

The lower aft outside mirror bracket (item 1 in Photos A and B), can contact the pilot's window and, after a period of time will cause the window to crack. To prevent this from occurring, add one thick washer, P/N AN960PD10, between the bracket and the window frame as shown in Photo C. This information will be incorporated into applicable manuals by future changes.

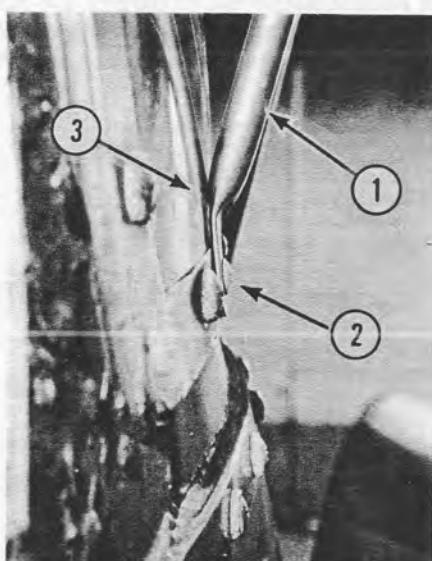
Photo B

1. Bracket
2. Screw
3. Point of contact
