# *Rotor Tips*

NOVEMBER-DECEMBER, 1973

Volume VIII No. 1

## TECHNICAL SECTION

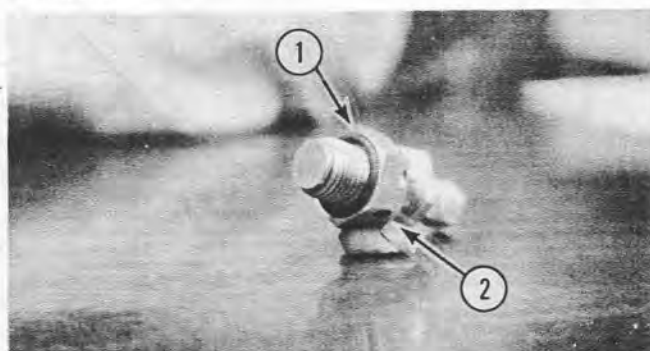
**A.** The part number of the O-ring (1 in the accompanying photo) is MS24690. Leakage at the charging valve can usually be traced to O-ring deterioration. O-ring replacement instead of replacement of the complete valve assembly is possible. The O-ring is normally supplied with the valve as an assembly, but may be ordered separately under Federal Stock Number 9Z5330-079-7381. This information will be incorporated into applicable manuals by future changes.

1. O-ring  
2. Charging valve

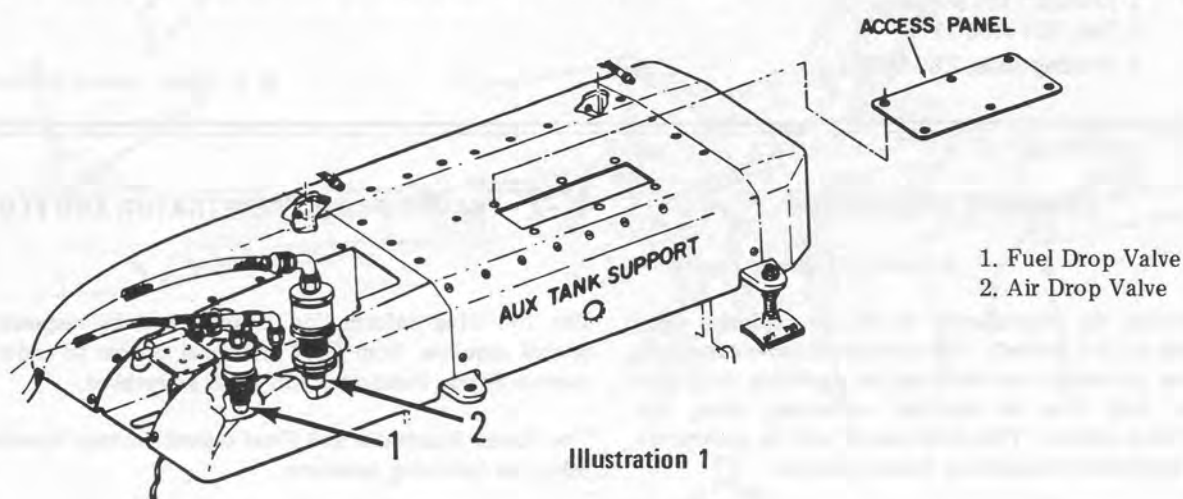
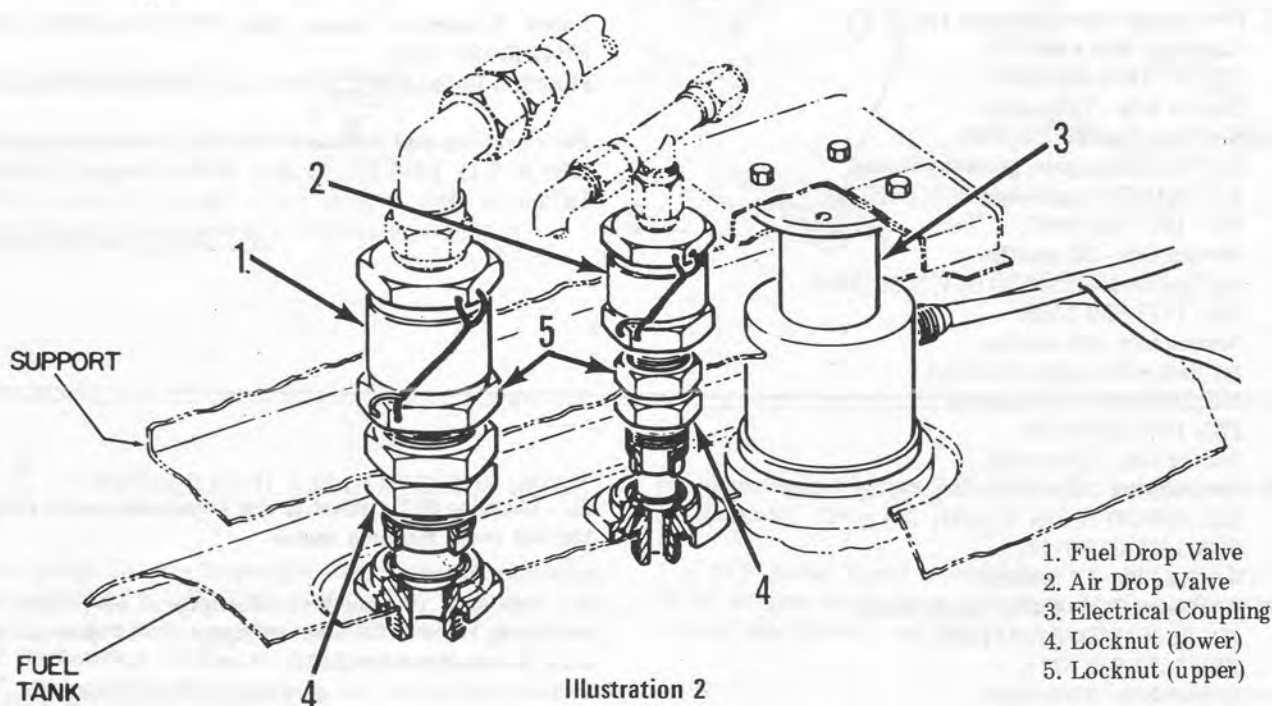
Photo A

Prior to aux tank installation, inspect the ball-end for nicks or scoring. The ball-end has a special, hard-coat finish and if found damaged, the valve must be replaced. Check the piston for freedom of movement. Push the piston completely up into the valve body by hand. If no binding exists, the piston will return to the extended position as soon as the pressure is removed. In the event binding does exist, remove the valve from the support and check the piston for

gouges or burrs. Light scratches or burrs may be blended out; deep penetration necessitates valve replacement. In cases where the cause of binding is not apparent, wipe the piston clean and apply a light coating of general purpose lubricating oil or jet fuel. Work the piston in and out of the valve body several times while rotating it to distribute the lubricating agent. If binding persists, replace the valve.

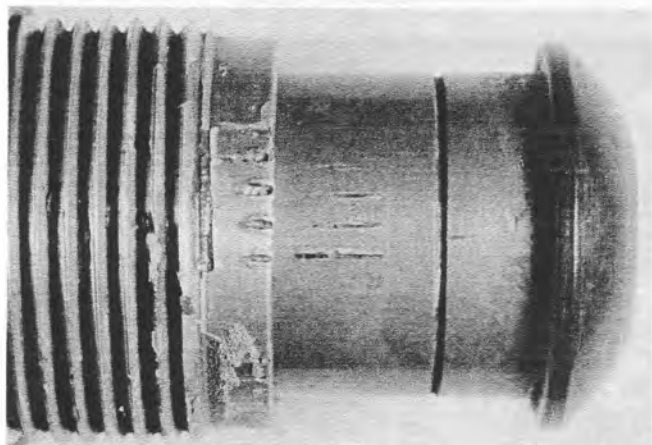
The valve piston shown in Photo B is an example of what NOT to do. After an aux tank had been installed, fuel leakage occurred at the point of contact between the ball-end and the aux tank receptacle. The mech correctly determined that the cause was improper seating due to piston hang-up or binding within the valve body. Instead of removing and cleaning the valve, a pair of water pump pliers was employed in an attempt to pull the piston out of the valve and down into the receptacle! The sought after tight seal was never attained—instead, the valve had to be replaced.

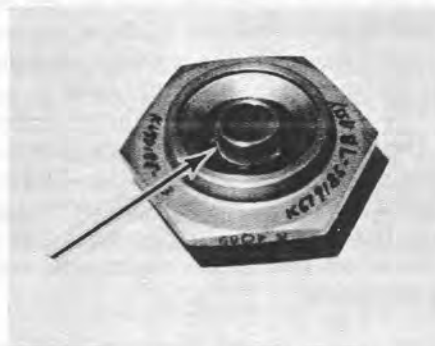
The drop valves mate against fuel and air fittings (P/N K679185-7 and -5, respectively) installed in the aux tanks. The condition of these fittings is as important as the condition of the drop valves. Photo C shows the -7 fuel fitting. (The -5 air fitting is similar except the air hole has a smaller diameter.)

Note that the sleeve in the center of the fitting extends above the O-ring seal approximately 0.25-inch. When properly aligned, the drop valve fits over the sleeve allowing the valve ball end to contact the fitting O-ring, thus providing a leak and fume proof seal.

Sleeve protrudes 0.25-inch

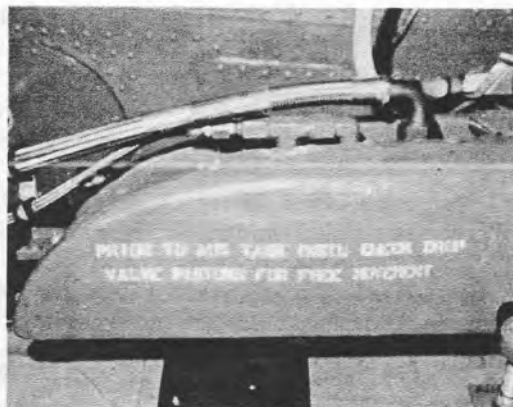
A change to Kaman Drawing K686703 provides mechanics with a reminder to check the fuel and air drop valves prior to installing the aux tank. The stencil, shown in Photo E replaces the previously authorized "AUX TANK SUPPORT" stencil. Fleet Activities may apply the stencil (1/4-inch letters) at their discretion. For further information concerning the drop valves and the aux tank, refer to NAVAIR 01-260HCA-2-4.

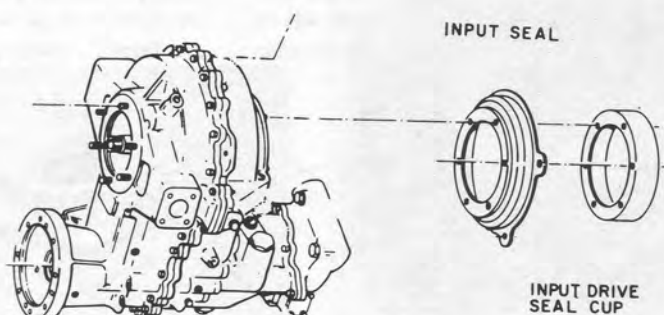
**A.** The 6 nuts which attach the input seal and the seal cup to the speed de- creaser gearbox (SDG) at the output shaft coupling hub, shown in the accompanying illustration, should be tightened to 80-100 pound-inches torque (It was formerly 120-143 pound-inches). The reduced torque will preclude damage to the seal cup from overtorque while still maintaining proper security of the seal. Figure 5-13 and Paragraph 5-20, Step e, of NAVAIR 01-260HCA-2-4, Dated 1 October 1967, changed 30 November 1971, will be changed to reflect this torque requirement and add the following procedure:

Do not initially tighten any single nut directly to full torque as this will distort the seal cup, allowing air leakage which will cause oil seepage from the combining gearbox (CGB) into the speed de- creaser gearbox (SDG).

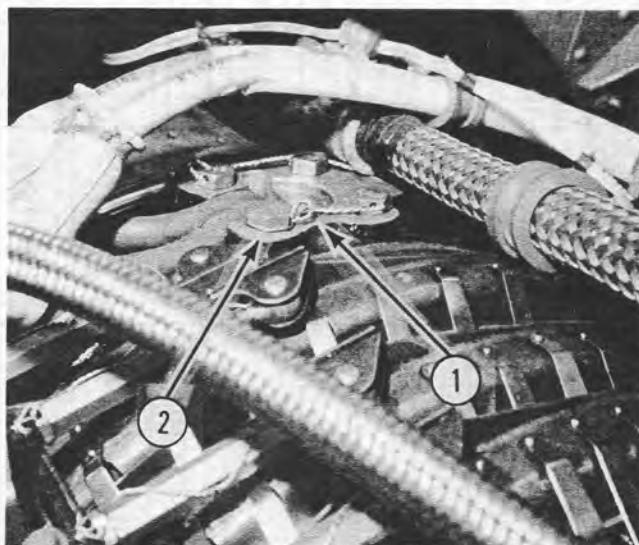
**Photo B**

into the engine, and to eliminate air burbling caused by the holes, it is necessary to install bolts as seen in the closeup Photo B. Use AN5CH4A bolts with one washer, AN960C516 under the head, and install in the top and outboard mounting pad bolt holes (total of eight bolts and washers). Be sure to lockwire the bolts. This information will be incorporated into applicable manuals by future changes.

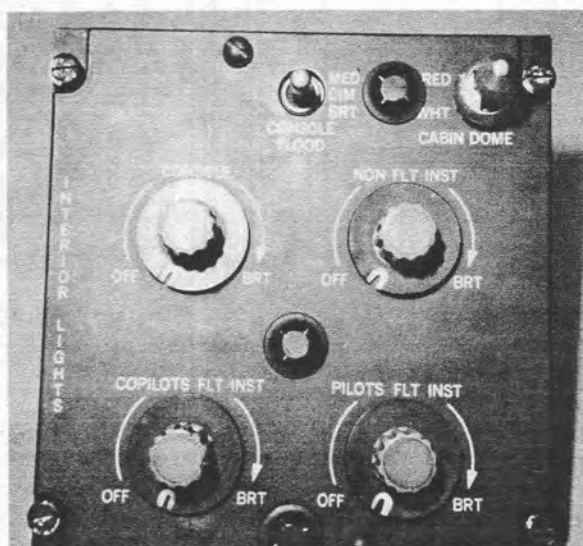
Modification of the instrument panel lights wiring was authorized by AFC 188. Incorporation of this change will increase the safety of night operations by precluding the loss of both pilot's and copilot's instrument lighting due to the failure of one circuit breaker. As can be seen in the accompanying schematic, AFC 188 modification consists of removing the pilot's instrument lights from the instrument light circuit and connecting them to the floodlight circuit through a change in the panel wiring.

The existing cockpit floodlight circuit breaker (3-AMP) on the main circuit breaker panel is replaced by a 5-amp circuit breaker and re-identified as the cockpit flood and pilot's instruments.

When replacing the interior light panel (shown in the photo), care should be exercised to insure the part number is correct for the aircraft application. If an unmodified panel were installed in an aircraft with AFC 188 incorporated, it would overload the instrument light circuit breaker and could cause the loss of all instrument panel lights.
