KAMAN

Rotor Tips

Volume VIII No. 3

TECHNICAL SECTION	7
-------------------------	---

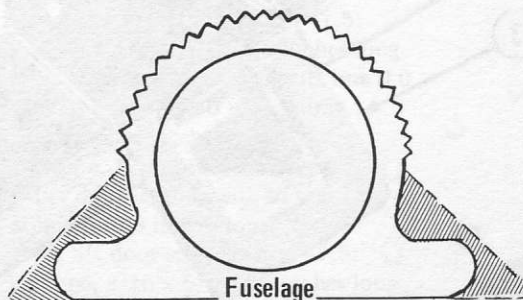
Illustration 1

Enlarged cross-section bulb-seal.
Note shaded areas indicating sealant.

After the adhesive has cured, apply a sealant fillet at joint on both sides of the seal, all around the frame, as shown in Illustration 1. Use sealant, EC1239A in accordance with MIL-S-7502A, or a suitable substitute such as EC1675 or EC801. Allow the sealant to air-dry with the nose doors open for at least 12 hours.

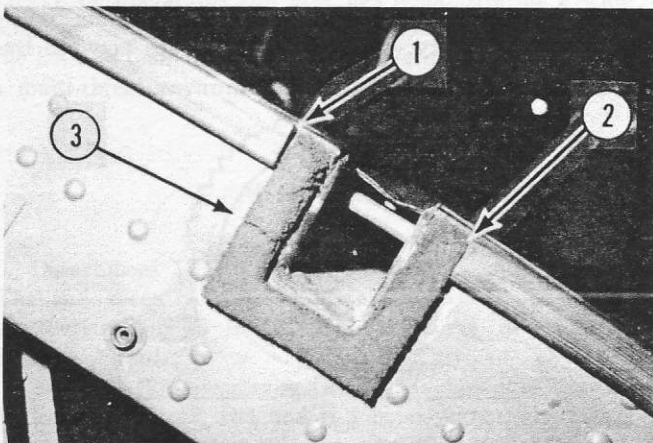
Photo 1

Reports from the field indicate an increase in water damage to "black boxes" located in the forward fuselage tub. Investigation of several aircraft revealed numerous cases of improperly installed, deteriorated, cracked or missing nose door seals. A subsequent review of seal installation procedures prompted preparation of the following article.

The nose doors and forward fuselage rubber seals must be "alive" and installed properly in order to keep water out. If the seals have deteriorated, are cracked and/or improperly installed (with gaps where butt joints should be), rain, spray, or wash water will enter and cause corrosion and possible malfunction of black boxes in the vicinity of the leakage.

1. Poor butt joint
2. Acceptable joint
3. Cracked; should replace with new U-shaped seal

Each door latch seal (2 per door; see Photo 1) is fabricated from a single piece of flat rubber to the dimensions listed on Illustration 2. The remaining seals at the BL 0.0 frame on the RH door are made from flat rubber (Illustration 3, items D, E and F). The remaining seals at the BL 0.0 frame for the LH door are made from the bulb-type extrusion seal (Illustration 3, items I, J and K). Lengths are listed in Illustration 3. Install nose door seals with edges flush with the skin and trim off excess lengths.

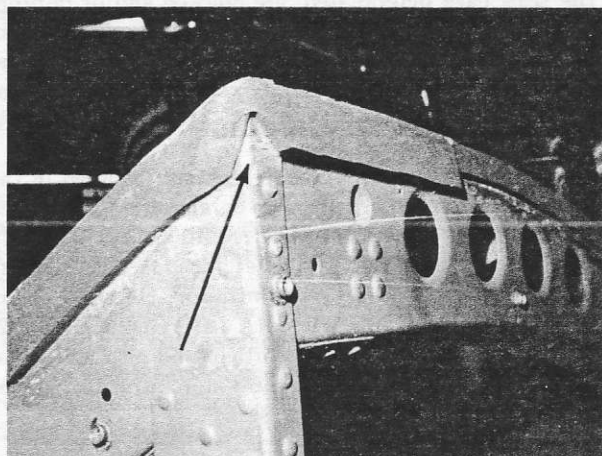
Arrow points to relief cut

The nose doors aft frame seals (station 47.5) are fabricated from flat rubber sheet and are dimensioned in Illustration 3. Install 35-inch seals, items G and H on the lower half of the door aft frame, from the bottom of one lower door hinge to the lower end of the BL 0.0 vertical door frame member. Install 52-inch seal, items C and L on the upper portion of the door aft frame from the top edge of the lower door hinge, up along the aft frame and AROUND THE UPPER CORNER of the BL 0.0 vertical frame member. It may be necessary to make a relief cut at the door corner as shown in Photo 2 to obtain a proper fit.

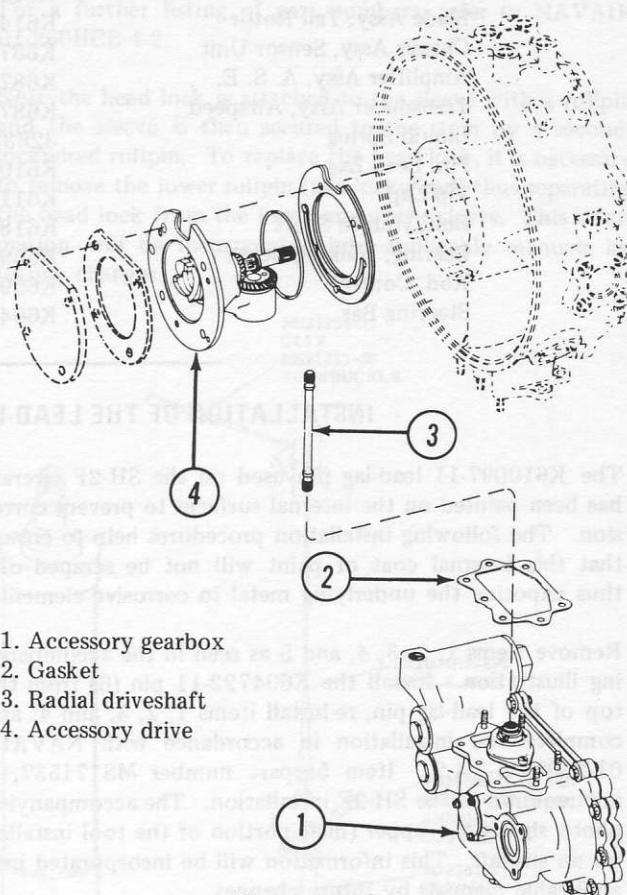
Illustration 1

When failure occurs in any component of the accessory gearbox train, drive to the engine accessories is lost and engine flameout occurs. The following suggestions are presented to assist in prevention of the more frequent causes of drive failures.

Do not attempt to DISASSEMBLE the accessory drive unit at Org level because bearing damage or disturbance of the gear mesh may occur, thus accelerating failure. (Disassembly and repair is an IMA function.) REPLACEMENT of the accessory drive is within Org level capability; however, the accessory gearbox and the radial drive-shaft must be removed before removing the accessory drive assembly. When installing the accessory drive, first insert the drive without the front frame gasket. A serviceable unit will fit flush against the front frame without the gasket. If internal interference prevents contact of the drive assembly flange against the front frame (without the gasket), reject the drive assembly. (This occurs when the drive

assembly splined shaft bottoms in the compressor shaft, creating an unacceptable condition.) Draw another drive assembly from supply and be sure to check the replacement unit in the same manner. If the replacement unit fits flush without bottoming (without gasket installed), remove, install the gasket, and complete the installation.

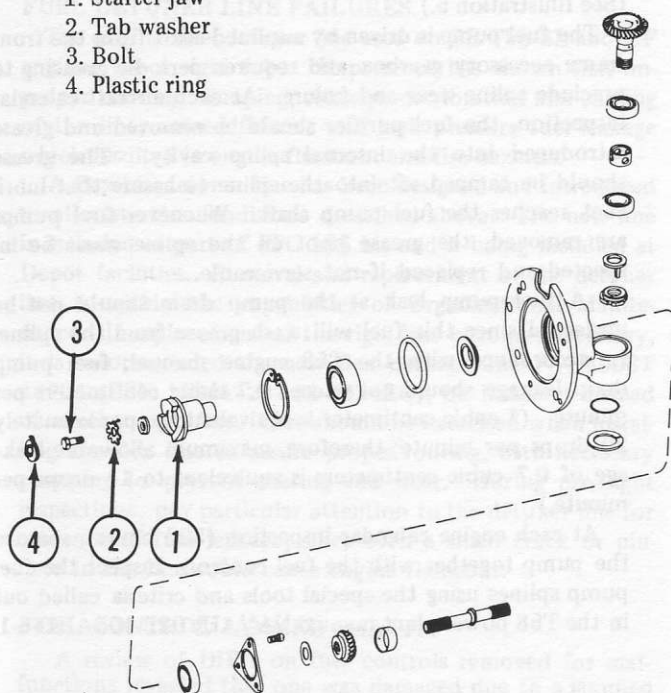
Illustration 2

1. Starter jaw
2. Tab washer
3. Bolt
4. Plastic ring

Do not use socket wrench on starter jaw bolt to rotate compressor. It will dislodge the locking tangs and loosen the bolt.

Be sure the starter jaw retaining bolt (Illustration 2) is tightened to the proper torque value and the tab washer is bent over to prevent loss of torque during operation. Do not rotate the compressor with a speed handle or ratchet on the starter jaw bolt. To discourage use of a speed wrench (or any other tool), install the plastic ring (PPC 105) over the starter jaw bolt so that the bolt cannot be used to rotate the gas generator. When necessary to rotate the compressor, use the special tool, P/N 21C2172P 010 (FSN 1RM4920-888-3934EQ) to engage the starter jaw. (Tool operation is shown in Illustration 3.)

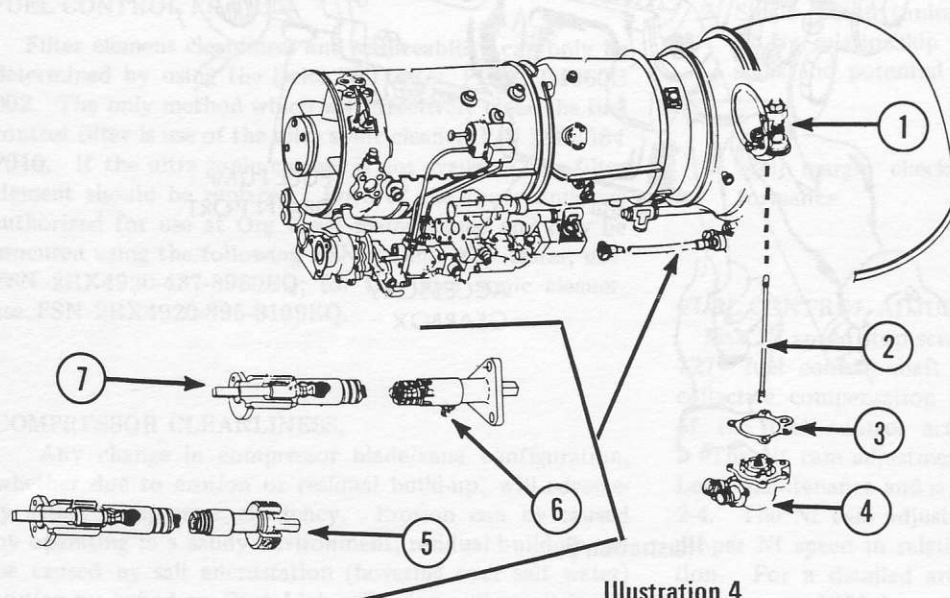
Illustration 4

POWER TURBINE RIGHT ANGLE DRIVE AND ACCESSORY DRIVE FAILURES. (See Illustration 4.)

signal (one of the parameters required for automatic governing of the engine). Failure of any part of this system can cause a possible engine overspeed.

1. Right angle drive
2. Radial driveshaft
3. Gasket
4. Power turbine accessory gearbox
5. Flex shaft before PPC 116
6. Lube fitting
7. Flex shaft after PPC 116

In accordance with IPPB 194, the right angle drive assembly, part number 278D998G003 (FSN 2RH2840-723-8651 EQ), should be replaced at approximately 1200 hours (2nd cal inspection) at the IMA level. IPPB 194 authorizes continued use of high time units in the event replacement drives are not available provided they meet the inspection criteria (including backlash check) as specified in the Bulletin.

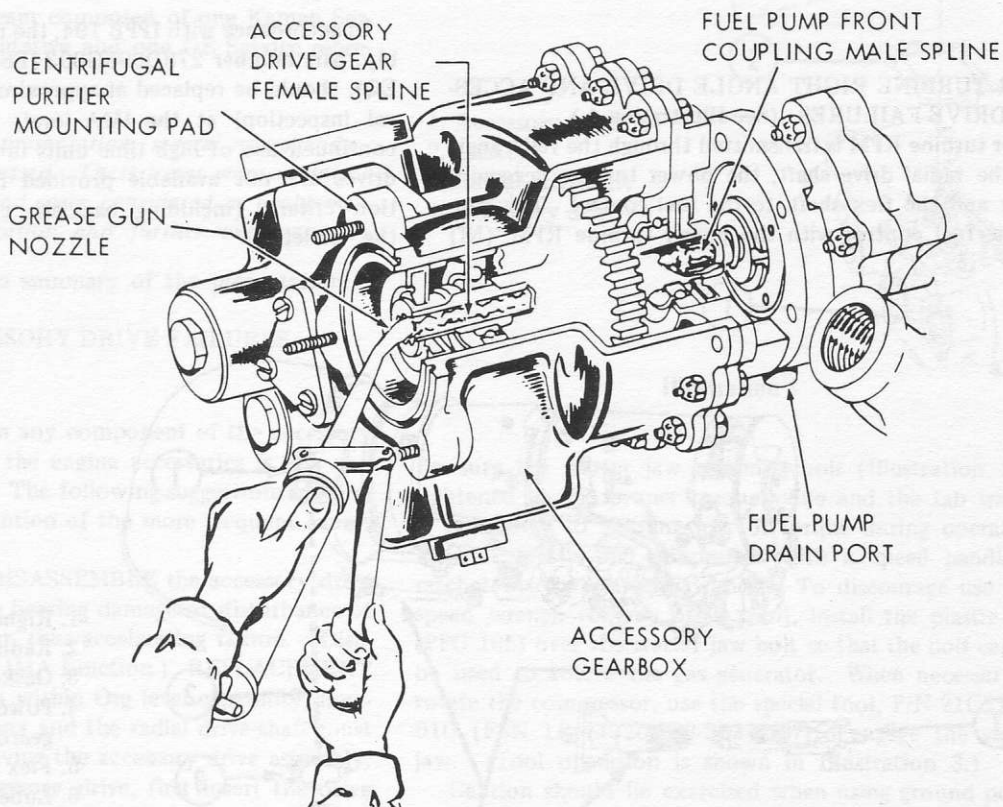
Illustration 5

FUEL PUMP SPLINE FAILURES. (See Illustration 5.)

The fuel pump is driven by a splined shaft from the front frame accessory gearbox and requires periodic greasing to preclude spline wear and failure. At each aircraft calendar inspection, the fuel purifier should be removed and grease introduced into the internal spline cavity. The grease should be tamped aft into the spline to assure that lubricant reaches the fuel pump shaft. Whenever fuel pumps are removed, the grease boot on the spline must be inspected and replaced if not serviceable.

A fuel pump leak at the pump drain should not be neglected since this fuel will wash grease from the spline. In accordance with the T58 engine manual, fuel pump drain leakage should not exceed 0.7 cubic centimeters per minute. (1 cubic centimeter is equivalent to approximately 20 drops per minute; therefore, maximum allowable leakage of 0.7 cubic centimeters is equivalent to 14 drops per minute.)

At each engine calendar inspection (500 hours), remove the pump together with the fuel control. Inspect the fuel pump splines using the special tools and criteria called out in the T58 power plant manual, NAVAIR 02B-105AHD-6-1.
