# *Rotor Tips*

Volume VIII No. 4

# TECHNICAL SECTION

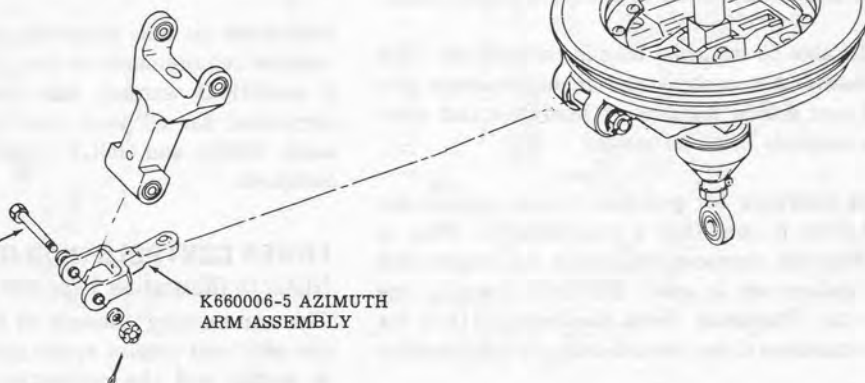
K660006-5 AZIMUTH  
ARM ASSEMBLY

1. A false torque produced by the nut bottomed out on the grip of the bolt.
2. Threads of the bolt extending into and wearing on the internal surface of the arm assembly bushing.

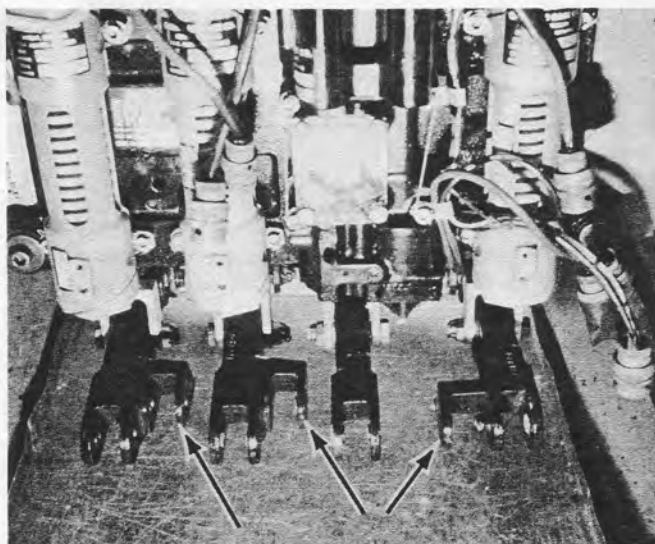
Photo C

Arrows point to Trim Strut Connections

Before installing a new boost actuator, check to ensure that the actuator has been bench rigged (per the MIM) and that the input levers are correctly installed. The trim strut connections on the input levers should face the center of the actuator with the chamfer in the clevis facing down-

ward. (Restricted control movement will result if the clevis is installed upside down.) After installing the boost actuator, check that the unit is securely mounted to the bulkhead. Looseness is usually caused by bottomed mounting bolts (failure to install washers under the boltheads or nuts) and results in shifting of the actuator rather than movement of the controls. Each model of the H-2 helicopter has a different collective bungee assembly and the spring loads are different. When replacing a bungee, be sure it is

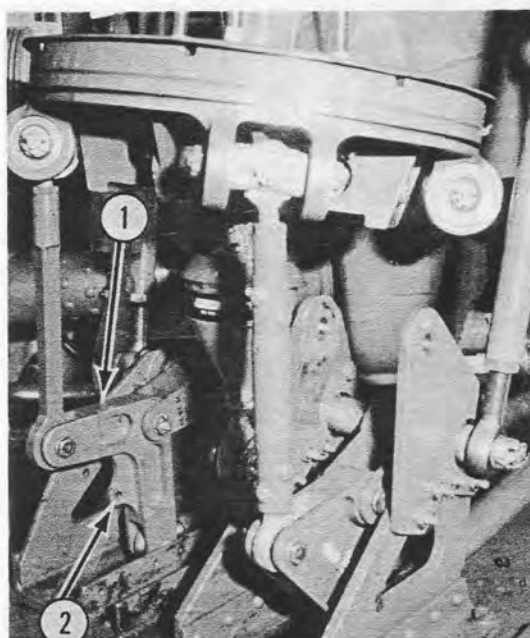
Photo D

Check the longitudinal output crank in the mixer assembly to be sure that the crank leg with the rig hole is pointing down. A reversed crank installation will result in an oversensitive longitudinal cyclic.

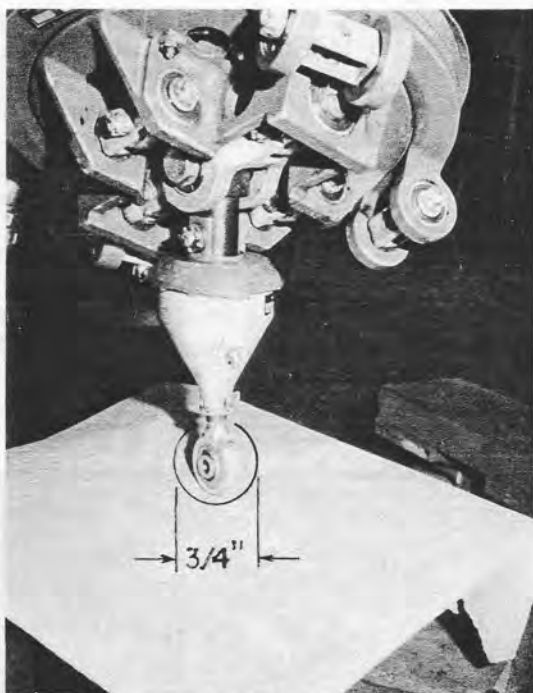
Photo G

Circle represents 3/4-inch movement

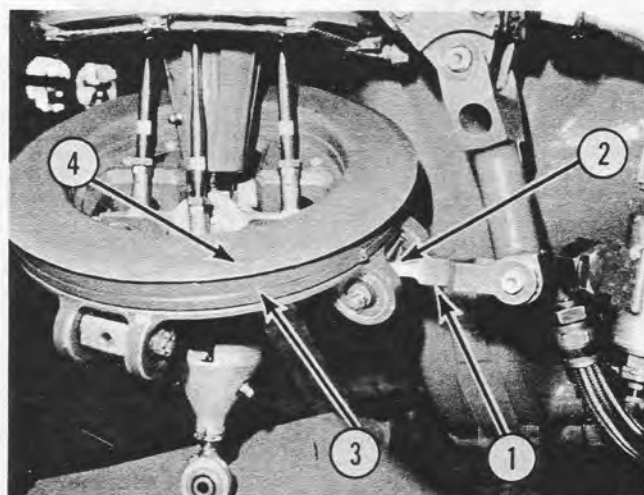
Photo I

1. Check the bearing in the end of the anti-rotation link arm for security. The bearing outer race should not protrude above the face of the arm. If protrusion is found, replace the arm assembly. **See Photo I.**
2. Check the link for wear/grooves from contact with attaching trunnion.

1. Link
2. Bearing (end of link).  
Measure relative movement  
between Items 3 and 4.

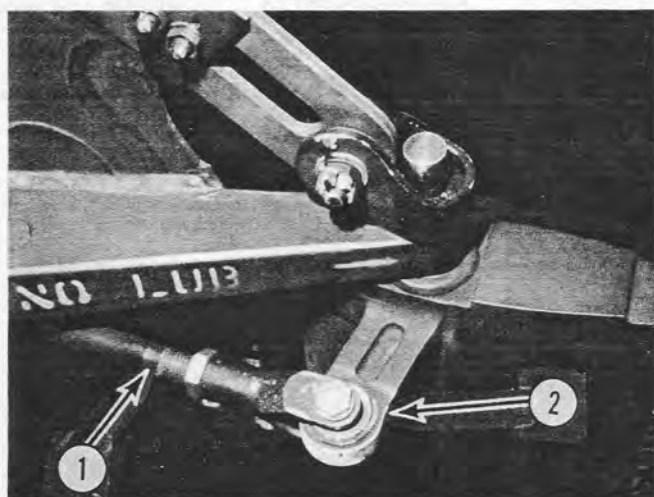
Photo J

3. Check that the chordwise rod which attaches to the flap horn is free to swivel (has rod roll) and that the flap horn bearing inner race is properly clamped in the clevis.

1. Chordwise Rod  
2. Flap Horn

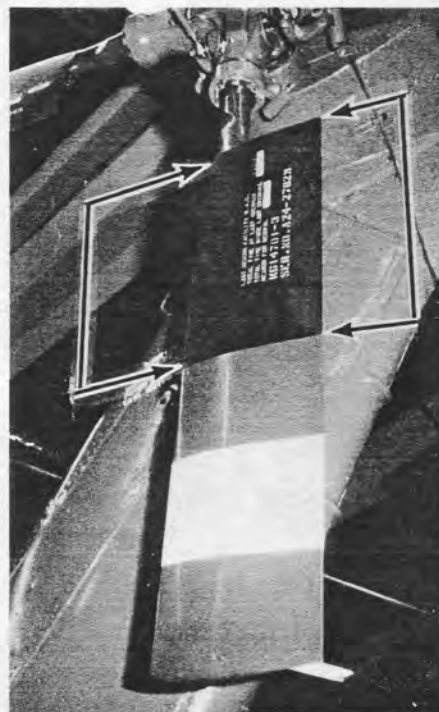
Photo K

3. Inspect blade skin surfaces for cracks. Pay particular attention to the area of the blade from the spar toward the trailing edge on either side of the blade within approximately 15 inches from inboard (grip) end of blade. It is extremely important that the blade surfaces be clean when conducting the inspection in order to detect even the slightest crack.

Pay particular attention to area between arrows.

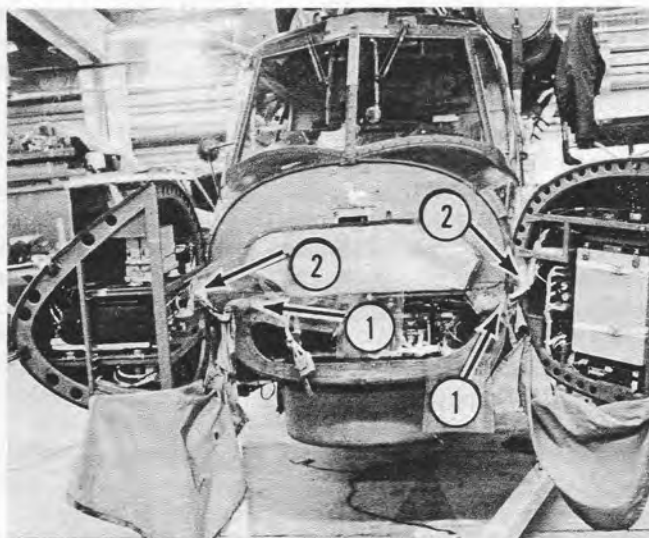
Photo 1

As observed in Photo's 1, 2, and 3, large wire bundles extend from the LH and RH nose door electrical components into the forward fuselage tub area. These bundles have a tendency to chafe against the radius of the aft outboard nose door frames just above the lower nose door hinge. To protect the wire bundles from chafing against the bare metal, a rubber cushion, P/N K633065-651, is bonded over the frame radius extending to both surfaces of the frame on either side of the radius. The positioning of the anti-chafing cushions is determined by observing the path of the wire bundles with the nose doors open.

1. Wire bundles extending from nosedors to forward fuselage tub.
2. Areas of interference.

In the event local manufacture is desired, the cushion material is MIL-C-3133, Type SB42LFF cellular rubber sheet. Dimensions are 0.12 inches thick, 1.50 inches wide, and 5.0 inches long. Bond cushion to nose door frame using MIL-A-5092 adhesive Type 3 or a suitable substitute. This information to be incorporated into applicable manuals by future changes.

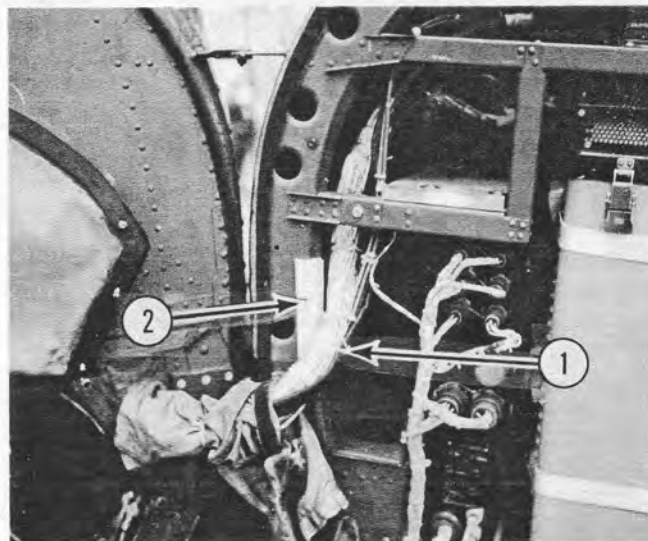
Photo 2

LH Nose Door

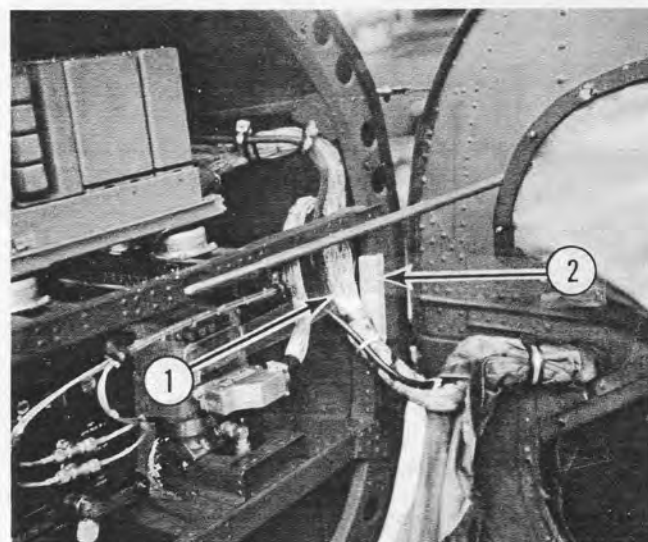
Photo 3

RH Nose Door
