CB  
**KAMAN** *Rotor Tips*

# Rotor Tips

Volume III Number 8

April-May, 1964

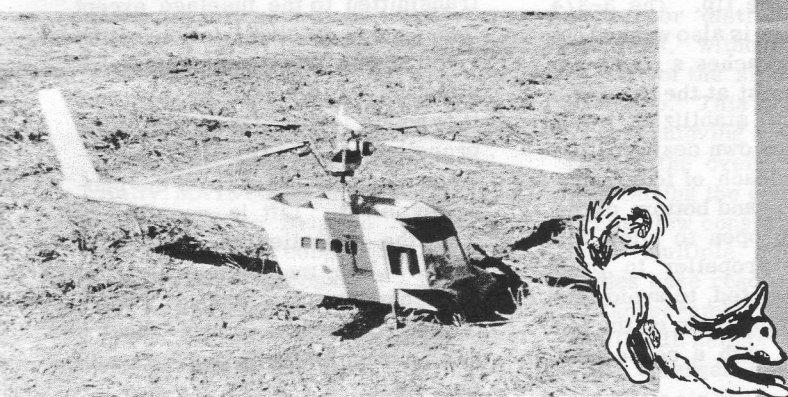
HUSKIE PUP III

Rotor system: Rotor blades are 3/32 inch sheet balsa wood reinforced with plywood and nylon. The remainder of the rotor system is built with 3/64 inch and 1/16 inch music wire, 1/16 inch and 3/32 inch ID brass tubing short lengths of 1/8 inch aluminum rod, number 9 lead fishing "bell" weights, sheet metal from tin cans, and 2-56 machine screws and bolts. The tank, which is an integral part of the rotor system, is made of brass shim stock and brass tubing.

The rotor systems used on both models are identical to each other. The rotor diameter is 25-1/2 inches. Each of four rotor blades is 9-1/2 inches long, 1-5/8 inches cord tap-
