# *Rotor Tips*

JULY-AUGUST, 1974

Volume VIII No. 5

## TECHNICAL SECTION

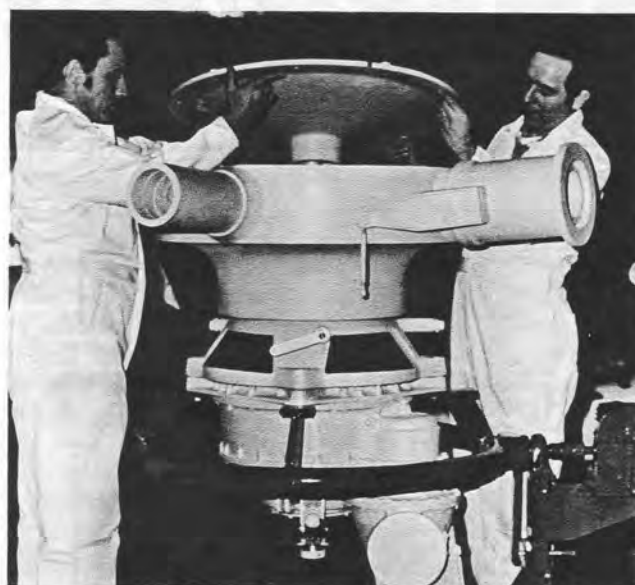
A full-scale mockup of the circulation control rotor system is shown in the photo at the right. The mockup was recently exhibited at the American Helicopter Society Forum in Washington, D.C.

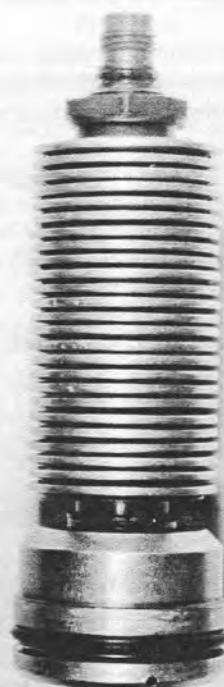
PHOTO 4

Photo 4 shows a partially-assembled filter. The retaining nut which secures the washer and the wafers should be hand-tightened until the wafers cannot be turned indi-

dually. The wafer pack, however, should turn relative to the cap when firm hand pressure is applied. Care must be taken not to over-tighten the retaining nut and thereby crush the wafers. After tightening the nut, carefully check for crushed wafers by viewing the wafer pack while it is back-lighted. After the inspection, install the cap assembly. The cap assembly, when installed, bears against the retaining nut; consequently, do not tighten the cap assembly beyond the point of firm resistance.

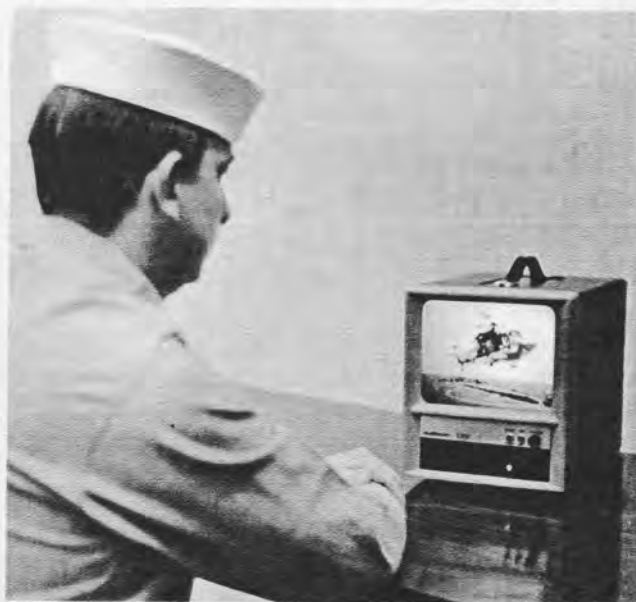
A program is viewed with a simple flick of a switch, which activates the narrated 16 mm color film.

Program lengths are held to a minimum, usually 12-15 minutes, centering on a single task performance to accommodate the usual attention span factor. Used in conjunction with approved operating and maintenance manuals, it is expected that the filmstrips — which include photos taken under actual operating conditions, as well as appropriate cartoons and drawings — will be an invaluable aid to personnel requiring refresher training in operation, maintenance or inspection tasks.

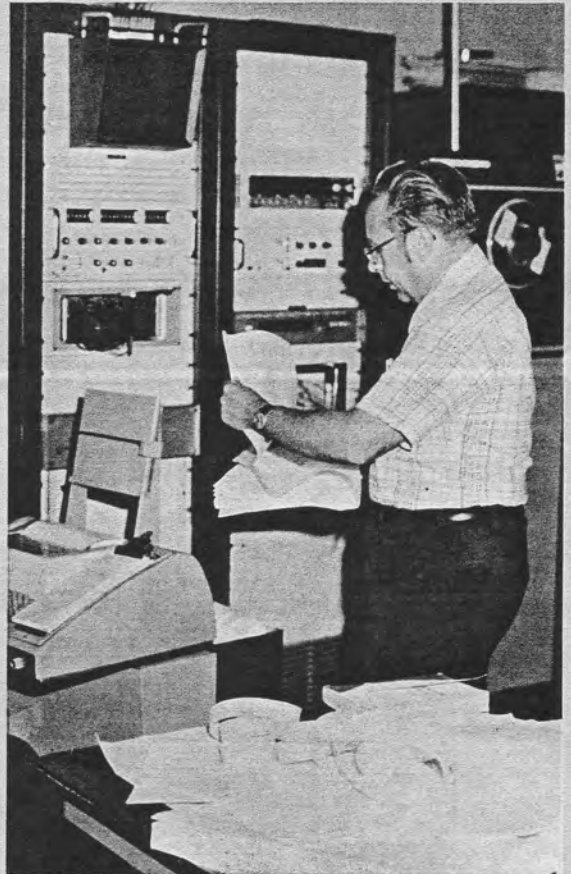
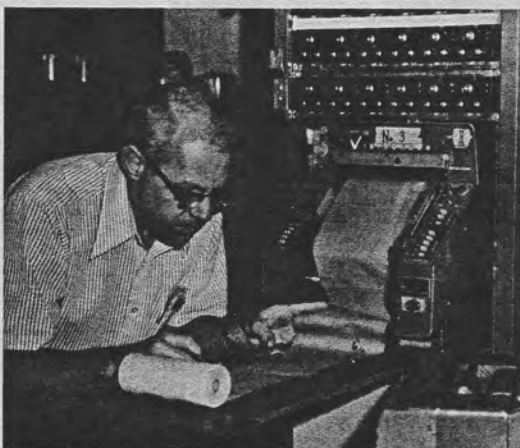
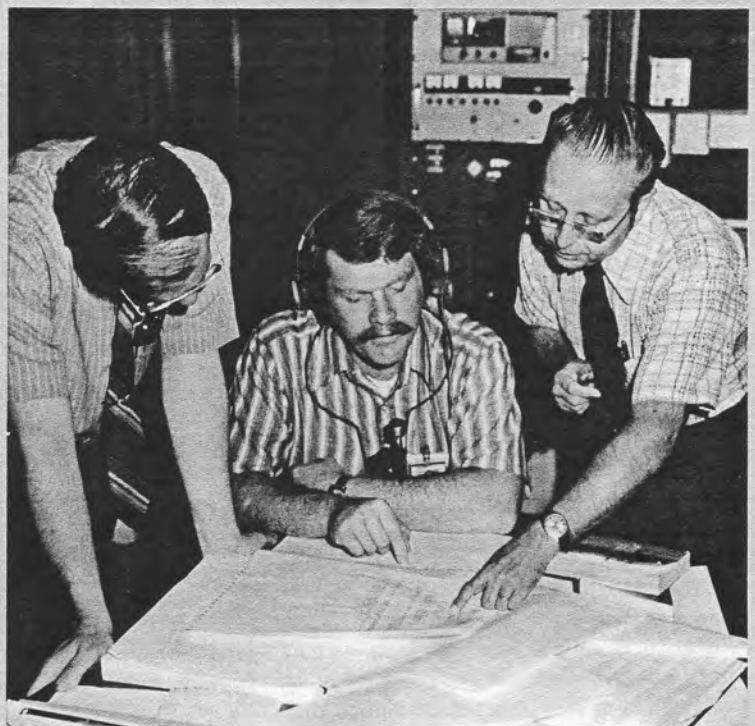
*'...the right combination of the efficiency of the machine and the ingenuity of man.'*

Later, with pen in holder, Kaman's ARTIST begins to draw additional pictures. (Engineers call them plots.) Calibration curves, time history plots, performance curves and spectral frequency displays are typically required for a test. The displays are turned out automatically since ARTIST's plotting device is guided by her computer, which reads the information stored on the magnetic tapes.

Perhaps less spectacular, but vitally important is the role that ARTIST plays during fatigue tests where full-scale, aircraft prototypes and components are deliberately stressed and vibrated, often until failure. Not only are test parameters monitored, but additionally, ARTIST has the capability of shutting down a test immediately should one or more parameters exceed a predetermined tolerance. This instantaneous sensing and response has frequently saved valuable hardware from unnecessary damage or destruction. (cont'd on p. 28)
