KAMAN Rotor Top

Volume III, Number 10

August-September, 1964

UH-2 BAROMETRIC ALTITUDE CONTROL

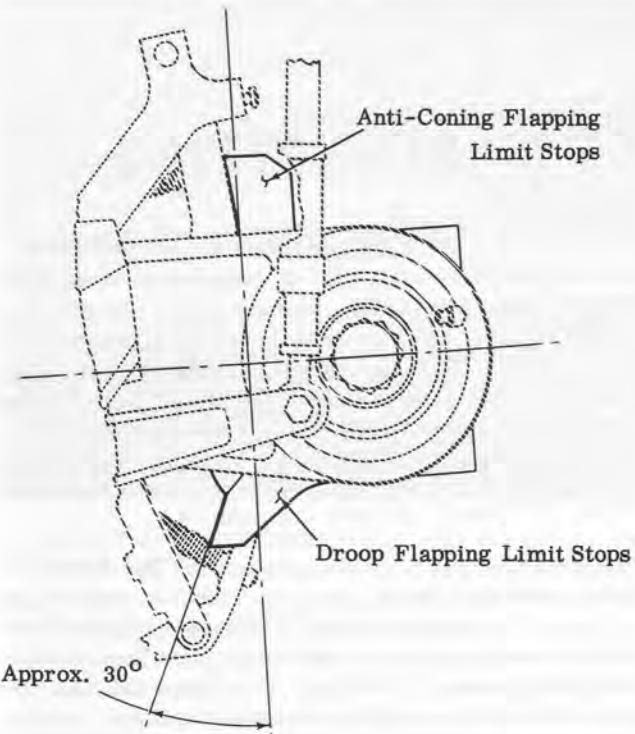
Q. (Applies UH-2) WHAT PRECAUTION SHOULD BE TAKEN WHEN INSTALLING THE K618312 CROSS ASSEMBLY IN THE RETENTION AREA?

A. Make sure the cross is not inadvertently placed upside down. Positioning of a retention cross upside down has no adverse effect on the blade flapping angles during flight, but static blade-to-fuselage ground clearances are considerably reduced. To assure correct cross-to-retention assembly, check the angle of the upper and lower protruding flapping limit stops on each side of the anti-coning and droop stop bumper recesses. When the cross assembly is installed correctly, see drawing, the upper stops point vertically and the lower slant down and outward at an angle of approximately 30 degrees.
