# KAMAN

## Rotor Tips

# Rotor Tips

Volume VI Number 7

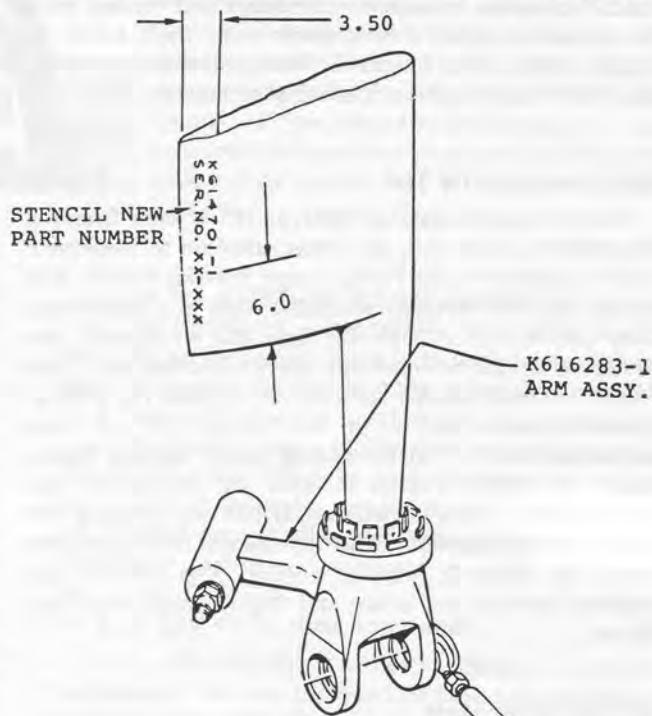
As can be seen in Photo A, the difference in flyweight size is slight. The only difference between a K614001-207 and a K614701-1 blade is the flyweight and its attaching bolt. (The lighter flyweight has a shorter attaching bolt.) Because of this small difference, either blade may be modified to the other configuration by changing the attaching bolt (6), flyweight (5), and Part Number stencilled on the blade. Modification of a blade should be accomplished only if the required blade is unavailable and appropriate authorization is obtained. Illustration 2 lists the parts required to modify tail rotor blades. The numbers in parenthesis refer to the index numbers in Illustration 1.

Necessary for K614001-207 configuration

- (3) MS20365-624 Nut
- (4) AN960-616 Washer
- (5) K616288-11 Flyweight
- (6) AN6C30A Bolt

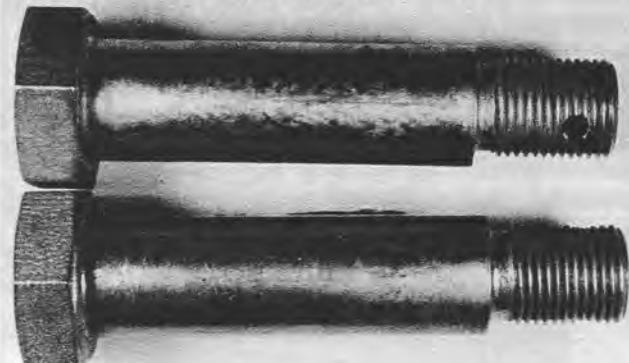
Photo A

Using a wrench, attempt to turn the bolt; if the installation is correct, the bolt (and nut) will turn with application of less than 25 pound-inches of torque. If considerable force is required to move the bolt (or if the bolt cannot be turned), it indicates the jawbone ears have been subjected to a preload due to use of the wrong bolt or installation of additional washers.

Old Bolt, K672769-11

Correct Bolt, K672770-11

In the event the preceding check indicates an incorrect installation, the jawbone must be removed and inspected for evidence of clamp-up damage to the ears. If necessary, the jawbone should be replaced. For information purposes, the dimension between the jawbone ears should be 1.455-1.465 inches.

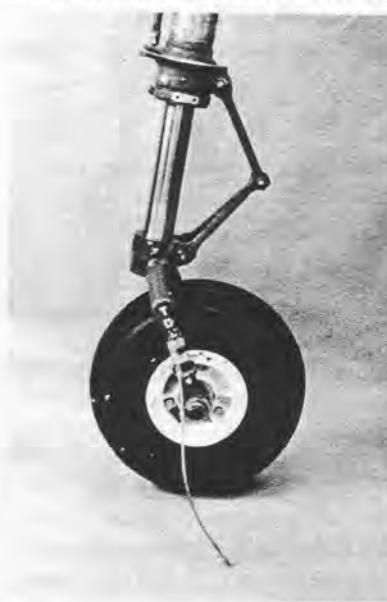
**Q.** (Applies H-2) PHOTO A SHOWS AN H-2 STATIC GROUND WIRE INSTALLED ON THE TAIL WHEEL FORK. WHAT IS WRONG WITH THE INSTALLATION?

**A.** In closeup, Photo B, notice how the static ground wire is attached to the tail wheel fork. *Under no circumstances should insulated clamps be used to attach a grounding connection.* Paint on the fork under the clamps should be removed before attaching the bare metal clamps. (The arrows point to where the two original clamps were installed.) The recommended installation, which is shown in Figure 3, NAVAIR 01-260HCA-4-4 and Figure 3, NAVAIR 01-260HCB-4-8, calls out a K683094-3 wire assembly to be used as a static ground. (See Photo C.)

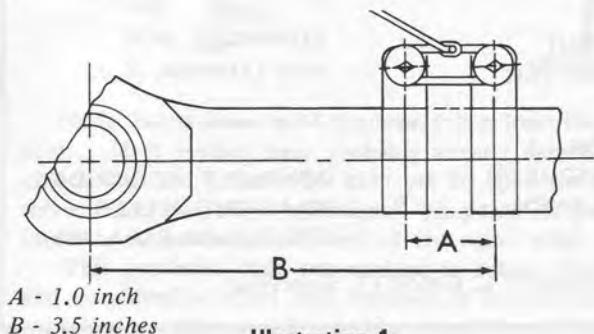
1. Remove paint from area on the fork where clamps will make contact. (Refer to Illustration 1 for detailed position.)

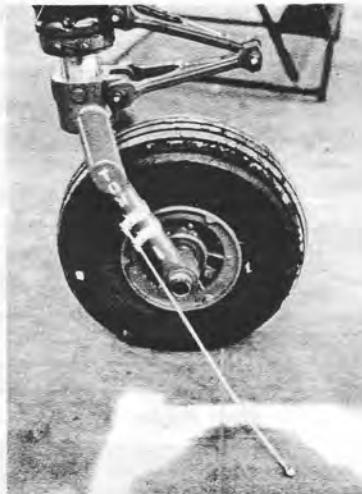
Photo D

Some Detachments, when unable to obtain a -3 assembly, have used a flex cable with a ball swaged on the end as shown in Photo D. If this is to be done, check the cable to be sure it is a good electrical conductor. When installing a static ground wire:

2. Be sure the ground wire is held securely by the two bare metal clamps. (Not only should paint be removed, but also remove the anodize finish.)
3. Be sure bare metal of the clamp is in good contact with the bare metal of the tail wheel fork.
4. If part-substitutions are made, be sure the parts used will provide a positive metal-to-metal contact. Flex cable, if used should be fairly stiff and should not be longer than 15 inches. The length is important because of the proximity of the tail wheel; too long a cable could catch under the wheel. Be sure the ball is securely swaged to cable end and in contact with ground.
5. Be sure to touch up the adjacent area with paint after installation has been completed.

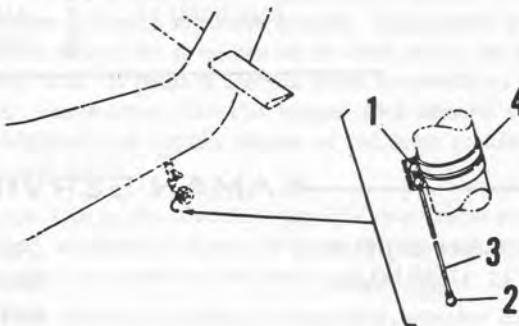
The accompanying Illustration 2 shows the correct breakdown and parts list for the tail wheel static ground. This information will appear in applicable handbook by a scheduled change.

1. Screw, P/N AN526C1032R10  
Flat washer (under head, wire, nut) P/N AN960PD10L  
Self-locking Nut, P/N NAS679C3M
2. Single shank ballend, wire rope, swaging
3. Wire, P/N K683094-15
4. Clamp, center mounting type, bare metal (2 required) P/N TA731D18

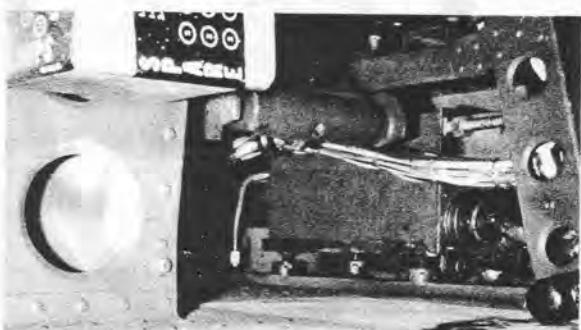
PHOTO B

This particular tool was wedged in rather forcefully and considerable effort was required to remove it; however, the screwdriver still could have come loose in flight. The necessity to occasionally lay a tool down while work-

ing in an area is recognized, but the need to remove that item when work is completed cannot be over-emphasized. The practice of wedging a tool to prevent it from rolling away is not acceptable by any standard. The history of jammed controls and catastrophic accidents from tools lodged in aircraft control systems is mute testimony to this fact.

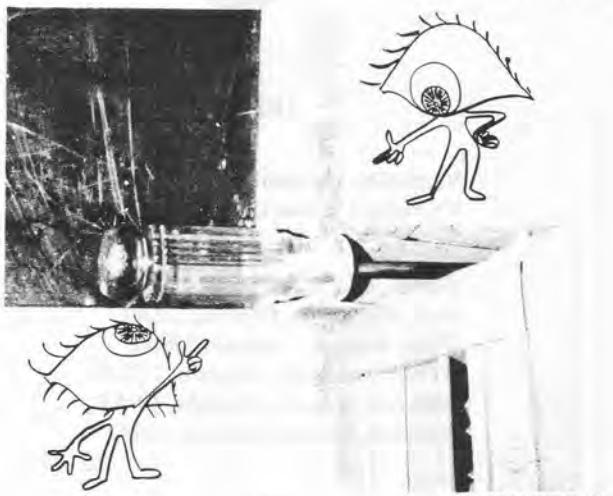
PHOTO C

One detachment spray-paints flight line tools with a fluorescent paint; another detachment etches consecutive numbers on each mechanic's tools. This allows a mech to readily determine if he has all his tools before he leaves the work area. If paint is used on tools, be careful of the color red. Some areas, like the hangar deck aboard ships, are red-lighted and certain shades of red seem to disappear in the red light.
