Rotor Tips

MARCH-APRIL, 1977

Volume VII Number 3

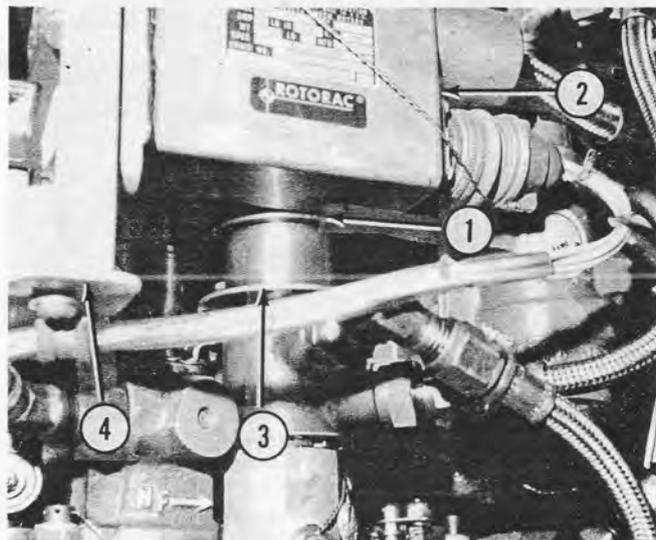
Caution must be exercised when installing and/or adjusting position of the emergency fuel control actuator to preclude chafing on adjacent engine lines or components. Several reports have been received concerning the actuator contacting the fuel metering valve cap at the point indicated by item 1 in the accompanying Photo. Two methods of positioning the actuator are available: The actuator may be moved in the slots provided in the bracket or the bracket may be slightly pivoted on its attach-points at the engine-tach-generator mounting boss. (The bracket holes are slightly elongated to provide for this contingency.)

1. Contact point
2. Actuator
3. Metering valve cap
4. Bracket

The actuator must be properly positioned prior to rigging and connecting the linkage to the emergency throttle rack. For further information, refer to NAVAIR 01-260HCA-2-4. This information will be incorporated into applicable manuals by a future Change.

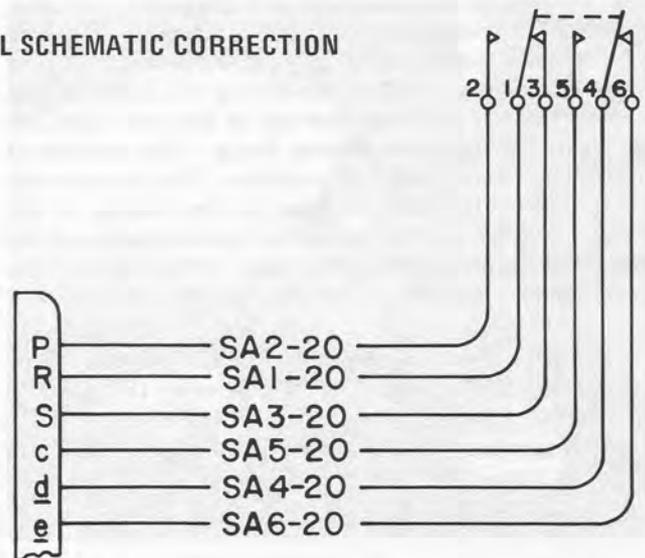
Schematics for wires routed between the Ship Aground Switch, P/N 41EN35-6B, and connector, P/N PTOOSE-18-32P (331/332), will be changed to reflect the information shown on the accompanying schematic. The schematic shown is a portion of Figure 27, Landing Gear Control, NAVAIR 01-260HCA-2-8.1, Dated 1 October, Changed 30 November 1971.

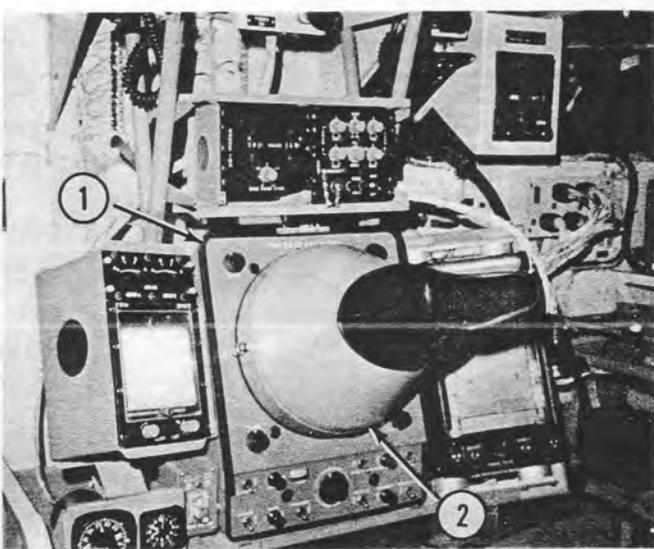
1. Magnatron Current Adjust setting. On pages 3-2 and 5-25 change 7.4 VDC to 6.1 VDC.
2. Pulse Repetition Frequency (PRF). On pages 1-2, 3-23, 5-13, 5-42, 6-1, and 6-7, change 500 pps to 388 pps. Also, on same pages, change 1000 pps to 1050 pps.
3. On page 4-23; item 27, PRF PCB Assembly part number should be changed from 220-189893-403 to 220-189893-404.
4. An item not called out in the manual is the display unit hood assembly, part number 620-732528-701, shown in the accompanying Photo.

1. LN-66 Display board
2. Hood assembly
