*Rotor Tips*

JULY-AUGUST, 1973

Volume VII No. 11

## TECHNICAL SECTION

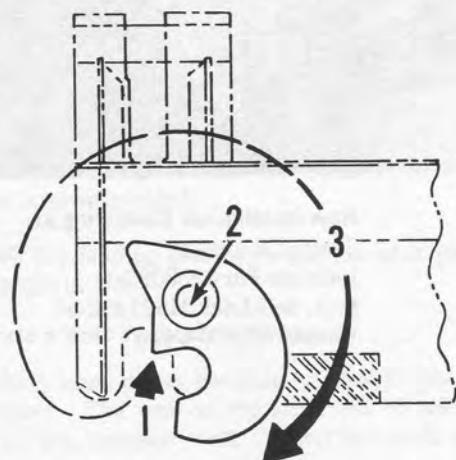
Illustration 1

A recent design change authorized use of a MOD 5 (P/N 63A119F2) bomb shackle as a completely interchangeable alternate to the standard MOD 4 shackle. The MOD 5 shackle has individual locking hooks which close when the external store is pushed up against the hook cam as shown in Illustration 1.

Pressure exerted at point 1...  
forces a pivoting action around point 2...  
causing hook to rotate to closed position, point 3...

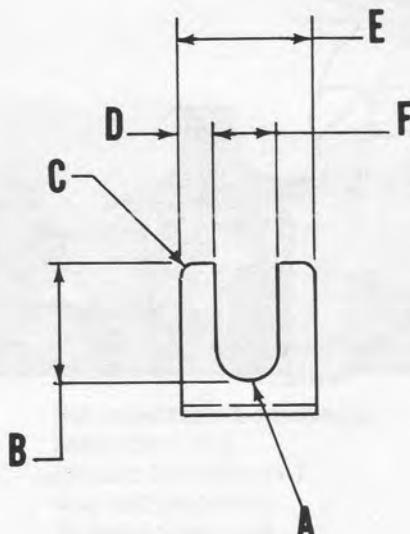
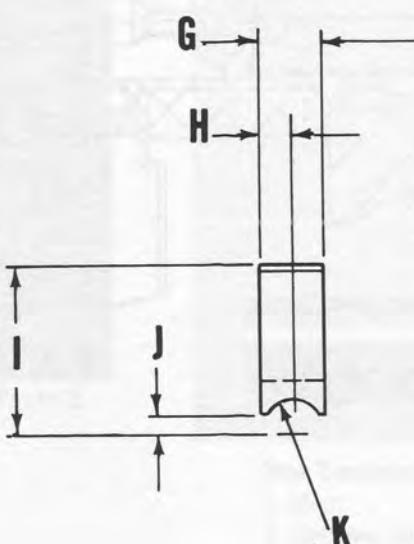
Illustration 3. Filler Stop

In order for the automatic-close feature to function, the shackle MUST be restrained from moving upwards into the support structure when external stores are pushed against it. Illustration 2 shows the authorized method used to restrain the shackle. Note the rubber filler block installed in the shackle attach-slots. Use of this block is mandatory on all MOD 5 shackles, regardless of which model aircraft the shackle is used on.

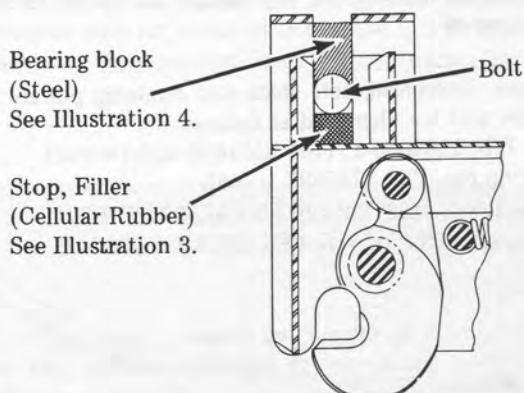
Illustration 2

Due to anticipated higher gross weights of external stores carried on SH aircraft, it is necessary and mandatory to use a bearing block in the upper end of the shackle attach-slots as shown in Illustration 2. The block prevents direct contact between the shackle mount bolts and the shackle pin, thus precluding excessive wear.

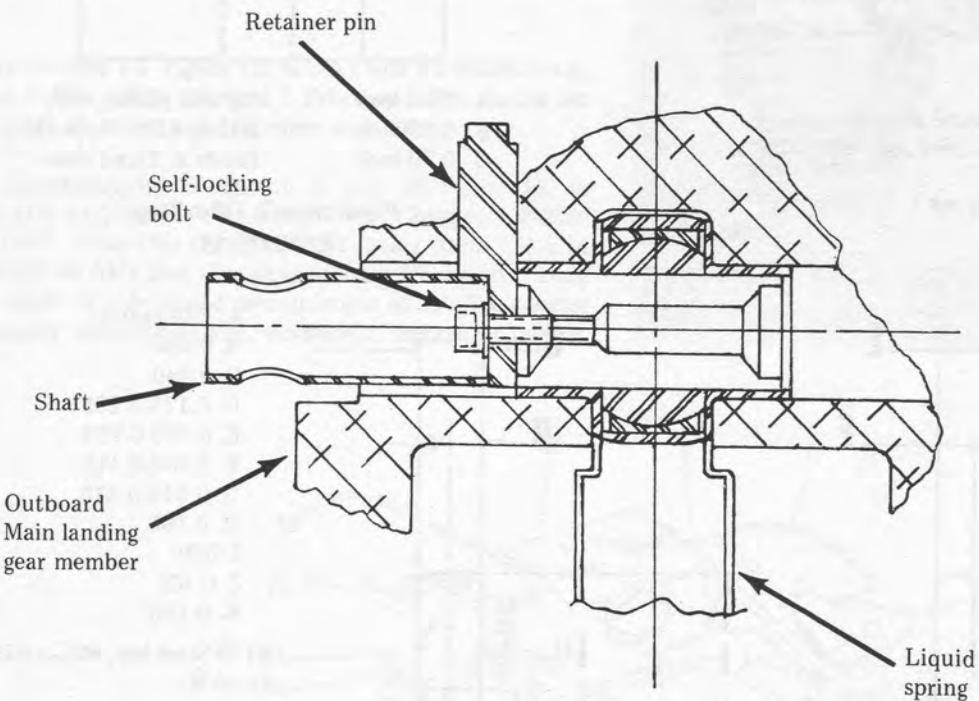
The corrosive action of salt spray from overwater flights and/or shipboard operations can ultimately cause the liquid spring upper shaft, P/N 3283129-3, to seize. A review of the situation has resulted in a design change to facilitate shaft removal.

As shown in the accompanying illustration and Photo 1, the new retaining pin protrudes above the landing gear main member 1/2-inch and is designed with integral wrenching flats. The new shaft protrudes beyond the side of the

main member approximately 1-inch and is provided with wrenching holes (Photo 1). To remove the shaft, after removal of the retaining pin, insert a rod through the wrenching holes, rotate and remove the shaft.

The following removal procedure for the present shaft, shown in Photo 2 (P/N 3283129-3), is recommended when changing a liquid spring:

Pending conversion to the new shaft and retaining pin, a Special 245-day removal, cleaning, and lubrication requirement has been established for the present installation in accordance with NAVAIR 01-260HCB-6-3, 1 October 1971, Maintenance Requirement Cards (MRC) Number 35, item 4.

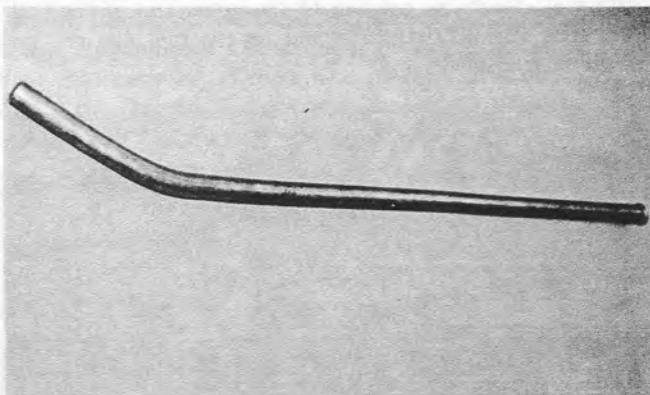
Photo 3

It is possible that after prolonged exposure to a corrosive environment, the shaft may be so tightly seized that the preceding removal efforts will not be successful. Rather than replace the complete main landing gear, the following procedure is recommended:

**Drift-Local Manufacture**  
Drift-Old Shaft Removal-  
Steel Rod 1/2 in. Diam. X  
24 in. length  
Center of 30° Bend  
4 inches from end.  
(Apply angle end against shaft)

1. Remove the landing gear hydraulic actuator per NAV-AIR 01-260HCA-2-2.
2. Fabricate a drift as shown in Photo 3.
3. The shaft bore passes completely through the landing gear member. The end of the shaft can be seen at the bottom of the actuator well. Insert the drift into the

actuator well, with the angle-end against the shaft and drive the shaft out. Prior to re-installation of the actuator, thoroughly clean and lubricate the shaft bore.

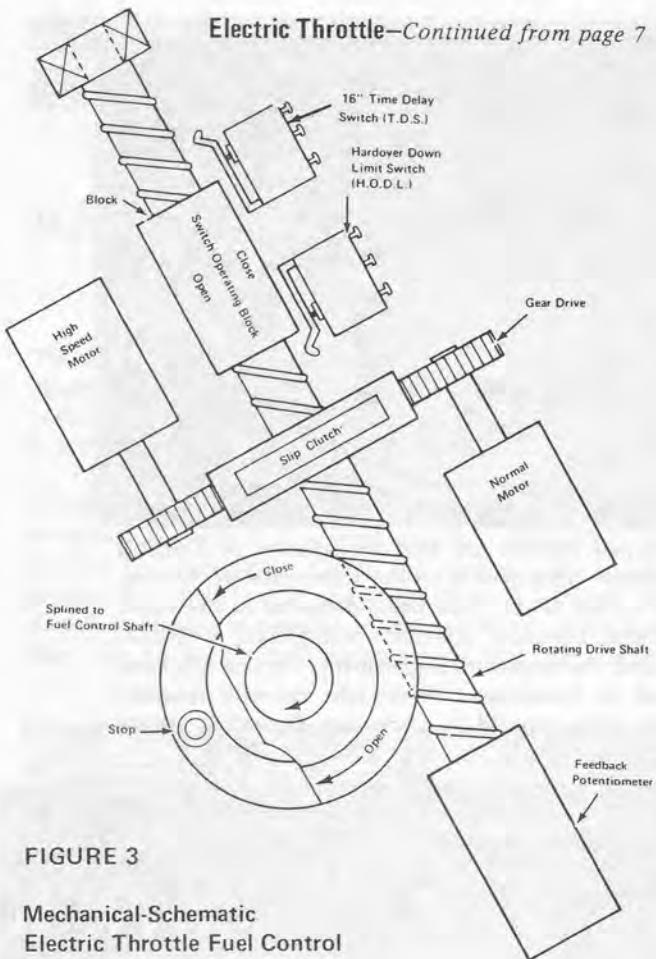
FIGURE 3

Mechanical-Schematic  
Electric Throttle Fuel Control  
Actuator

Figure 3 above shows the major elements of the electric throttle fuel control actuator with the function of each major element described.

**Hard Over Down Limit Switch**—This switch causes the actuator to stop running should a failure of the throttle intelligence system cause the actuator to run toward OFF when the engine condition lever is in the fly position. The switch is actuated by the switch operating block. Since the operating block is driven by the rotating drive shaft, its position is always in a specific relationship to the angular position of the splined shaft on the fuel control. The setting of this switch is accomplished on the bench and

since certain engine/fuel control combinations require different spline shaft angular settings for the same  $N_f/N_r$  readings, wide variations in  $N_f/N_r$  readings can be seen when checked. This is of no real consequence as long as rigging check confirms that the switch does not permit the actuator to assume an angular position out of the  $N_f$  governed range (below 70°). The switch should not be set so high as to prevent achieving the recommended minimum  $N_f/N_r$  Beep range setting. As long as this criteria is met, then the hard over down limit switch is performing its intended function.

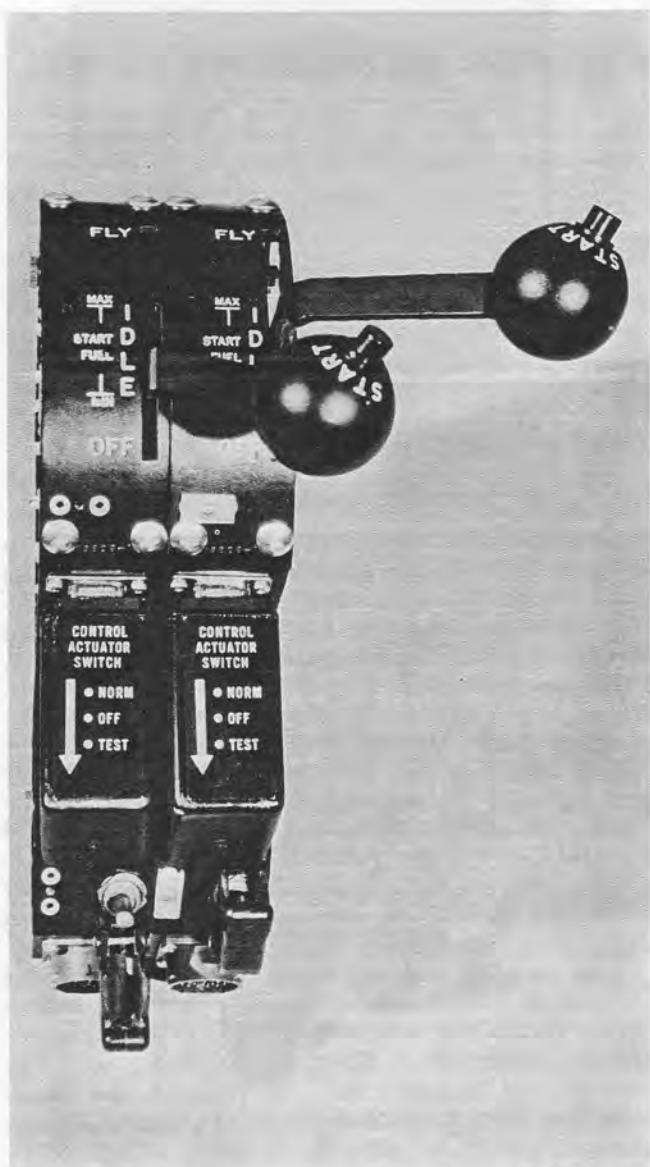
**FIGURE 4**  
**Throttle Quadrant**

The electric throttle fuel control actuator is controlled from the cockpit by means of engine condition levers on the throttle quadrant, see Figure 4, opposite page, and the "beeper" switches located on the collective stick.

No two engines are identical as to RPM/power output for a given angular setting of the fuel control splined shaft. For this reason, an adjustment feature must be provided in the throttle system to compensate for these engine differences. These adjustments are located on the throttle quadrant and are used to set  $N_f/N_r$  RPM at minimum and maximum beep limits as well as an adjustment for idle. An idle adjustment should rarely be required for reasons stated earlier.

Prior to making final adjustments to min and max beep settings, the helicopter should be flown for approximately 30 minutes to exercise the fuel control and to stabilize fuel control and engine temperatures. In order for the RPM range specified in the NATOPS Manual to be valid, the throttle system must be adjusted to the specific RPM value called for. For example, in order for min beep RPM to fall within its specified RPM range (94 - 96% RPM -

Standard Rotor) for all temperature conditions, it must be adjusted to the specified value (95%  $N_f/N_r$ ) after being flown for approximately 30 minutes. The acceptable range for normal operations should not be confused with adjustment criteria.

D. Use care when adjusting max and min beep settings. To avoid damaging the adjustment potentiometers, use the correct size screwdriver and very gently turn the adjusting screw to achieve the desired results. Do not force the adjusting screw as damage to the potentiometer will result.
