Rotor Tips

Volume VIII No. 6

Table of Contents

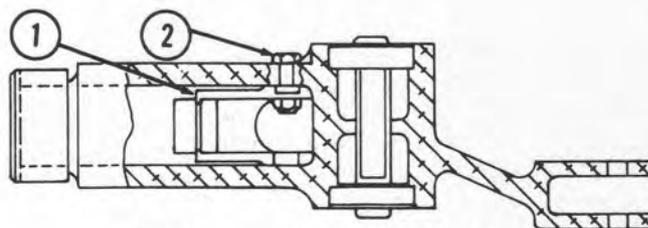
FIGURE No. 1

1. Adapter assembly, K651061-1
2. Nut, AN345A
Washer, AN960D

- A. Removal of pilot or copilot adapter assembly, P/N K651061-1, from the socket assembly, P/N K651015-5 or -6. Refer to Figures 1 and 2.

- B. Installation of pilot or copilot adapter assembly, P/N K651061-1, into the socket assembly, P/N K651015-5 or -6. Refer to Figures 1, 2 and 5.

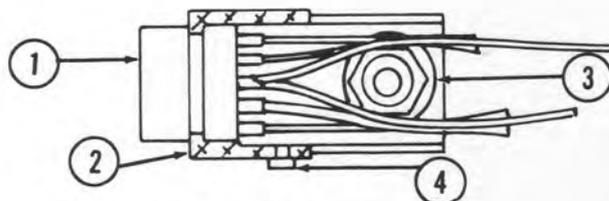
FIGURE No. 2

1. Connector, M8600-19B132
2. Adapter, K651063-11
3. Nut, 22NDS-02
4. Locator pin, K651065-15

The adapter is procured as an assembly as shown in Figure 2 with 45 inches of wire on each pin of the connector.

1. Install vinyl tubing over the wires of the adapter assembly.
2. Thread the wiring from the adapter down thru the socket until the adapter bottoms in the socket.
3. Align the bolt hole of the adapter with the socket and install the AN3H5A bolt.
4. Splice the wiring from the adapter assembly into the aircraft wiring (see Fig. 5). Re-tie wire bundle in accordance with NAVAIR 01-1A-505.

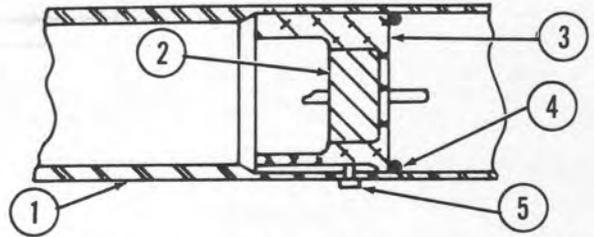
FIGURE No. 3

The adapter assembly, Figure 4, can be very difficult to remove due to close tolerances and/or corrosion. If the adapter assembly cannot be eased from the cyclic stick, the connector will most likely be damaged and a new one will be required.

1. Cyclic stick, K651035-1
2. Connector, M8601-19/32
3. Adapter, K651064-1
4. Retaining ring, 5008-100
5. Locator pin, K651065-13

3. If necessary, break the bond between the adapter/connector by pushing the connector up into the stick. Remove the adapter ring with a small gear puller. If the connector is to be replaced, cut the wiring as close to connector pins as possible.

3. Insure the inside of the cyclic stick tube and the adapter assembly is free of corrosion. Coat both surfaces with a light coating of Dow Corning, P/N DC-33 medium, to prevent corrosion and to aid in installing the adapter assembly.
4. Insert the adapter assembly into the cyclic stick by aligning the groove in the adapter with the locator pin, then, push it into the stick. Lock in place with the 5008-100 retaining ring. Refer to Figure 3.

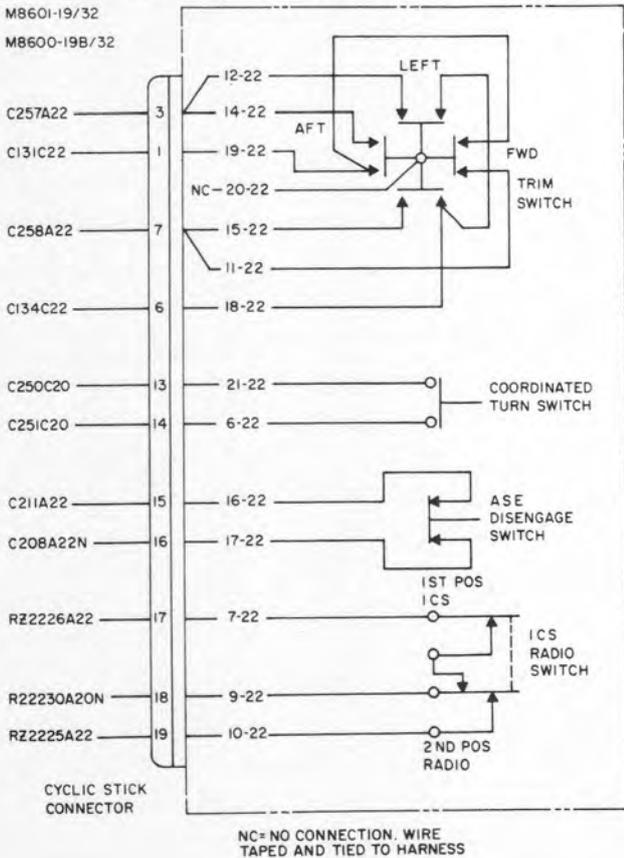
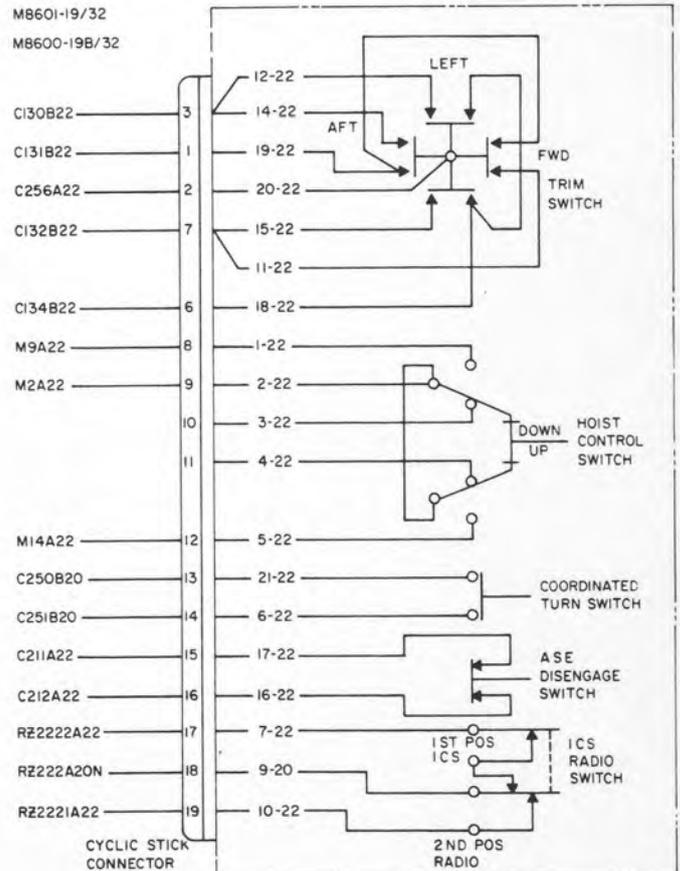
FIGURE No. 5

COPILOT'S CYCLIC CONTROL STICK GRIP SCHEMATIC

PILOT'S CYCLIC CONTROL STICK GRIP SCHEMATIC

1. Solder cyclic stick wiring to the connector pins as shown in Figure 5.
2. Bond the connector into the adapter ring using EC 2216, a two-part epoxy cement. Insure that the Number 8 pin on the connector is aligned within $1/2^{\circ}$ to the centerline of the groove in the adapter ring and also that the connector is flush with the flange of the adapter ring. Refer to Figure 4.

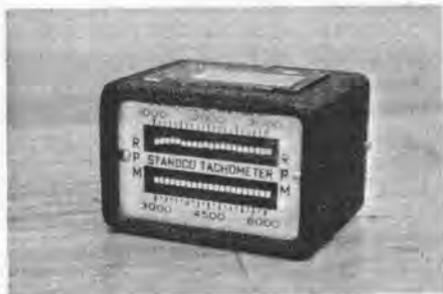
The accompanying photo shows a K604154-1, Vibration Indicator or "Vibratach." The vibratach is a mechanical version of what every sports car owner has and worships, a tachometer. A tachometer indicates RPM. A mechanical tachometer placed on supporting structure of a rotating object, will (unless the body is in absolute perfect dynamic balance) indicate at what RPM the object is rotating. (Are you starting to get the connection?) Let's take a hypothetical example and see how it can be of help.

Suppose a pilot returns from a flight, and reports a medium freq vibration. He does not specify anything else, so the mech now has the problem of determining what is causing the vbe. The best bet is to make a ground turn up. After rotor engagement and max beep is reached, the vibratach should be placed at various points on the aircraft structure, where it will indicate at what frequency the vbe is occurring. In our hypothetical case, assume the reed at 1200 goes to full scale. Since a four-per-rev of the main rotor would fall near the indicated frequency, it is logical to expect the problem is occurring in that system. Because the reed at the 1700 mark is not vibrating, there is no need to suspect a problem in the tail rotor system.
