Rotor Tips

MAY-JUNE, 1975

Volume VIII No. 10

TECHNICAL SECTION

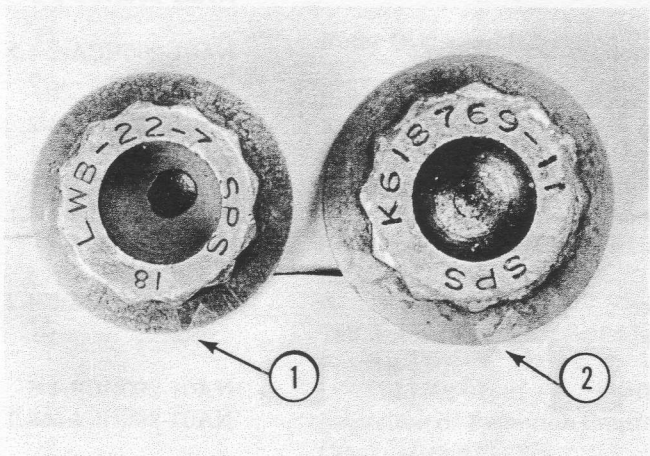
PHOTO 2

Although the bolts shown in Photo 1 have the same shank diameter, they are not identical because one has a higher tensile strength and a larger bearing head as can be seen in Photo 2. The larger-head, higher-strength bolt, P/N K618769-11, is used on the SH-2F aircraft. While the stronger bolt may be used on all H-2 aircraft, in no case should the smaller-headed bolt, P/N LWB-22-7-46, be used on SH-2F aircraft. The bolt secures the main rotor hub to the main transmission as seen in Photo 3. When installing the bolts be sure to use new PLI washers, P/N PLI7-14.4.

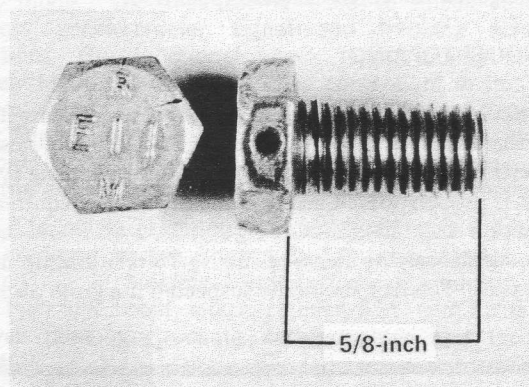
PHOTO 2

A recent inspection of the forward engine mount installation, P/N K672751-3, revealed the presence of unauthorized and, in some instances, unsafe mount bolts (too short). The correct bolt, P/N AN103912, shown in Photo 1, has a 7/8-inch threaded grip length, a recessed head with 6 lockwire holes, and the marking E11 or E1. (The E11 mark supersedes the E1 mark.) The markings identify the material specification and heat treat condition: IT DOES NOT INDICATE BOLT LENGTH! For example, Photo 2 shows a bolt with the E11 marking; however, note also that the head is solid, has only one lockwire hole, and only a 5/8-inch threaded grip. This bolt must not be used in the engine mount installation. Photo 3 shows the correct and incorrect bolts inserted in the engine mount fitting. Note the difference in threads available for engagement.

To inspect for correct length of installed bolts, insert a thin three or four-inch long piece of wood or aluminum into the open end of the bolt holes from inside the engine air inlet. Bottom the "gage" against the end of the installed bolt and make a pencil mark, flush with the end of the bolt

hole. Withdraw the "gage" and measure the length from the pencil mark to the end which butted against the bolt. If dimension is more than 3/8-inch, the bolt is too short and should be replaced with an AN103912 bolt.

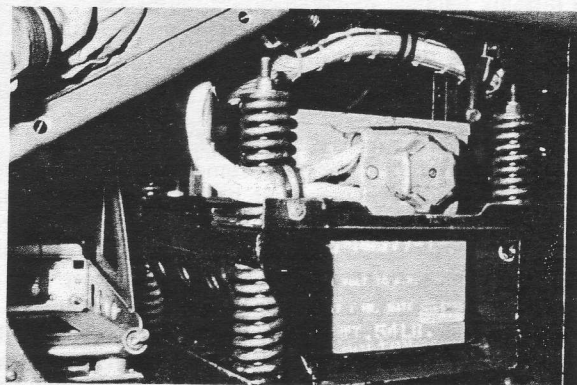
Vibration Absorber

We previously stated that various means of damping or tuning are used to minimize inherent vibrations in helicopters. In the H-2, the main battery is mounted and tuned so as to resonate in opposition to four-per-rev vibratory inputs. NAVAIR 01-260HCA-2-1 and the March/April, 1970 issue of Rotor Tips provide detailed descriptions of its operation. In troubleshooting this vibration, two points should be considered. First, be sure that the absorber is tuned to resonate at four-per-rev frequency, at a preselected main rotor RPM. Secondly, be sure that the selected RPM is at the desired point within the flight beep range. Always be sure that the battery absorber installation is properly secured and free of interference with adjacent structure and wires. Adjustments to the absorber installation should only be accomplished in accordance with the MMI, NAVAIR 01-260HCA-2-1. As explained in the MMI, the installation is tuned to a frequency range or null by adjusting the springs. Then, by adding or subtracting weight to the entire mass, we can move the null point to the proper RPM. In the SH-2F, the proper point is at 105-106% NR.

The greatest asset in troubleshooting any problem is common sense. If an aircraft has flown without four-per-rev problems for a number of hours and then returns from a flight with excessive four-per-revs after the main battery has been replaced, it does not make much sense to start checking the folding pins or locks; the battery weight and absorber installation should be checked first. Apply logic and do a little research into past maintenance actions whenever any vibrations "pop up." In many cases, a clue might be that a component was replaced and/or adjusted.
