# *Rotor Tips*

## Rotor Tips

Volume VI Number 5

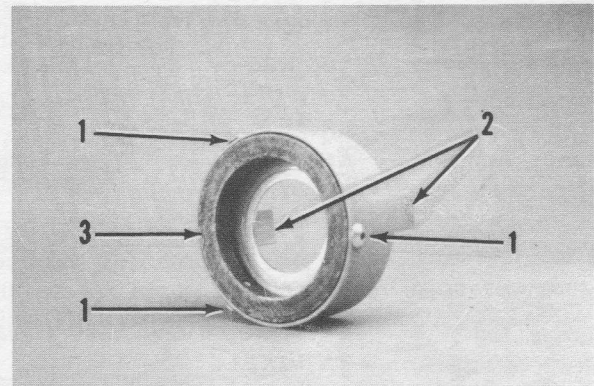
ment of the PLI washer tabs (item 2, Photo A), can indicate one of the following: Loss of torque on the spindle attaching bolt, P/N 65694-18H; or a looseness of the screws which attach the tabs to the lockwasher. Photo B shows the PLI washer assembly. The three screws (item 1, Photo B), secure the tab ring to the PLI washer. If one or more of the screws become loose, the tabs will move even though the washer is securely held in place by the bolt head. If the screws loosen while the PLI washer assembly is installed, tab movement will be slight. If a loss of torque were to occur, considerable rotational movement of the tabs will be evident when checked. This information will be incorporated into applicable handbooks by a future change.

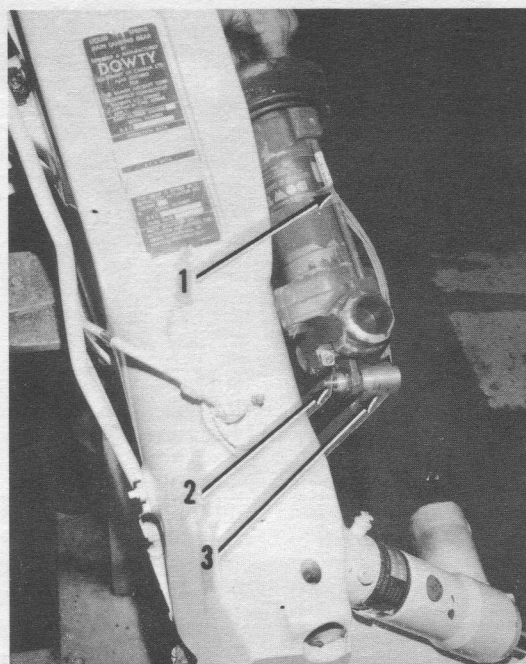
**PHOTO A**

**A.** As received from supply, RFI (ready for installation) actuators P/N 3283400-5 (LH) and -6 (RH), are not interchangeable; however, they can be converted (a -5 to a -6 and vice versa) by rotating the actuator micro switch so that the plunger end of the switch faces the opposite direction. Viewing the actuator as it should be installed in the main landing gear member (see Photo A), the external tube (1) on the cylinder must face up, and the plunger end (2) of the micro switch (3) must point aft. To convert an actuator, (Illustration 1), remove the two screws (4) which retain bracket (5). Rotate the bracket (5) so the hinge end points in the opposite direction. (It is not necessary to remove the micro switch if it is attached to the bracket (5). Reinstall screws (4) and stake in position. Prior to installing the actuator into the landing gear member, check to insure that the external tube (1, in Photo A) is up and the plunger end of the micro switch points aft.

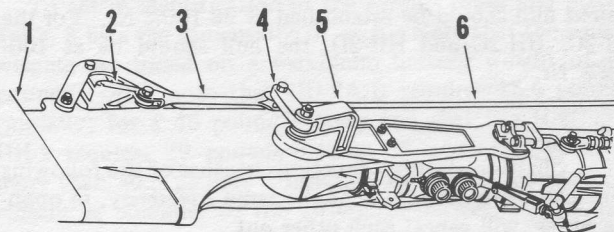
**A.** The inspection criteria for the main rotor control rod (item 6 in the illustration) is as follows:  
Maximum bend over entire length not to exceed 0.50-inch. No sharp bends or kinks permitted; no mechanical straightening permitted. Dents up to 0.005-inch deep may be blended out; damage beyond limits specified necessitates rod replacement. This information will be incorporated into applicable handbooks by a future change.

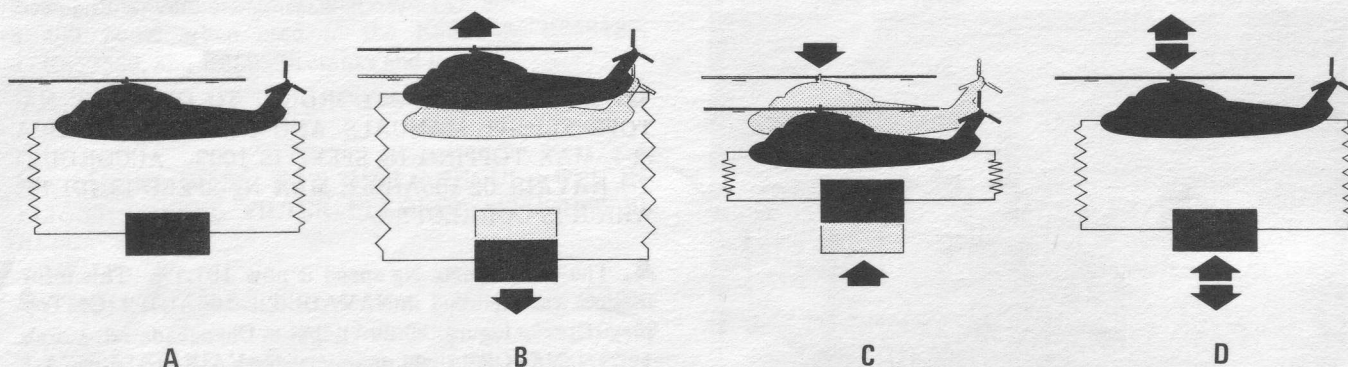
ILLUSTRATION 1

View A of illustration 1 shows the rotor, fuselage, springs and vibration absorber assembly at rest. In View B, the VA assembly has started to react to the vertical force induced by the rotors. (The shaded areas indicate at-rest positions.) View C is opposite to View B; notice the springs are at the fully compressed position. Assuming the vibration absorber assembly is properly tuned to the expected rotor RPM, the result would be as depicted in View D. The vertical forces are still prevalent at the rotors and the absorber assembly, but now the fuselage is in the same position as that shown in View A. Moral? Keep that vibration absorber tuned properly!
