Rotor Tips

NOVEMBER-DECEMBER 1972

Volume VII Number 7

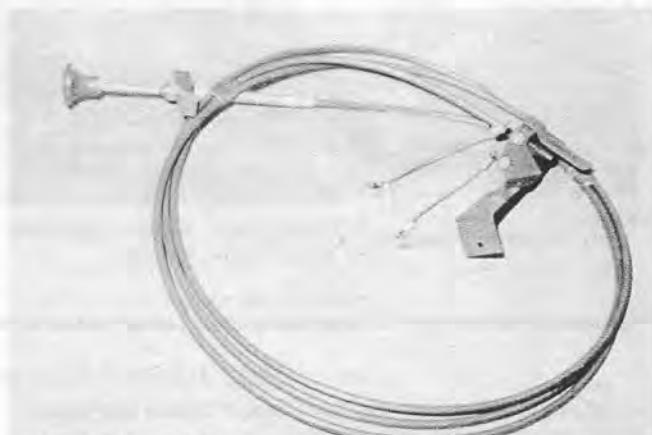
Photo A K604524-1, Remote lockout assembly, stator vane assembly

The engine stall margin check entails engine operation at a speed high enough for the variable stator vanes to fully open (approximately 87 to 92% Ng). With the vanes open, and the stator vane actuator mechanically locked by the remote tool to keep the stator vanes from closing, reduce Ng speed to the point where the vanes would normally be partially closed. If, under these conditions, compressor stall does not occur, compressor condition is satisfactory.

An engine stall margin check is required at each engine Calendar Inspection, at every fuel control change, and at 50-hour intervals when operating under environmental conditions which may be conducive to premature compressor blade erosion or compressor efficiency deterioration. For detailed stall margin check procedures, refer to paragraph 10-25 of NAVAIR 02B-105AHB-2, dated 15 May 1972. The paragraph refers to test cell engine operation but it will also apply to installed engines with the exception that Ng is reduced by 3% instead of the 6% called out in step f. Also, the Kaman remote lockout tool must be used in lieu of the GE locking link. (The close proximity of the rotors to the top of the engine precludes use of the GE lockout link.) The 14-foot-long Kaman tool enables the pilot or crewman, whoever is monitoring the stator vane position indicator to remotely engage the stator vane actuator piston, thus preventing the vanes from closing. (*Continued on page 12*)

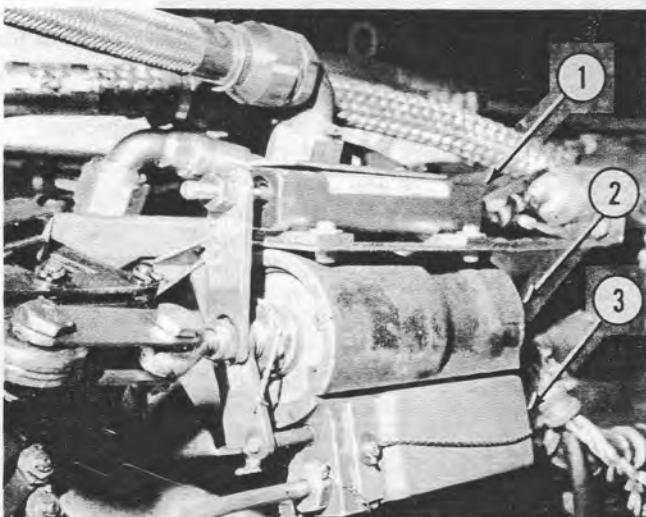
Photo C

1. Stator vane position indicator
2. Stator vane actuator
3. Cover

1 Remove the stator vane actuator cover. See Photo C. (Some covers are secured with three screws; most are secured with two screws.) Retain the screws for re-installation.

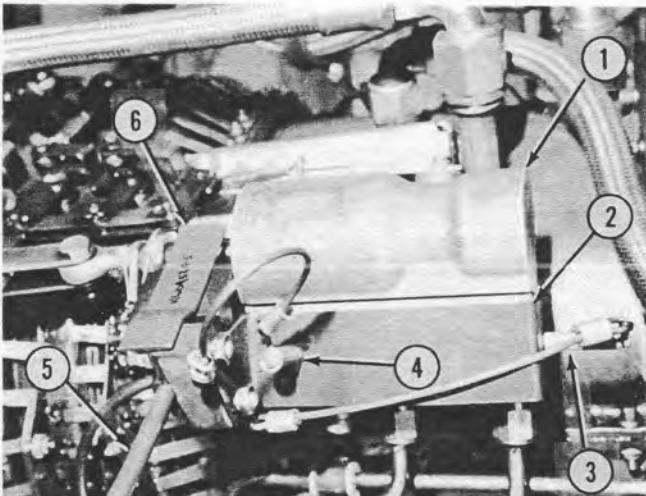
Photo D

1. Actuator
2. Tool bracket
3. Knurled screw
4. Knurled screw
5. Tool cable assembly
6. Tool guide

2 Install the lock-out tool bracket onto the stator vane actuator in place of the cover as shown in Photo D. Secure the bracket with the two knurled screws attached to the bracket or use the previously removed screws.

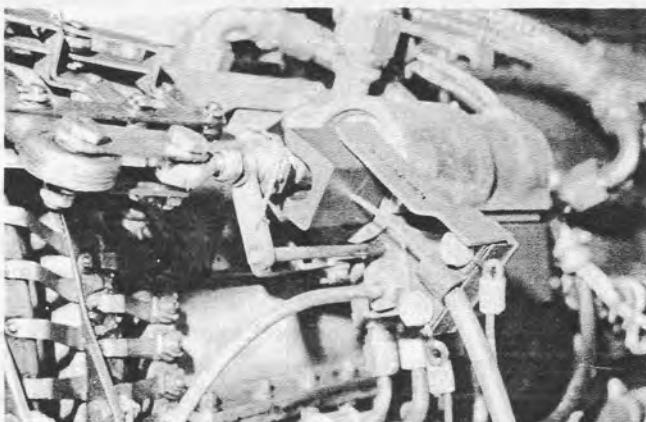
Photo E Block assembly engaging piston assembly

- a. Push the tool handle in and hold; check that the gauge block engages the actuator piston as shown in Photos E and F.

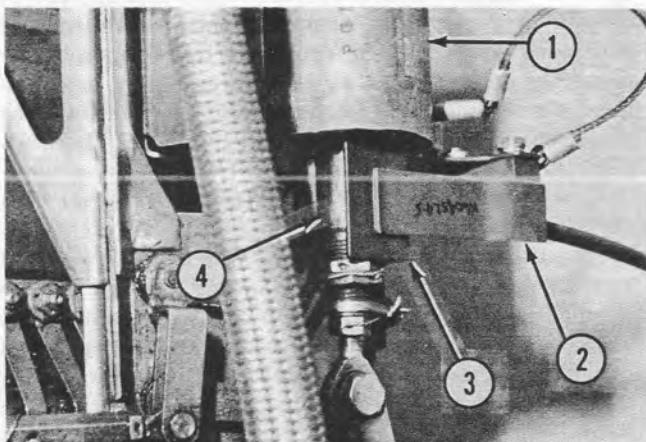
Photo F

1. Actuator
2. Guide
3. Gauge block
4. Actuator piston

F. Increase engine speed to fully open the vanes (0° on the stator vane position indicator). Push the lockout tool handle in to engage the actuator piston as shown in Photos E and F. (Hold in this position for duration of the check.) The piston will be locked out as shown until the handle is released. Slowly decrease engine speed and allow the engine to stabilize at the Base Ng. Slowly decrease Ng to 3% below the Base Ng. This 3% band is the engine stall margin. Compressor stall should not occur within this band if compressor condition is satisfactory.

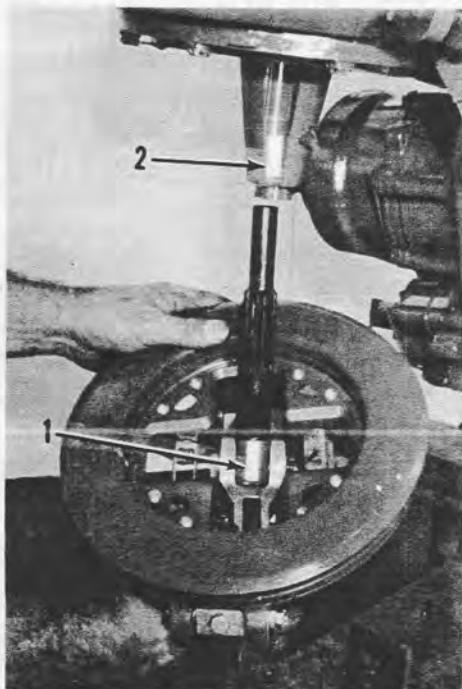
A recent flight control problem was traced to the azimuth assembly where, it was discovered, the master spline had been improperly installed, shearing the roll pin. In order for this to occur, someone had to force the components together, probably by attempting to lower a main gearbox onto an azimuth which was already installed into the aircraft. In the event the gearbox is lowered onto the installed azimuth, the two may appear to mate properly but due to the mass involved, no "feel" for possible interference will be evident. Consequently, damage can result, and as in the previously described incident, much maintenance time is expended attempting to correct the error.

The stripe on the spindle (item 1, View 1 and the accompanying photo), is in line with the master spline located inside the support. The photo shows an azimuth assembly with the azimuth spindle about to be inserted into the support. Notice the paint stripes indicated by the arrows. This information will be incorporated into applicable manuals by a future change.

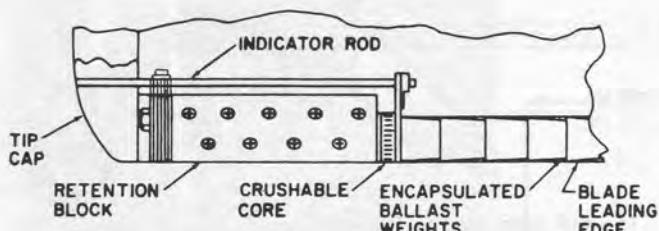
A. No. The main rotor blade tip cap failsafe indicator rod is a quick method of determining whether the blade ballast weight bond is intact. Blade ballast weights are bonded to the blade leading edge and the assembly built up as shown in the accompanying illustration. If the bond fails, centrifugal force will cause the weights to shift outward and crush the impact assembly core. The indicator rod, which is threaded into the impact assembly, will also shift outward and protrude from the tip cap. If the core has been crushed, the blade must be returned to an overhaul facility; occasionally, however, the rod may loosen and protrude from the tip cap.

To determine whether a blade change is necessary when an indicator rod is discovered protruding, remove the four screws and remove the tip cap. (Tip cap installation and removal instructions are contained in NAVAIR 01-260HCA-2-4.2.) Photo A shows the blade tip with the cap removed. Photo B shows the components removed from the blade (right-hand side of photo represents the outboard end). After removing the tip cap, use a mirror and light to check the impact assembly for evidence of having been crushed. If the impact assembly has been crushed, return the blade to Overhaul.

If the impact assembly core has not been crushed, remove the rod, inspect the threads for damage; if necessary, replace the rod (P/N K611583-13). If the rod is not damaged, apply a drop or two of Locktite, Type C, on the threads, re-install into the impact assembly and replace the tip cap. Be sure to seal the screws.

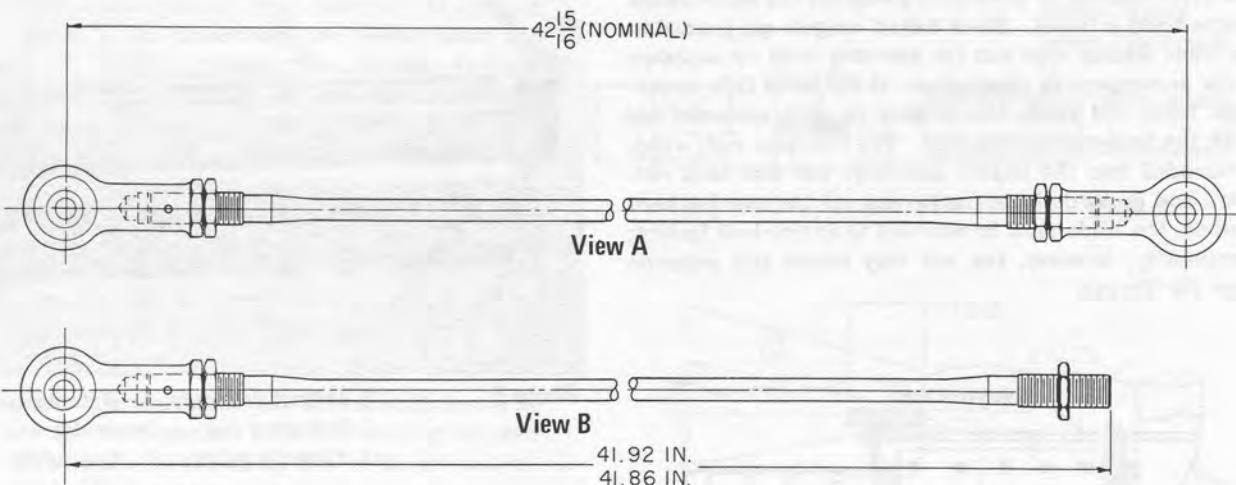
Paragraph 4-105 of NAVAIR 01-260HCA-2-2.1, dated 15 April 1972, changed 15 June 1972, details assembly of azimuth rod assemblies, P/N K659027-5. The instructions establish a nominal preset length of 42-15/16 inches (View A) between the fixed and the adjustable rodend centers. During installation of the rod into the aircraft, the adjustable rodend is removed and installed into the azimuth. The rod is then installed down through the main rotor hub and is threaded into the installed rodend. In order to take advantage of the nominal length to which the rod was pre-set, it is important not to disturb the checknut when removing the adjustable rodend from the rod.

To aid in installation, it is recommended maintenance personnel apply a drop of Locktite, Type C, to the checknut threads when bench rigging the rod assembly. With

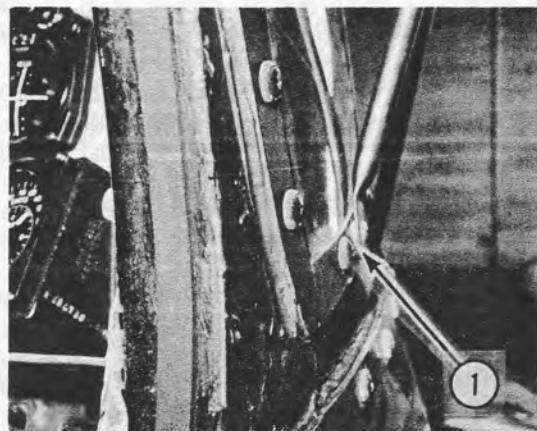
Photo C

The lower aft outside mirror bracket (item 1 in Photos A and B), can contact the pilot's window and, after a period of time will cause the window to crack. To prevent this from occurring, add one thick washer, P/N AN960PD10, between the bracket and the window frame as shown in Photo C. This information will be incorporated into applicable manuals by future changes.

1. Washer
