# *Rotor Tips*

NOVEMBER-DECEMBER, 1973

Volume VIII No. 1

## TECHNICAL SECTION

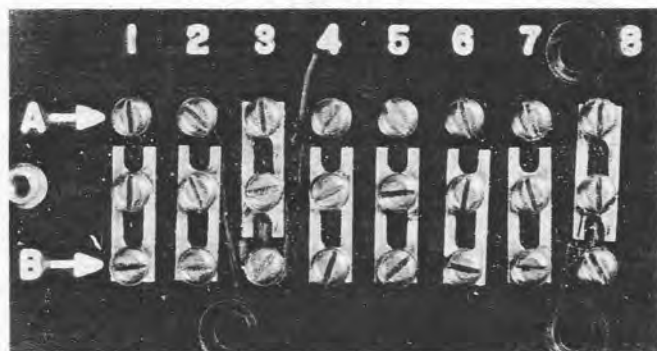
When the Juliet 28/KY-28 system is installed in an aircraft, the J-1013/AIC interconnecting (junction) box must be set up for operation as shown in the accompanying photo. Note slide links 3 and 8 are in the "A" position while all the remaining slide links are in the "B" position. If the box is not set up as described here, the KY-28 system will not function properly.

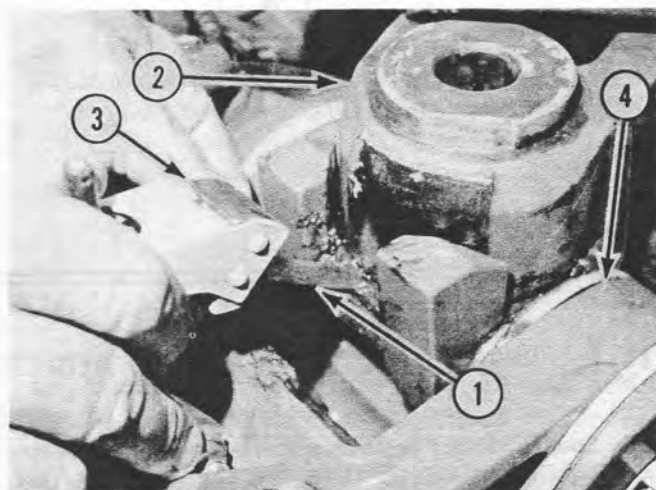
1. Feeler gage  
2. Hub

3. Anti-coning stop  
4. Retention

Correct shimming procedures are contained in NAVAIR 01-260HCA-2-4.2.

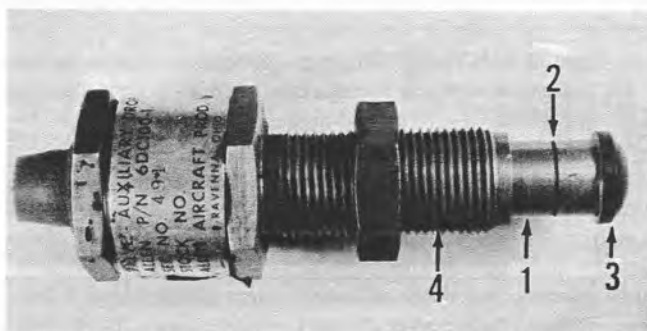
Photo A

Prior to aux tank installation, inspect the ball-end for nicks or scoring. The ball-end has a special, hard-coat finish and if found damaged, the valve must be replaced. Check the piston for freedom of movement. Push the piston completely up into the valve body by hand. If no binding exists, the piston will return to the extended position as soon as the pressure is removed. In the event binding does exist, remove the valve from the support and check the piston for

gouges or burrs. Light scratches or burrs may be blended out; deep penetration necessitates valve replacement. In cases where the cause of binding is not apparent, wipe the piston clean and apply a light coating of general purpose lubricating oil or jet fuel. Work the piston in and out of the valve body several times while rotating it to distribute the lubricating agent. If binding persists, replace the valve.

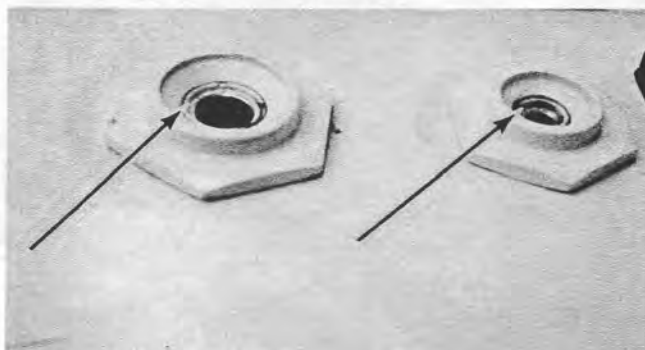
Photo D

Mis-aligned drop valves may contact the end of the fitting sleeve and force it down into the fitting body flush with the seal as shown in Photo D. If this occurs, leakage will be evident and it will be necessary to change the fitting.

Incorrect sleeves do not protrude

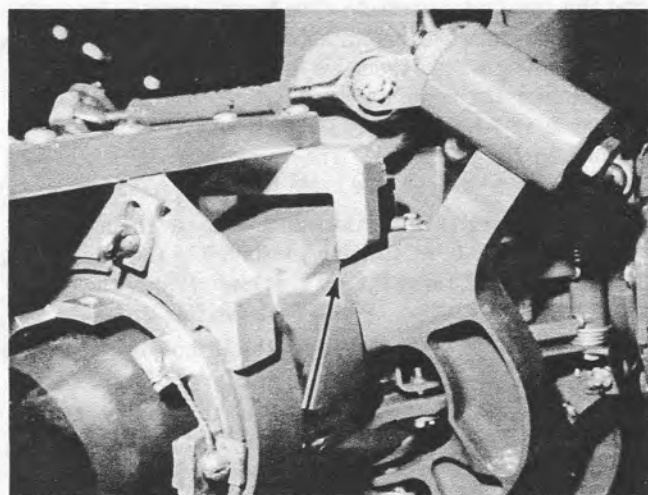
**Photo A**

Fleet activities which have not modified the K604403 tail rotor blade rigging protractor should do so as soon as possible to provide clearance between the tail rotor blade pitch arm and the support which rests on the tail rotor blade grip. The Photo shows a modified protractor installed on a tail rotor blade grip. The controls have been placed in the full left position and the close proximity of

the inboard leg of the support and the pitch arm can be seen (Arrow). The accompanying illustration lists the dimensions necessary to accomplish the modification.
