KAMAN

Rotor Tips

Volume VIII No. 3

TECHNICAL SECTION	7
-------------------------	---

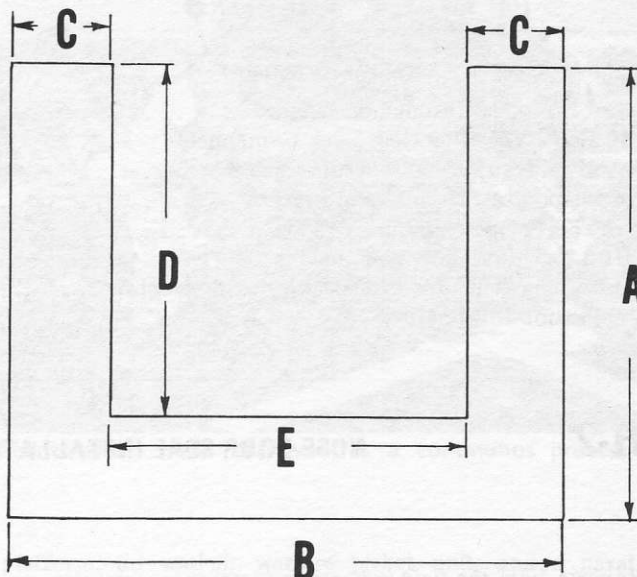
Illustration 2

Each door latch seal (2 per door; see Photo 1) is fabricated from a single piece of flat rubber to the dimensions listed on Illustration 2. The remaining seals at the BL 0.0 frame on the RH door are made from flat rubber (Illustration 3, items D, E and F). The remaining seals at the BL 0.0 frame for the LH door are made from the bulb-type extrusion seal (Illustration 3, items I, J and K). Lengths are listed in Illustration 3. Install nose door seals with edges flush with the skin and trim off excess lengths.

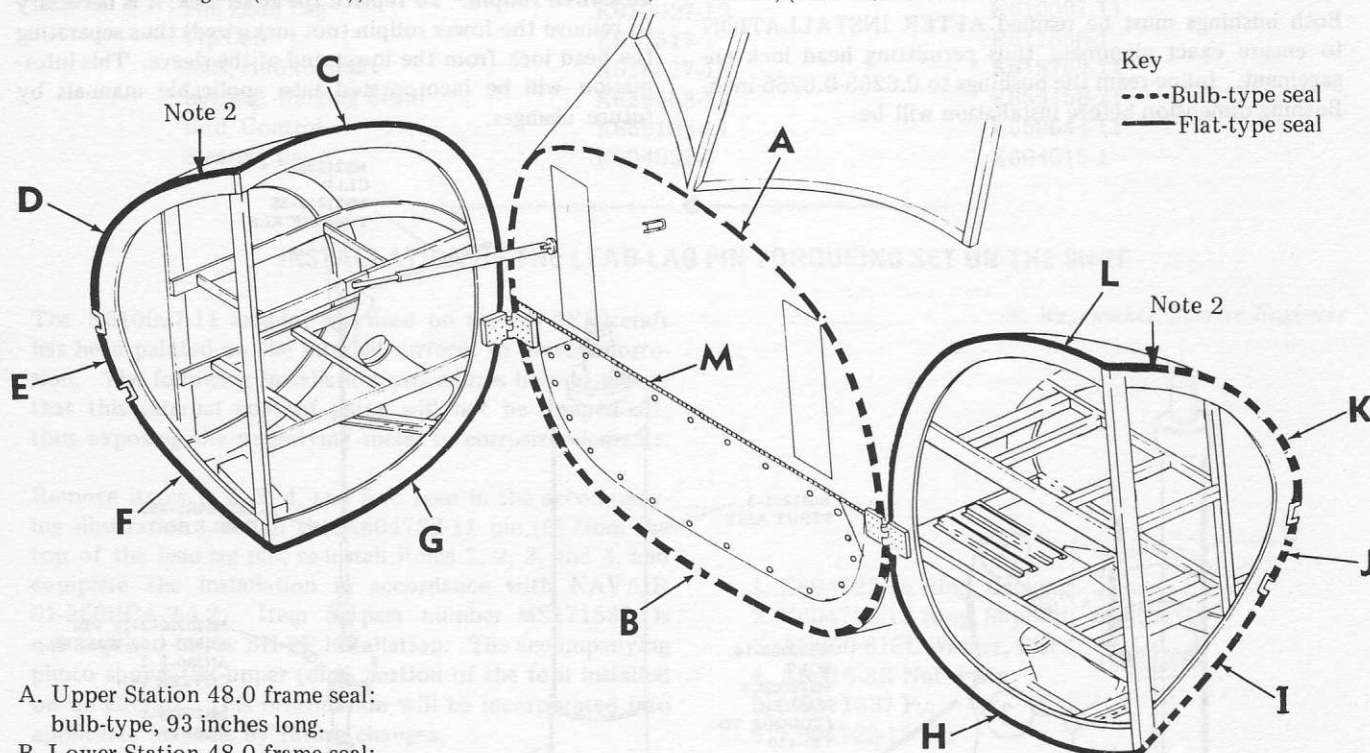
As an added precaution, to exclude water entry from the forward tub area, apply sealant to the upper joint formed by the nose door curtain mounting strap and the fuselage frame, (item M, Illustration 3).

A. Upper Station 48.0 frame seal:
bulb-type, 93 inches long.

B. Lower Station 48.0 frame seal:
bulb-type, 68 inches long.

After the adhesive has cured, apply a sealant fillet at joint on both sides of the seal, all around the frame, as shown in Illustration 1. Use sealant, EC1239A in accordance with MIL-S-7502A, or a suitable substitute such as EC1675 or EC801. Allow the sealant to air-dry with the nose doors open for at least 12 hours.

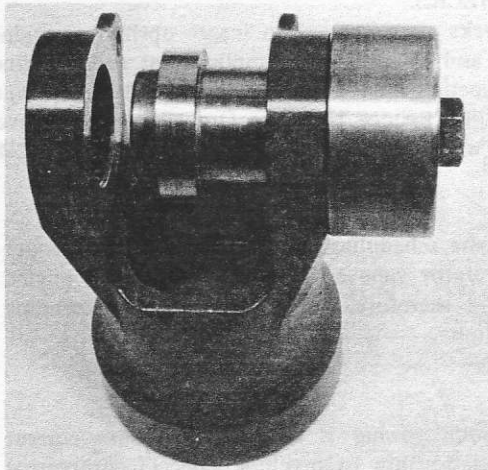
While an arbor press is usually utilized to remove the tail rotor flapping bearings, P/N K616300-1, from the grip assembly, an alternate method may be used during field replacement when a press is not available. This entails fabrication of the bearing installation and removal tool shown in the accompanying drawings and photographs. Steel stock should be used and all tolerances are ± 0.015 -inch unless otherwise specified. Figure 1 shows the finished tool which consists of a bolt, installed in the back-up housing, and a bearing follower. Figure 2 shows the tool in position on the tail rotor blade grip

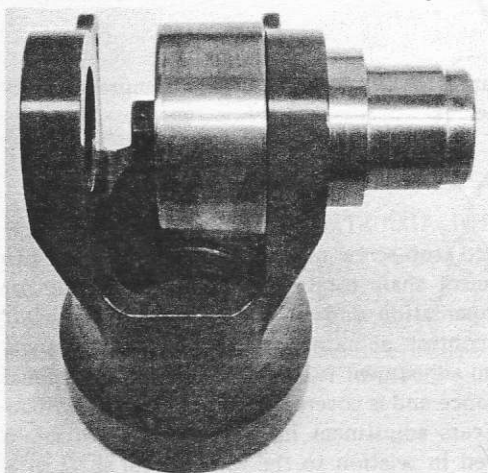
during bearing removal. The bearing follower, in the in-board position, has eased the bearing out of the grip assembly and into the recess in the back-up housing. When using the tool, carefully align the bearing follower and the back-up housing while slowly turning the bolt clockwise until it is finger tight. Check the alignment and then use a wrench to slowly turn the bolt. As the bolt is turned clockwise, the bearing follower pushes the bearing out of the blade grip and into the recess in the back-up housing. When the follower butts against the grip the bearing has been removed (See Figure 2). Remove the bolt from the follower and remove the old bearing from the recess in the back-up housing. Figure 3 shows the position of the tool at bearing installation. Note that the bearing follower is positioned outboard. Place the back-up housing inboard, against the grip. Push the bolt through the back-up housing and insert a new bearing in the chamfer on the blade grip. Thread the bearing follower onto the bolt. Before using a wrench on the bolthead, check to see that the back-up housing, new bearing and bearing follower are all in line. When the tool and the bearing are lined up with the grip, slowly turn the bolt clockwise. If the new bearing is lined up properly, it will slide into the grip. If the bearing does not enter the grip, recheck the alignment. When the bearing follower butts against the grip as shown in Figure 3, the new bearing is installed. Remove the tool from the grip.

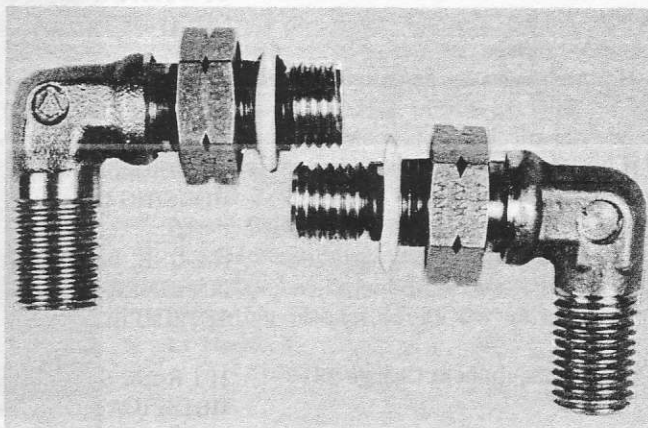
A. No. Substitute elbows installed at the auxiliary metering inlet port on the fuel control will probably bind the emergency throttle control valve. Careful selection of the proper part is required because some standard elbows closely resemble the special elbow required. The illustration shows two elbows—the one on the left is the correct part; the one on the right is a standard elbow. Both elbows have a machined recess between two threaded portions to receive a washer and an O-ring. Close inspection of the two elbows will show that the one on the right has two more threads on the outer portion. If the longer threaded end is installed, it may restrict movement of the emergency throttle control. The correct installation procedure is to select the designated elbow by Part Number (37B200243P

101), thread it into the opening up to the last outer thread and, while holding the elbow in position, tighten the nut.
