# *Rotor Tips*

Volume VIII No. 4

# TECHNICAL SECTION

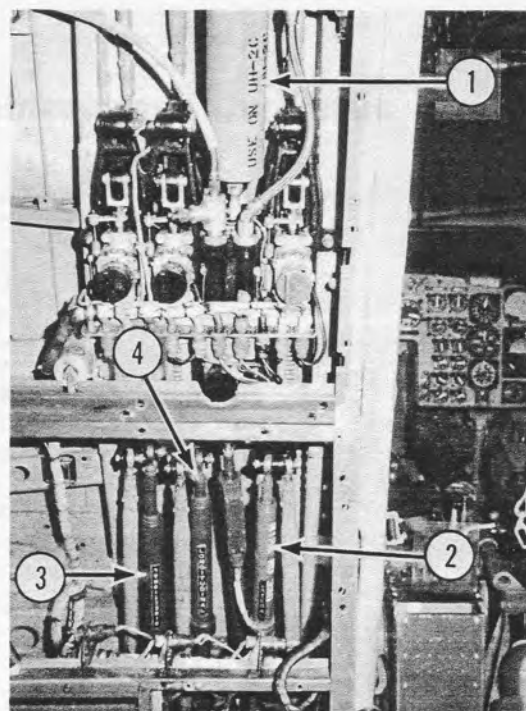
Photo A

Disconnect the collective bungee assembly and/or the cyclic and directional trim strut assemblies to relieve the spring force. If necessary to replace the cyclic stick, ensure that the cannon plug pins are straight and that the stick mounting socket is free from dirt and foreign material. (Many man-hours have been expended tracing an intermittent radio interference caused by bent pins or dirt in the socket.)

1. Collective Bungee
2. Lateral Trim Strut
3. Directional Trim Strut
4. Longitudinal Trim Strut

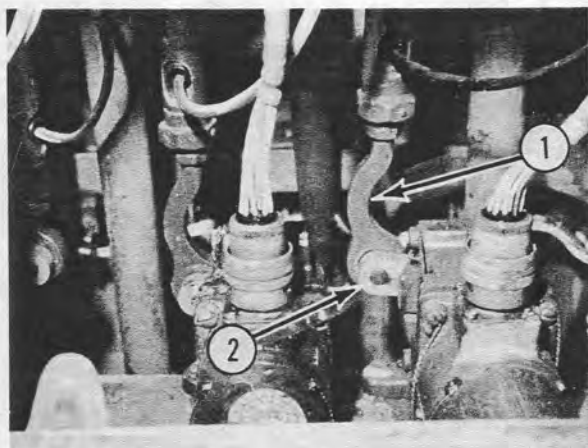
Photo B

When installing the lateral and longitudinal trim strut assemblies, care is required to ensure that the lower rodend which attaches to the trim actuator arm is positioned with the dog leg facing AWAY from the actuator arm. Binding controls and restricted trim response results from incorrect installation of the rodends.

- 1. Dog Leg
- 2. Actuator Arm

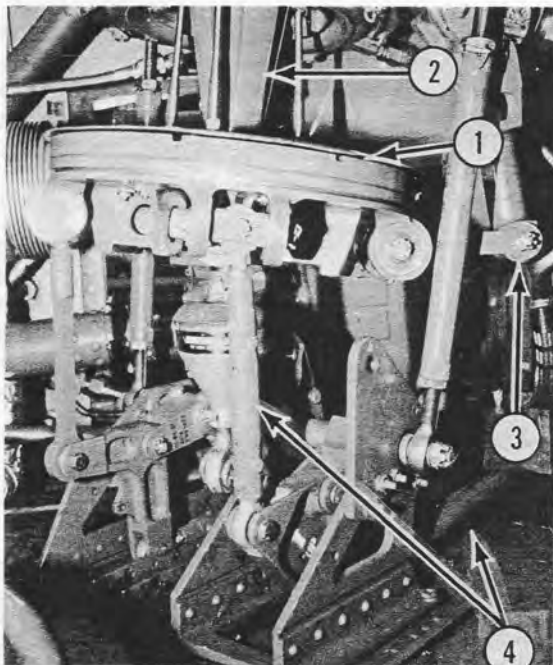
The azimuth control installation is the heart of the flight controls, and it consists of the azimuth assembly, azimuth spindle support (part of the main gearbox), the anti-rotation link and the input and output linkage. Basic rigging consists of setting the collective height and flatness (mixer assembly pinned) and adjusting the lateral and longitudinal input rods to provide azimuth tilt. MIM's must be used to ensure correct rigging for the particular model H-2 being maintained.

| 1. Azimuth Assembly | 3. Anti-Rotation Link |

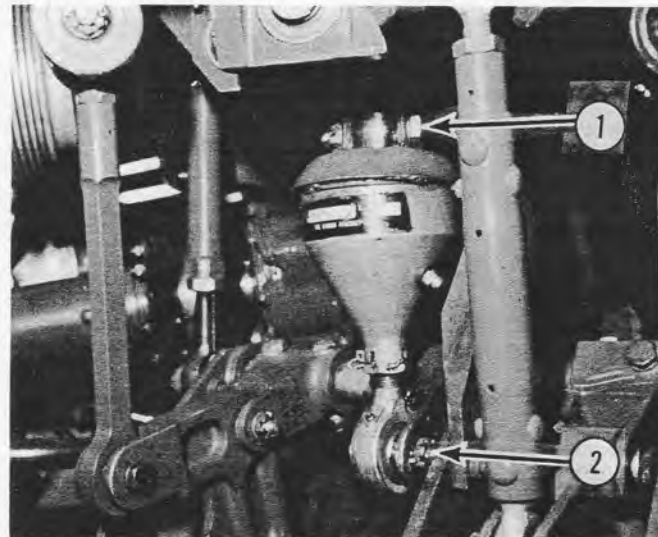
3. Remove the collective thrust rod assembly by disconnecting it from the collective input crank on the mixer and the lower end of the spindle. When removing the collective thrust rod/spindle bolt and nut, it is necessary to support the remainder of the azimuth to prevent it from dropping out of the spindle support.

| 1. Spindle Bolt |

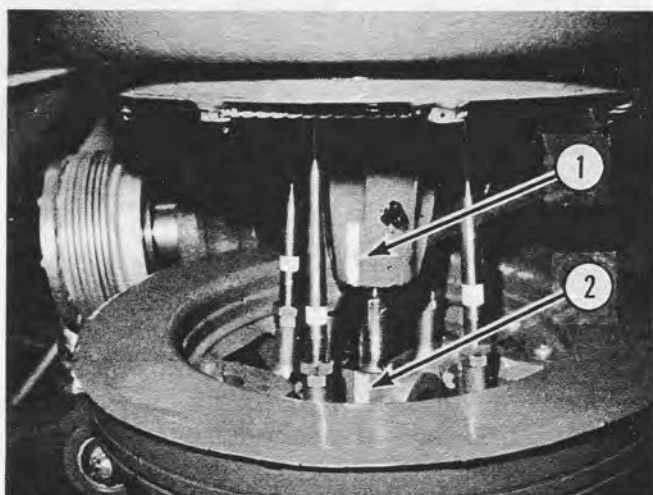
Photo H

1. Spindle Support Paint Stripe
2. Spindle Paint Stripe
