Rotor Tips

AUGUST 1961

ROTOR BLADE FIELD INSPECTION

by J. L. KING
Senior Field Service Representative; and
N. E. WARNER
Analyst, Dynamics;
Field Service Department

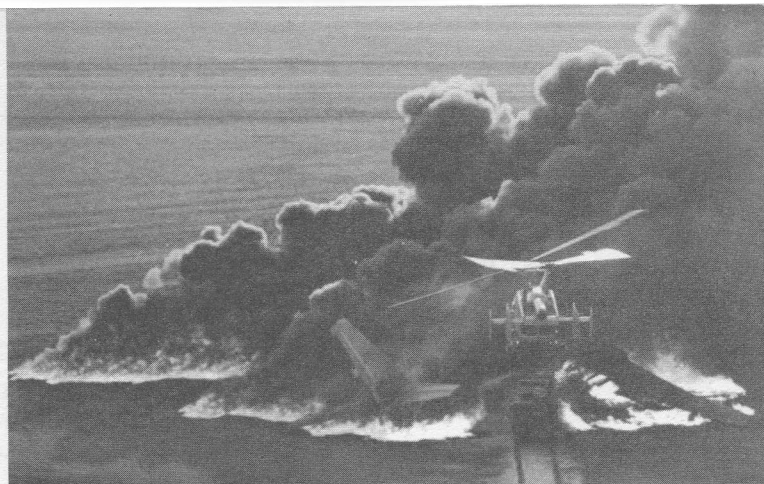
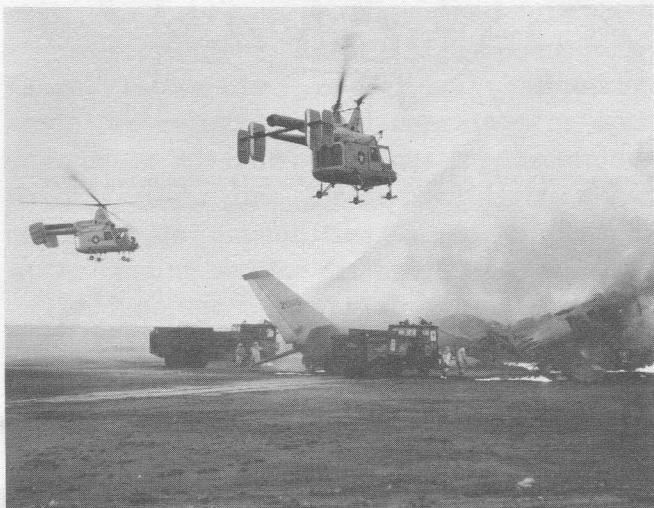
PHASE I—The O-10 using ground sweeps and turrets on stream penetrated immediately to wing root of B-47 and foamed the cockpit area. Fire has been going for 45 seconds. No attempt to rescue was made. Firemen could have used hand lines—made rescue from atop fuselage—or continued to use turrets. O-10 was withdrawn after 30 seconds in fire.

As soon as the HUSKIE took position, the 0-10 was able to move to the wing root of the B-47. The cockpit was sprayed with foam and then the truck was withdrawn after 30 seconds. No heat was felt by the crewmen, they reported; and it was observed the hand linesmen could have gone into operation at that point. Also, someone from the aircraft could have jumped on the fire truck during the 30 seconds.

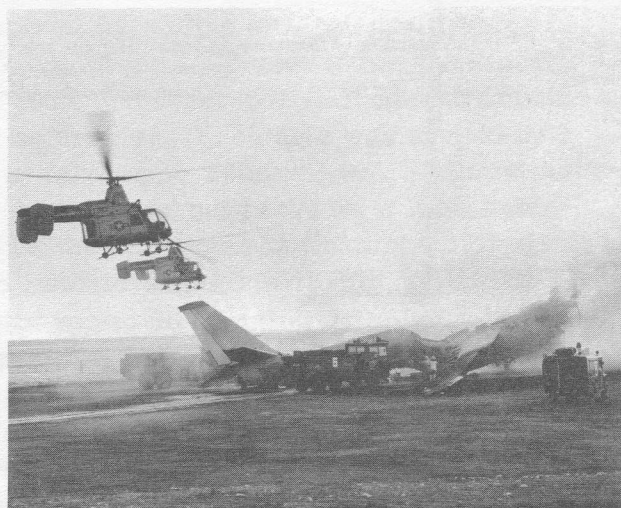
PHASE II—O-11 and O-10 move into fire on either side of tail. Second H-43 approaches position and immediately fire is controlled. Best procedure is helicopter into position first, thus allowing better penetration with fire trucks. Note how flames and smoke have dissipated. Time is two minutes thirty seconds from ignition. Aircraft was allowed to burn while photographer was let off second H-43. Pilots, Captain Seebo in 91559, Lt. Glover in 91560 on left. Note how turret stream is solid and aimed downward.

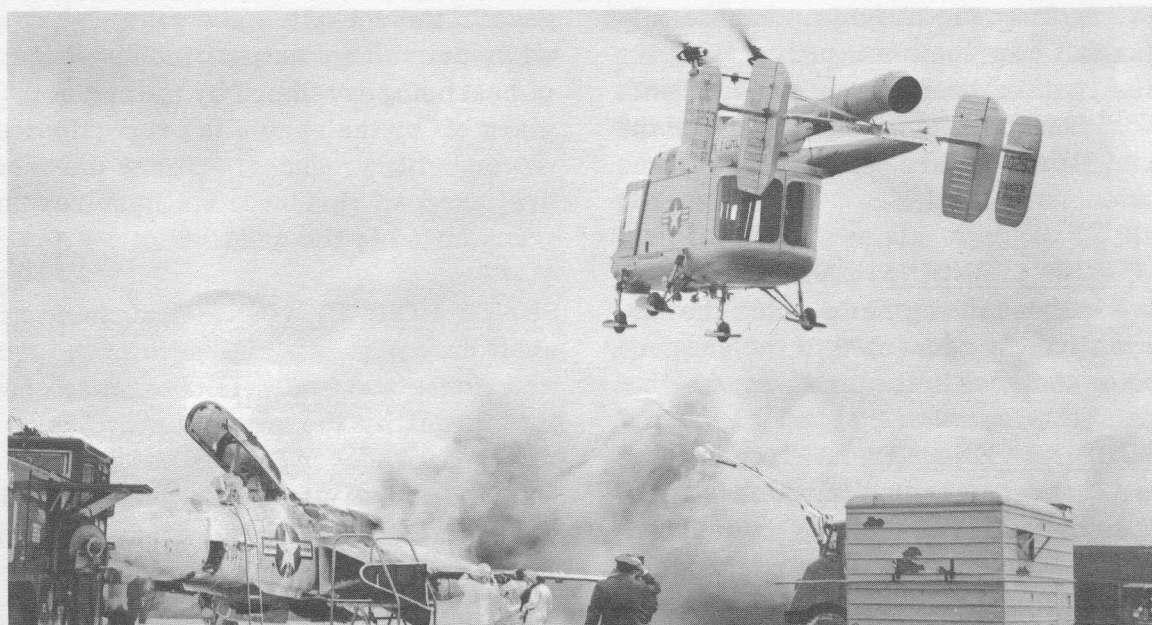
ON THE JOB—1st Lt. Gordon Hall, attached to the Rescue Section at Griffiss AFB, N.Y., was turning up an H-43B when an F-101 nearby caught fire during ground run-up. Quickly the lieutenant took off and, using the rotor downwash, aided ground firemen in controlling the blaze. (USAF photo)

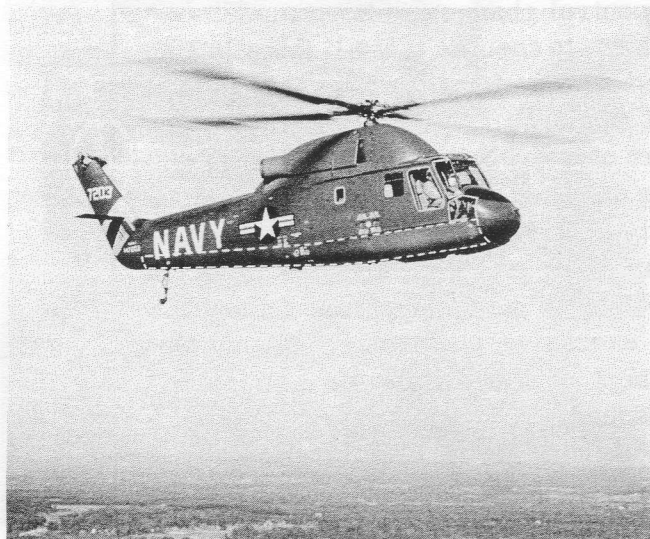
HU2K-1'S WATERTIGHT COMPARTMENT and flotation gear are located in area indicated by broken white line.

The fuselage has a lower watertight compartment which provides the required buoyancy. The structure for this section is stressed to withstand landing loads; ditching loads have also been applied to the structure during test to assure sufficient strength to prevent any structural failure occurring on contact with the water. This provision allows adequate time for crew evacuation if necessary. The basic structure of the hull consists of aluminum frames on each side of a keel beam. The frames are spaced close together in the forward fuselage but the spacing is increased between them as they extend into the aft fuselage compartment. The aluminum keel beam is of constant depth in the forward and center fuselage but, as it goes aft from the main cabin, it tapers to the depth of the frames. All through-hull fittings are kept watertight

An appreciable measure of rolling stability has been achieved by the addition of two inflatable rubber air-bag sponsons located one on each side of the forward fuselage opposite the cockpit openings. When not in use, the sponsons are stowed in the forward extension of the landing gear fairings. This arrangement provides positive lateral stability up to 30 degrees of roll and will enable the helicopter, which in addition also inherently possesses adequate lateral and longitudinal stability, to remain upright if ditched in moderate sea states. It will also be practical, under certain conditions, to actually effect an operational water landing, make minor repairs or adjustments, and then resume the flight. In instances where ditching must be made in sea states of such severity that capsizing is inevitable, the sponsons will keep the aircraft afloat to facilitate rescue of the occupants.
