KAMAN *Rotor Tips*

KAMAN AIRCRAFT CORPORATION

DECEMBER 1966

H-43B FUEL SYSTEM

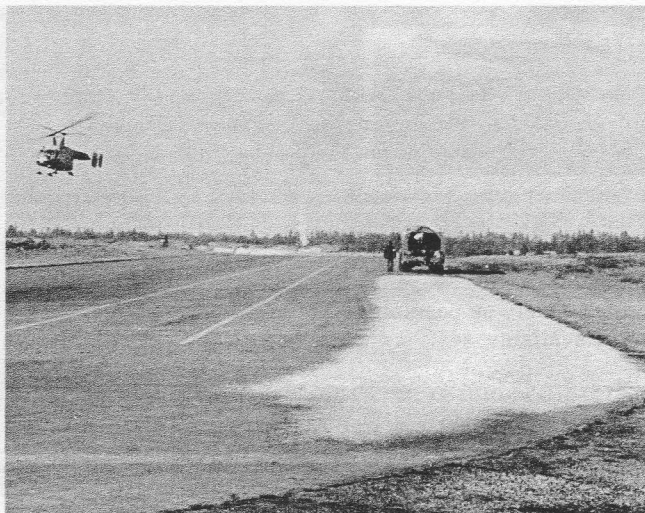
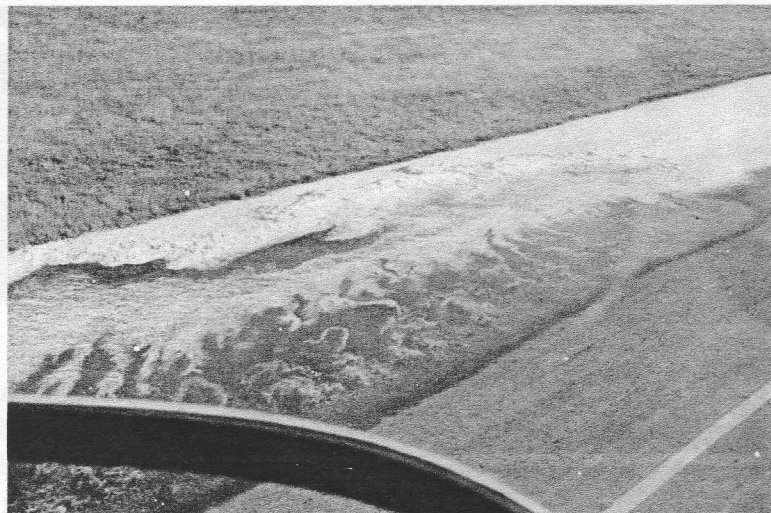
RUNWAY FOAM REMOVAL - Det. 5, WARC, ARS, at McChord AFB, Wash., utilizes H-43B to expedite removal of fire preventive foam from runways. The water tanker waters the runway so the liquid flows under the foam blanket; the helicopter then approaches the runway at a 90° angle and the rotor wash literally rolls the foam off the side of the runway. A strip of foam can be removed in approximately one-third the time required when two O-11A crash trucks perform the same task. Top left photo shows the foam before the helicopter approaches. For an actual landing the strip would be wider, of course. Top right photo was taken from HUSKIE after water had been applied and helicopter started blowing the foam. Third photo shows results. This demonstration was given by Det. 5 at the base as part of the Air Force observance of National Fire Prevention Week. (USAF photos)
