# KAMAN Rotor Tips

**KAMAN AIRCRAFT CORPORATION**  
PIONEERS IN TURBINE POWERED HELICOPTERS

APRIL 1966

# Climatic Testing The UH-2A

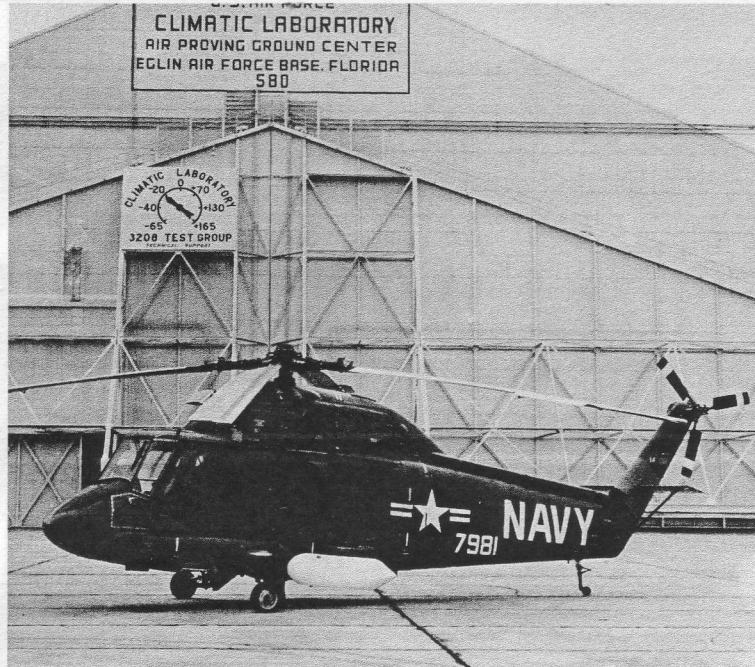
In the top photo, left, the UH-2A is shown outside the climatic laboratory while another aircraft is undergoing testing at  $-20^{\circ}\text{F}$ . In the middle photograph, left, the SEASPRITE is being prepared for the rigorous testing to come. The large pipe in the rear conducts the exhaust fumes to the outside atmosphere.

Pictured at the bottom, left is the UH-2A at  $-65^{\circ}$ . When the photo was taken the aircraft had been exposed to this "deep freeze" for three days and would soon be turned up without preparatory warming. The helicopter remained at this temperature for lesser intervals and starts were made after each period. At least four engine and rotor runs were carried out at each temperature;  $+70^{\circ}, 0^{\circ}, -25^{\circ}, -45^{\circ}, -65^{\circ}$ , and  $+110$  (in that order). In top photo, right, the SEASPRITE is shown wired for instrumentation and on jacks during a systems checkout at  $-25^{\circ}$ . Approximately 18 different instruments were monitored by personnel during the various tests. The instruments indicated engine, fuel, hydraulic and rotor system performance.

Shown in the middle photo, right, are the radio control heads on the cockpit console. Note the heavy frost accumulation which formed at  $-65^{\circ}$  on the various switches, dials and collective stick. Operation of these units at this temperature is not required since, under all but the most unusual circumstances, the inside of the cabin would be heated.

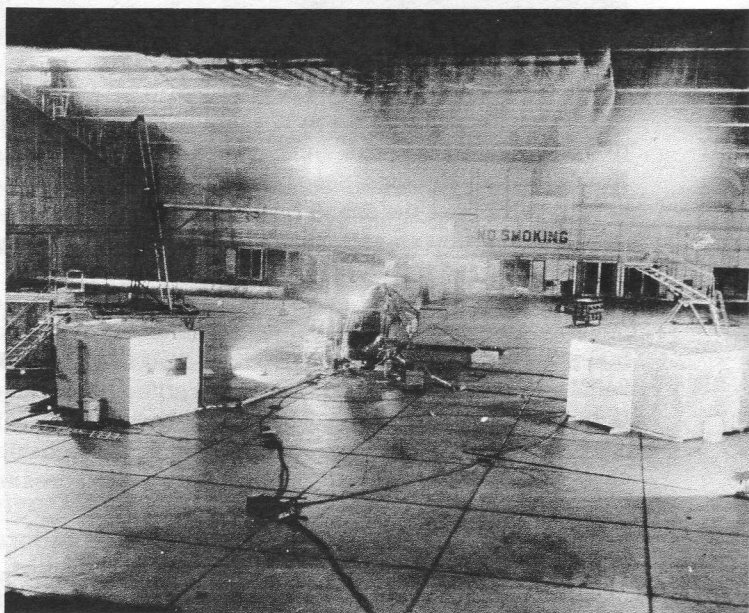
**I**n top photo, left, parka-clad Navy personnel check engine and cockpit areas at  $-25^{\circ}$  while third specialist stands by hydraulic power unit preparatory to landing gear test. How does the rescue hoist function at  $0^{\circ}$ ,  $-25^{\circ}$ ,  $-45^{\circ}$  and  $-65^{\circ}$ ? The Navy specialist in the middle photo, left, is finding out. The lead bars being hoisted weigh 600 pounds.

The view of the UH-2A at the top, right, shows the means used to tie the helicopter down during testing. Note the "weight tray" extending to the left and right at the aft end of the helicopter. The containers were loaded with lead ingots weighing 100 pounds apiece and similar weights were secured in another weight tray beneath the aircraft.

Not only was the SEASPRITE subjected to temperatures far below zero, it also underwent icing tests while at Eglin. In the middle photograph, right, the aircraft is being sprayed with water while the temperature hovers around the  $-40^{\circ}\text{F}$  mark. The helicopter was also spray tested at  $+23^{\circ}$ , and  $+15^{\circ}$ . Purpose of this testing was to check the de-icing system on the rotor blades and to ascertain if the engine and induction system had any unusual icing characteristics. In the lower photograph, right, a parachute has been wrapped around the rotor head and heat applied at  $-45^{\circ}$  in order to isolate the rotor components from the rest of the aircraft as part of a dynamic check. No rotor heat was required prior to run-ups. (USN - USAF photos)

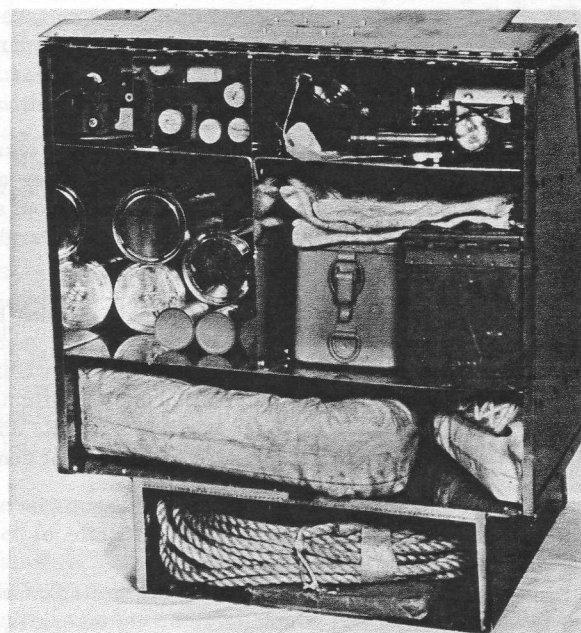
2. The box provides neat, orderly compartments for all equipment required by ARSM 55-4, plus ample room for extra equipment. The box is secured with a padlock to prevent loss and pilferage. Equipment is protected from oil and grime which accumulates when the items are exposed.

3. The entire box may be quickly and easily removed, to facilitate maintenance requirements and configuration changes. It is secured in the aircraft with cargo straps attached to existing cargo tiedown rings. Indentations in the bottom compartment accommodate litter poles.

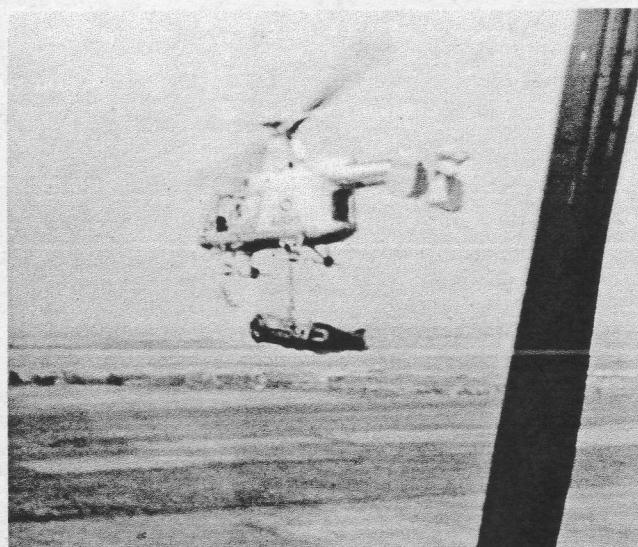
**THE EASY WAY**—After a fighter plane crashed in a flooded rice paddy the Royal Thai Air Force took this means of recovering the 2,500-pound engine. Neither cars or trucks could approach the crash site due to water and mud. HH-43B pilot was Capt. N. Nopairt, Major Chulard, commanding officer of 63rd Rescue Sqdn., RTAF; copilot, and MSgt Chanit, crewchief.
