# **KAMAN** *Rotor Tips*

JUNE-JULY, 1964

# PREFLIGHTING THE HH-43B

# UH-2 TOPS 216 MPH DURING TEST

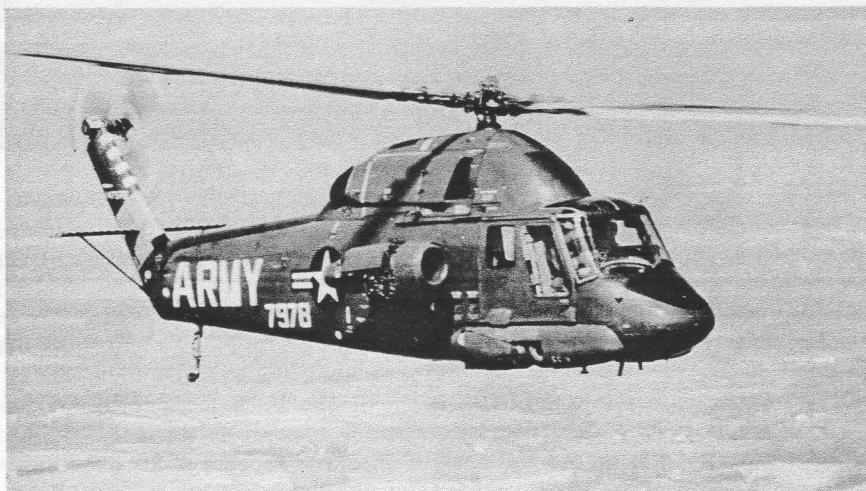
**A** Kaman UH-2 helicopter, using a General Electric YJ-85 Jet for horizontal thrust augmentation, repeatedly achieved true airspeeds of over 200 miles per hour during a flight test program conducted recently for the U.S. Army Transportation Research Command, Fort Eustis, Va.

The research UH-2 made its fastest level flight at a true airspeed of over 216 miles per hour during tests to investigate rotary wing characteristics at high speeds by use of jet augmentation. Because this is a research program, no attempts to establish world records have been made or are anticipated.

*UH-2 with jet pod streaks across sky during test run. For description of current program at Kaman Aircraft, turn to page eight. Cover by Donald D. Tisdale, Service Publications.*

The aircraft is presently configured with a jet pod that provides thrust augmentation necessary to obtain high-speed flight data in the 200-knot regime. The addition of a wing to determine the benefit to be derived from an auxiliary lifting surface is planned for the immediate future. This research program is sponsored by the U.S. Army's Transportation and Research Command, in cooperation with the U.S. Navy.

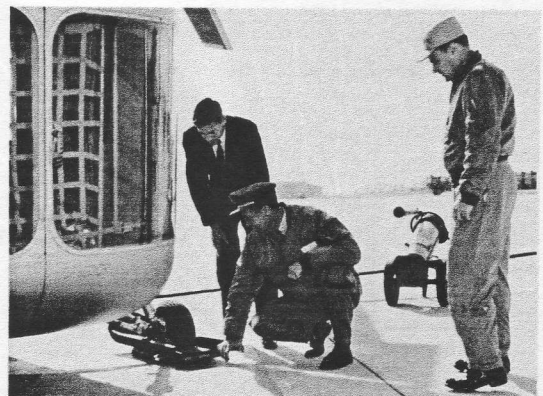
**SPANISH COMMANDER MEETS HUSKIE**—Colonel Llosa, commander of Zaragoza AB, Spain, examines bear paws on HH-43B as R. L. Lambert, KAC field service representative, explains their use. Watching is Capt F. W. Schnee, commander of Det 8, AARC, stationed at the base. Captain Schnee later took the colonel on an aerial tour of the base. (USAF photo)
