KAMAN *Rotor Tips*

Volume III Number 12

December-January, 1964/65

UH-2 WATER OPERABILITY CHARACTERISTICS

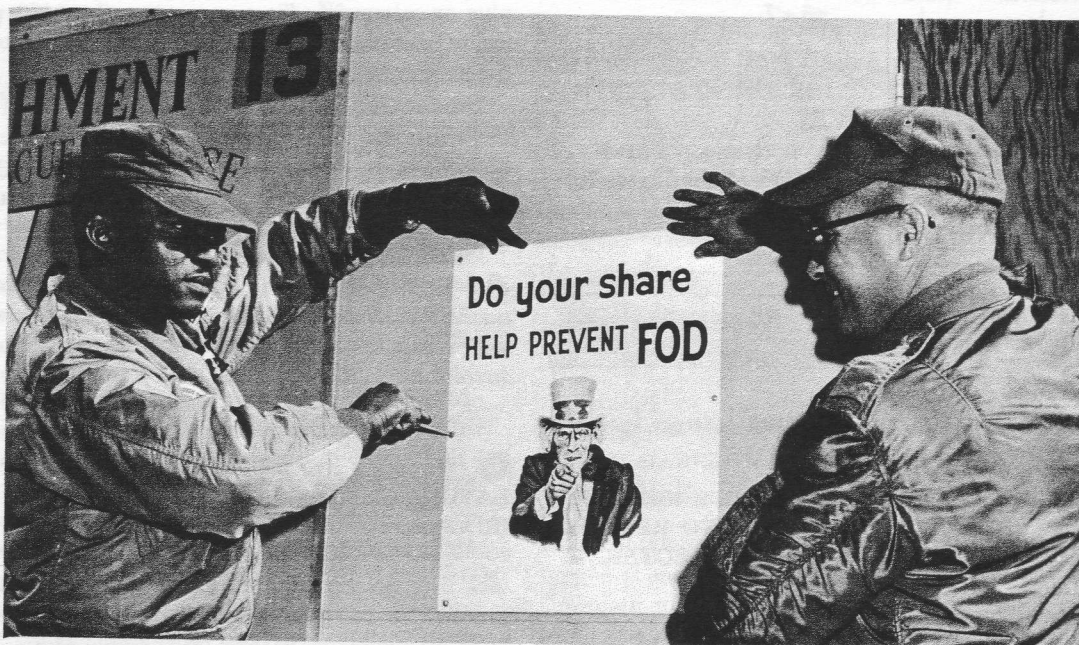
HELP STAMP OUT FOD—ARS Det 13, EARC (MATS), Brookley AFB, Ala., has taken this means of constantly reminding personnel to be on the lookout for foreign objects which could be ingested into the turbine engine on the HH-43B. SSgt Walter Johnson, left, and SSgt Joseph R. Chesson are hanging the multi-colored sign at eye level next to the main entrance of the alert trailer where it will catch the attention of anyone entering the area. Posters such as this are an effective aid in the war on FOD. Another means of combating foreign object damage may be found on page 15. (USAF photo)

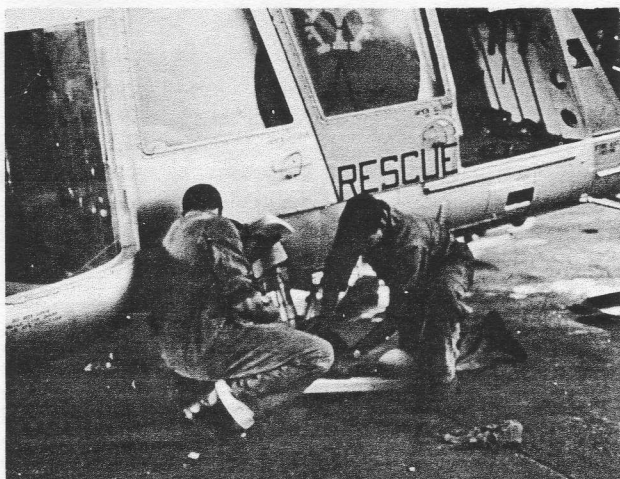
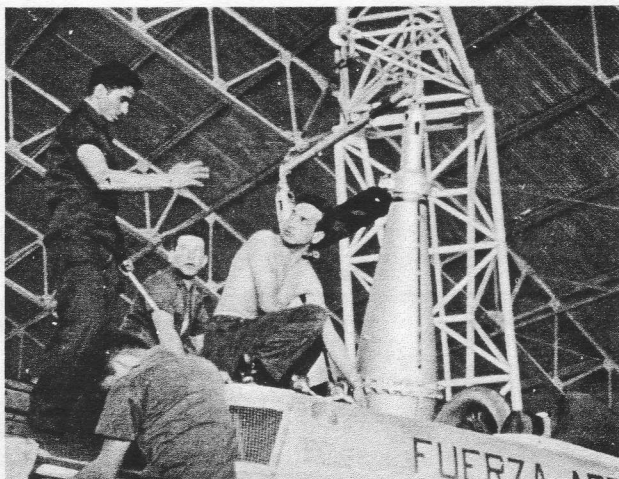
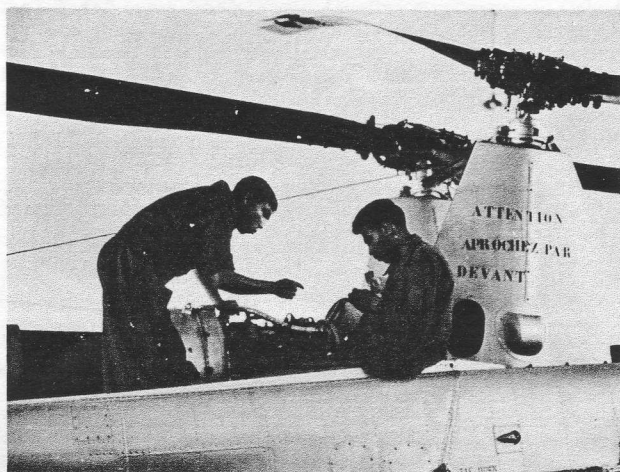
IN MANY PLACES—Typical of HUSKIE maintenance operations in many countries and many parts of the world are these photos of Moroccan and Colombian helicopter mechanics at work. In top photo, left, Sgt Kébir Ziat and Sgt Chef Ahmed Tamir of the Moroccan Air Force pull a post flight inspection on HH-43B's landing gear. In bottom photo, Sgt Mohamed Fathe and Sgt Moussa Houssam change multi-speed switch on engine. In top right photograph, ST2 Inaggio Monsane of the Colombian Air Force gives directions to ST2 Dario Ramirez and ST2 Fernando Plazas during transmission removal. In bottom photo, ST Monsane, ST2 Pearo Rojas, ST Plazas and ST2 Fabio Bedoya install sling on shaft and housing.
