MAN Rotor Tips

KAMAN AIRCRAFT CORPORATION

HH-43B CREWS AID IN MATS MAPPING OPERATION

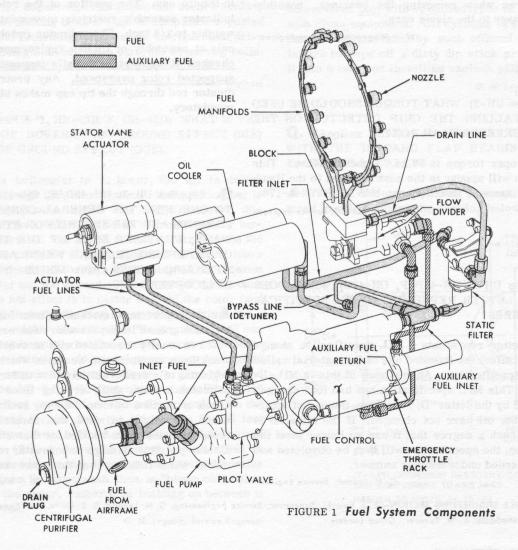
(a) General: The power plant fuel system (see fig. 1, fuel system components) delivers fuel from the aircraft supply to the combustion section of the engine. Fuel is supplied by the aircraft boost pump to the inlet of the engine-driven centrifugal fuel purifier. It then passes into the engine-driven fuel pump inlet. The fuel is converted into high pressure by the high pressure element of the fuel pump and then passes through the fuel control filter into the fuel control unit. Metered fuel then flows from the fuel control, through the oil cooler, the static

(b) Centrifugal Purifier: The centrifugal purifier (see fig. 1) is mounted on the left side of the engine on the forward face of the accessory drive gear case. It is driven by a splined shaft from the accessory gear train and removes fuel contaminants by centrifugal action. The filtering element consists of an inner and outer centrifuge, each of which includes a contaminant trap. The element rotates at a speed of 4200 RPM when the gas generator RPM is 26,300 (100%). A simple clamp arrangement permits removal of the element for cleaning and inspection without removing the entire purifier from the engine, and without disconnecting any of the lines. A drain plug is provided to drain off trapped fuel before the element cover is removed.

(c) Fuel Pump: The fuel pump (see fig. 1) is mounted on the aft left face of the accessory drive gear case, opposite the centrifugal purifier. It is driven by a splined shaft from the accessory gear train and is bolted to the fuel control. Removal of the pump requires removal of the complete fuel control and fuel pump as an assembly, after which the pump can be separated from the fuel control. The engine-driven fuel pump converts aircraft boost pump pressure to the high pressure required to operate the fuel control. The pump is composed of two sections: a centrifugal impeller boost pump and a single element high-pressure gear pump. Both are contained in a single housing. Fuel from the purifier is directed through the fuel pump 'IN' port which leads to the impeller boost pump section. It then passes into the high-pressure gear pump section, through the pump in**FUEL**

(d) Fuel Control, Pilot Valve and Stator Vane Actuator: The fuel control (see fig. 1) is attached to the fuel pump and is driven by a splined shaft from the pump. It includes the pilot valve which controls the variable stator vanes. The fuel control filters the fuel, controls the internal fuel pressure and automatically adjusts fuel flow to maintain the desired power output.

- (e) Oil Cooler: The engine mounted oil cooler (see fig. 1) merely provides a path for the fuel flow. Engine oil heat dissipation is accomplished by absorption of heat from the oil by the lower temperature fuel as it flows through the respective passages in the cooler.

- (f) Static Filter: The static filter (see fig. 1) is mounted up-stream from the flow divider, at the 7 o'clock position on the rear flange of the combustion case. Fuel flows from the oil cooler through the static filter and into the flow divider. Its primary purpose is to exclude contaminants from the flow divider and the fuel discharge nozzles. The static filter is a small bowltype high pressure unit. The bowl contains a removable 40-micron micromesh pleated filter element. The filter unit head includes a spring loaded by-pass valve which opens when a pressure differential of 25 to 35 psi occurs due to a clogged filter element.

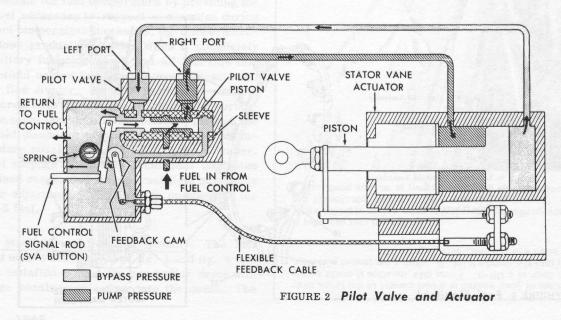
The pilot valve (see fig. 2,pilot valve and actuator) is mounted on the forward part of the fuel control. It is connected to the variable stator vane actuator by a flexible feed-back cable and two fuel tubes. A signal rod from the fuel control mechanically positions the pilot valve piston, which meters fuel from the fuel control to the stator vane actuator. This metered fuel positions the actuator piston which, through mechanical motion, adjusts the variable stator vanes to the position called for by the fuel control. The flexible feed back cable senses the relative change in the position of the actuator piston and mechanically transmits this back to the pilot valve, returning the pilot valve piston to a neutral position, where it is then ready for new input signals from the fuel control.

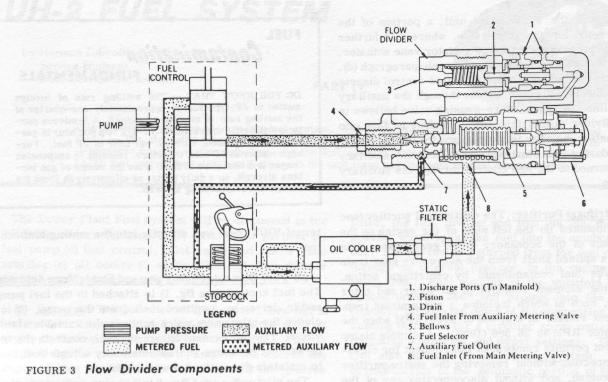
- (g) Flow Divider: The temperature sensing flow divider (see fig. 1 and fig. 3 flow divider components) is mounted on the fuel manifold block which, in turn, is secured to the outer combustion chamber. It is essentially a pressure-operated unit with a fuel temperaturesensing bellows to compensate for fuel temperature variations during the starting cycle. It limits fuel flow during starts to prevent exceeding exhaust gas temperature(EGT) limitations at low compressor speeds. As RPM increases, it automatically increases fuel flow to properly support combustion. During the starting cycle, when fuel pressure into the flow divider reaches approximately 140 psi, a spring-loaded piston opens allowing fuel flow into no. 1 fuel manifold and into the combustion chamber through the 8 primary fuel discharge nozzles. At the same time, auxiliary fuel from the fuel control is directed into the temperature-sensing bellows which compensate for fuel temperature by providing the additional fuel necessary to support combustion during start. As fuel temperature increases, the temperaturesensing bellows gradually closes. When it completely closes, auxiliary fuel flow stops and all fuel flow into the fuel manifold occurs through the pressure-actuated ports in the flow divider. As RPM increases, and fuel pressure increases to approximately 185 psi, the springloaded piston opens farther allowing fuel flow through the no. 2 manifold discharge port and through the remaining 8 secondary nozzles into the combustion chamber. Internal fuel seepage which may occur past the piston seals is drained overboard. An external field adjustable fuel selector adjustment is provided to compensate for JP-4 or JP-5 fuel.

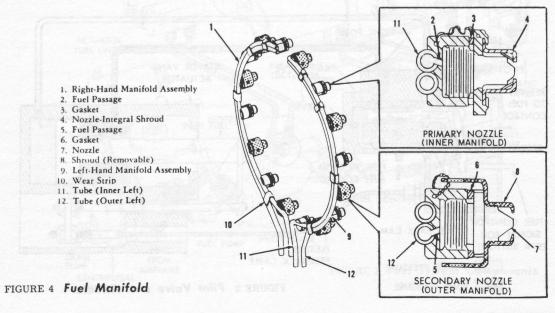
- (h) Fuel Manifold and Nozzle Assembly: The fuel manifold and nozzle assembly (see fig. 1 and fig. 4 fuel manifold) is installed against the combustor dome with the discharge nozzles projecting into the dome. The

assembly consists of two halves. Each half is composed of an inner or no. 1 tubular-type manifold, and an outer or no. 2 tubular manifold. Each half has 8 discharge nozzles. Four discharge nozzles are attached to the inner (referred to as the no. 1 fuel manifold) and 4 nozzles are attached to the outer (no. 2 fuel manifold) for a total of 8 nozzles in each half or a total of 16 nozzles for the complete assembly. The nozzles on both the inner (no. 1) manifolds are referred to as the primary nozzles. Fuel flow occurs through the primary nozzles first during the initial stage of the starting cycle. The nozzles attached to the outer (no. 2) manifolds are the secondary nozzles. After the initial phase of the starting cycle occurs and the fuel is ignited, additional fuel required to properly support combustion flows into the combustor section through the secondary nozzles. The primary and secondary nozzles have a different spray pattern and are, therefore, not interchangeable from one manifold to the other. Integral shrouds around the orifice of the primary nozzles and removable shrouds around the orifice of the secondary nozzles direct compressor discharge air about each orifice to reduce the formation of carbon residue on the nozzles. K

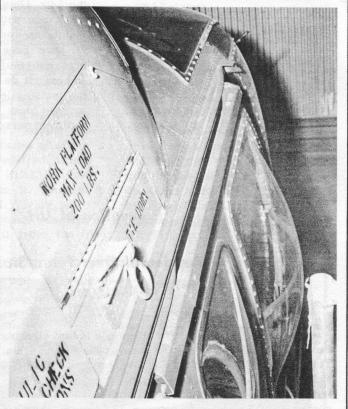
FOD FACTS

How good are you at finding FOD? To check yourself, study the photograph and then see the inverted answer. Only one loose object is shown which could cause foreign object damage if ingested into the engine.

The object of your search is a bolt caught in the track over the cabin door of a UH-2. From this location it could easily be drawn into the engine inlet. If, after a prolonged scrutiny, you still can't see the bolt, turn to page 17.

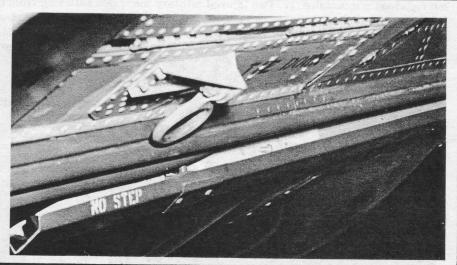
The photographer wasn't in the right position so neither you nor his camera could "see" the loose bolt behind the track. It is, however, clearly shown in the photo which was taken from a slightly higher angle. Remember, BEFORE removing ladders or platforms after work has been performed on the aircraft, use these vantage points to search for loose objects which could be ingested into the engine and cause damage or in-flight failure. Rotor Tips was purposely "sneaky" on this one—but then so is FOD!
