KAMAN *Rotor Tips*

KAMAN AIRCRAFT CORPORATION

MARCH-APRIL, 1967

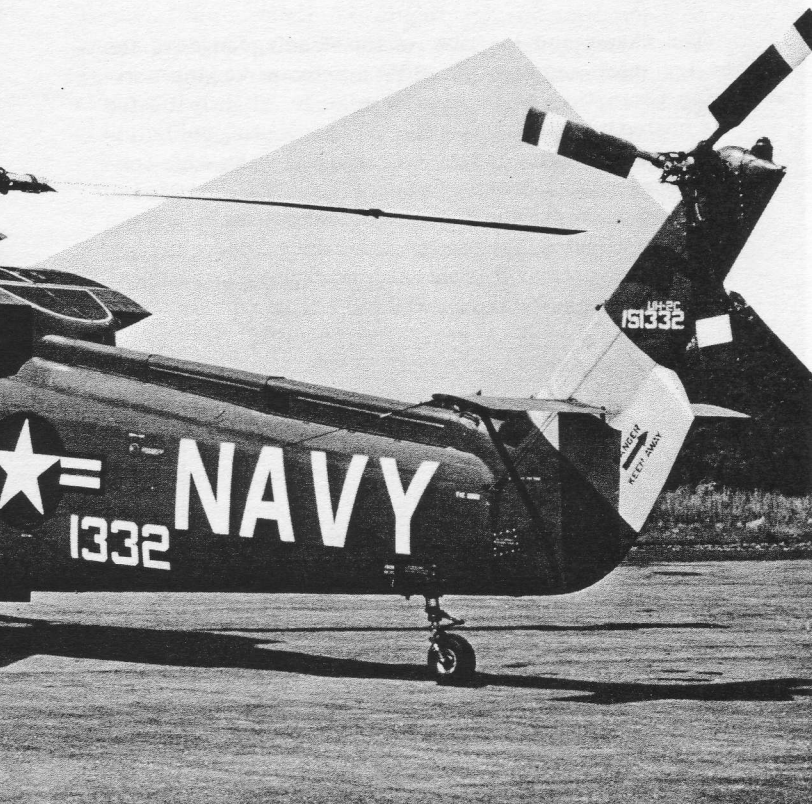
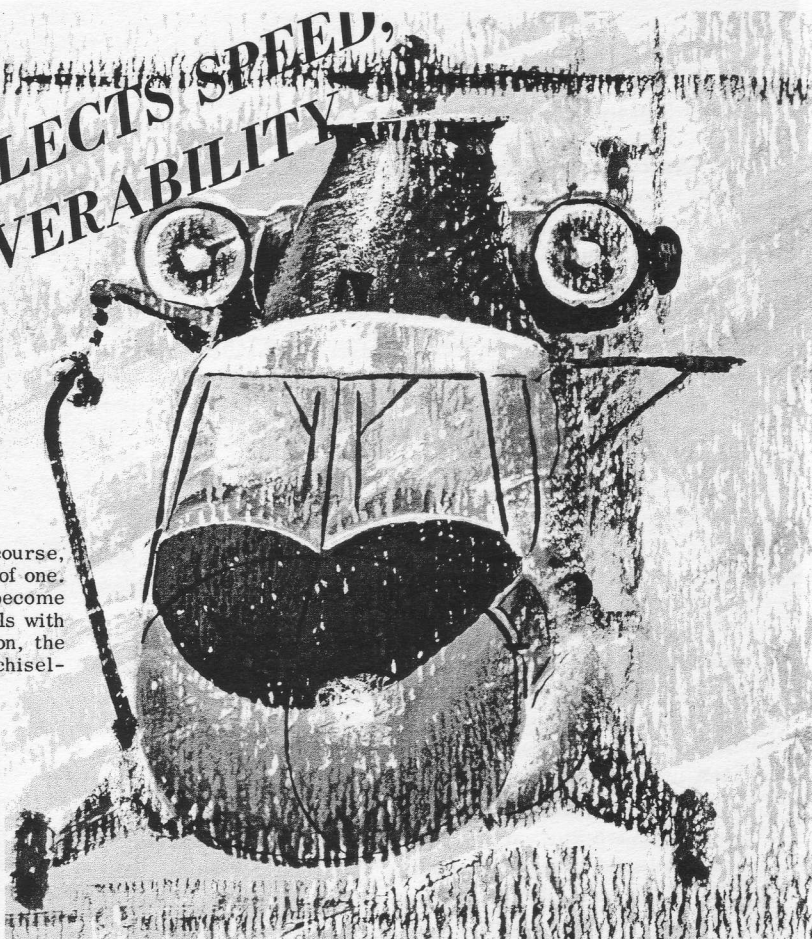
STEP-CAMBERED TAIL ROTOR PYLON

The step-cambered design of the tail rotor pylon is the optimum shape dictated by flight operations at: (A) near zero hovering airspeeds and (B) the higher forward flight speeds. Narrowing the chord of the pylon improves tail rotor effectiveness during hovering and sideward flight — the narrow pylon decreases the blockage to the tail rotor airflow. This feature is most important during crosswind hovering and sideward flight since a larger amount of tail rotor thrust is made available for these maneuvers. Directional stability and pedal control margins are improved by widening the chord and cambering the cross-section of the pylon. The wide area acts as a vertical stabilizer surface to improve directional stability. The cambered cross-section acts like a rudder as airspeeds increase above 80 knots. In this manner the tail rotor thrust required is reduced and the directional control pedals tend to become neutral. This feature provides a greater margin of control available for directional maneuvering.

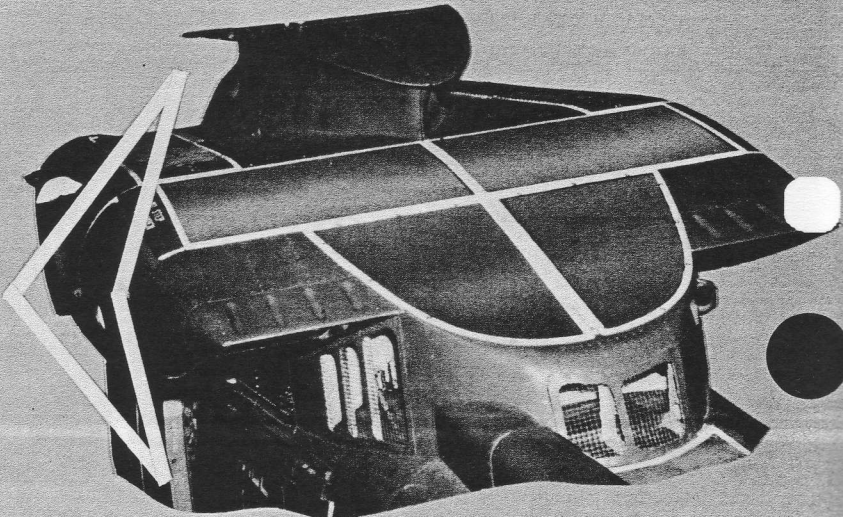
TRANSMISSION AND ROTOR SHAFT FAIRING

The streamlining effect of the UH-2C transmission and rotor shaft fairing raised the maximum level flight airspeed by about 5 knots. This was accomplished by the reduction in flow separation, and therefore drag, on the aft end of the engine and transmission compartment cowling. Tuft studies and smoke tests were conducted to define the optimum contour around the transmission, the size of the shelf below the hub and the minimum length along the after deck. The streamlined airflow along the top surfaces of the engine nacelles and aft cowling eliminates turbulent vortices from the tail rotor inflow and provides smooth flight characteristics at all airspeeds.

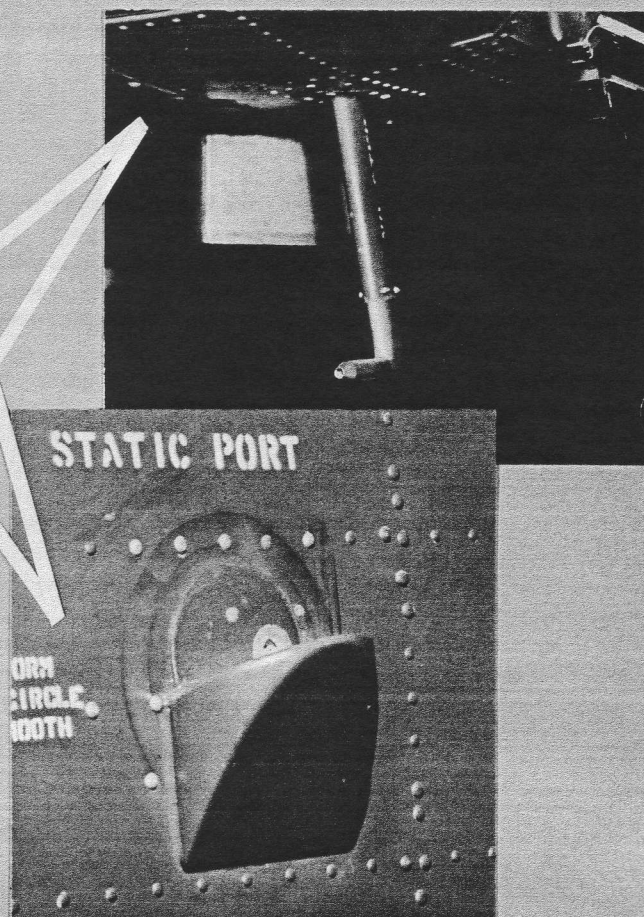
NEW PITOT TUBE LOCATION AND STATIC PORT FLOW FENCES

The pitot tube on the UH-2C is located on the fuselage directly beneath the copilot rudder pedals to provide accurate and steady airspeed readings in high powered climbs at low airspeed. On the UH-2A/B the pitot tube is located on the fuselage above and slightly ahead of the left cockpit door. It was found, however, that this location was unsatisfactory on the twin-engine helicopter since distracting airspeed indicator fluctuations were encountered during climbouts. This was due to the UH-2C's high velocity rotor downwash and greater rate of climb. The new location also improves indications at low speed because the fuselage screens the pitot tube from the turbulence of the rotor inflow air.

Flow fences are installed on the UH-2C below the static ports to provide a slight pressure head, thereby correcting indicated airspeed in hover to zero. The incidence angle of the flow fences was chosen to make the working surface align with the free stream at cruising airspeeds. These devices also contribute to the overall stability of the indicator needle from hover to maximum airspeed.

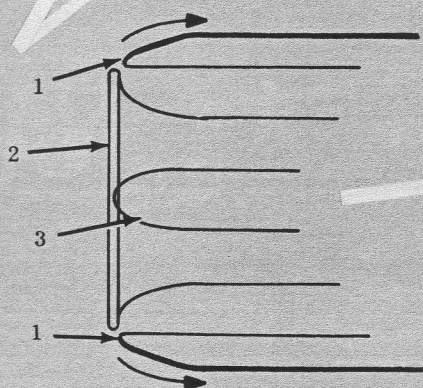
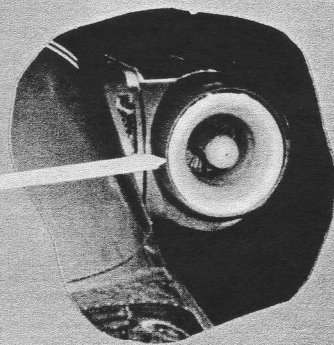
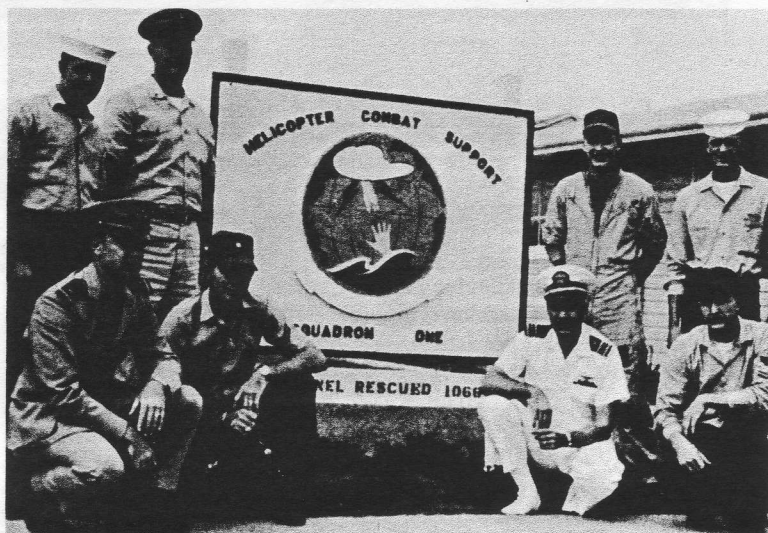
CHISEL-NOSE ENGINE NACELLES

The shape and location of the leading edge of the engine inlet nacelles provide maximum engine anti-icing protection. The leading edge is slightly behind the heated inlet bellmouth, thereby preventing ice build-up at the stagnation point. The sharp leading edge contour prevents ice build-up along that surface. Added to these features are the heated starter bulletnose and the engine anti-icing system for the inlet guide vanes and front frame struts. The result is complete engine anti-icing protection for the UH-2C helicopter.

1. ENGINE NACELLES
Chisel-like leading edge keeps air moving.
2. BELLMOUTH
Heated engine inlet
3. BULLETNOSSE
Heated engine starter

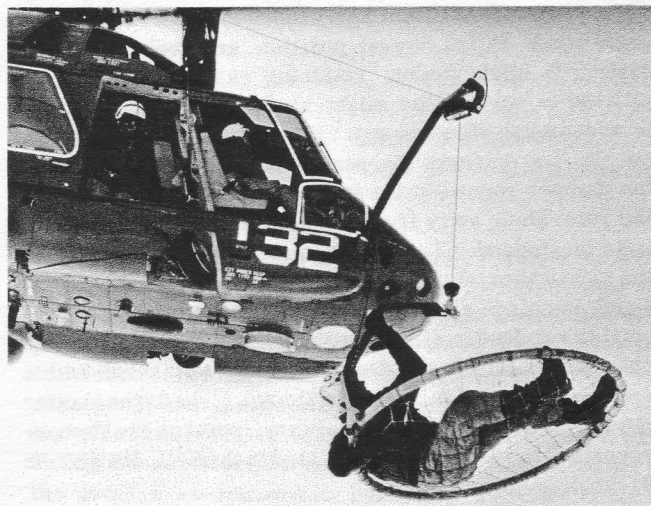
ATTENTION SHUTTERBUGS—This dramatic photograph of a UH-2 equipped with a rescue net was taken by Jerrold C. Bruce, AMH3, and first appeared in the Lakehurst Station Break at NAS Lakehurst, N.J. Kaman Rotor Tips is always interested in receiving unusual photographs of this nature and welcomes contributions. If published, name credit will be given, of course. Petty Officer Bruce's photograph shows "Angel 32" with a Kaman-designed net which was tested and evaluated by HC-2 several months ago. The "netted" man is George R. Gowan, PRC, an aircrew survival equipmentman. LCdr Leon C. Drake, HC-2 development officer, is the pilot and Donald L. Wright, AMH1, the aircrewman. In the photograph, on the UH-2 and directly above Chief Gowan's left hand, is shown the loud hailer with which the pilot is able to give instructions to rescuees. The net is suspended from a rescue "fishpole" boom. Information on both these devices appears in the "Design For Rescue" article in this issue of Rotor Tips.

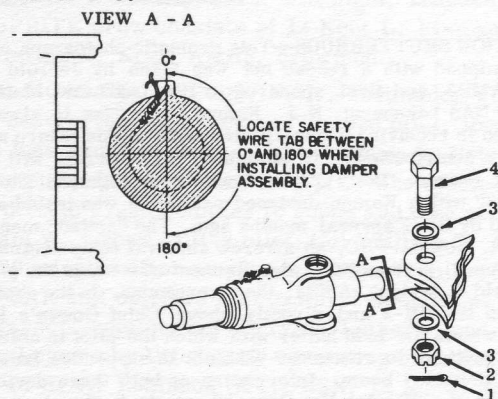
Q. (Applied UH-2) MAIN ROTOR BLADE DAMPERS, P/N K610029 AND 101264, HAVE A LOCKWASHER, P/N 100934, INSTALLED ON THE INBOARD END OF THE DAMPER TO LOCK THE RODEND TO THE PISTON SHAFT. AT DAMPER INSTALLATION SHOULD THE TAB ON THE LOCKWASHER FACE TOWARD OR AWAY FROM THE SPINDLE?

A. The lockwasher tab should face away from the spindle. If the damper is installed with the lockwasher tab facing inboard (toward the spindle), the tab lockwire may hit or rub against the retention lag spindle. If this is allowed to continue, the lockwire will break and the piston rod will back off from the rodend. In the event the damper is already installed on the aircraft with the tab facing inboard, move the blade and retention through the lead and lag range while checking for clearance between the lockwire and the retention spindle. If a sufficient gap is evident and no contact can be made, it is not necessary to take further action; however, if the clearance is marginal and contact could possibly occur, it is necessary to turn the damper rodend 180 degrees. Refer to the illustration and proceed as follows: Set the rotor blade at its lowest position and lock the rotor brake. A blade folding retaining assembly should be utilized to control the slight blade movement required to accomplish this change. Remove the cotter pin (1), nut (2), two washers (3), and the bolt (4) which attaches the damper rodend to the main rotor hub. Slowly move the rotor blade away from the damper just enough to expose the rodend. Turn the rodend 180 degrees so that the lockwasher tab faces away from the retention spindle. Guide the blade slowly back toward its original position until the rodend is aligned with the bolt holes in the main rotor hub. Attach the damper rodend to the hub with a washer (3), bolt (4), washer (3), nut (2) and the cotter pin (1). Inspect and, if necessary, service the damper according to the instructions listed in the HMI, NAVWEPS 01-260HCA-2-5.

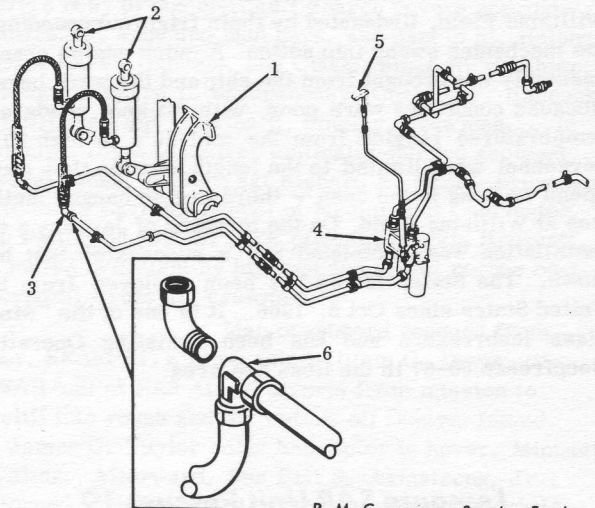
Q. (Applies UH-2) WHAT METHODS ARE AVAILABLE TO UNLOCK THE MAIN LANDING GEAR PARKING BRAKE?

A. The standard method of unlocking the landing gear parking brake is to apply toe pressure to the left brake pedal (1) shown in the illustration. When toe pressure is applied, the control valve locking pin piston is forced inward releasing the valve lever, allowing the spring-loaded parking brake handle (5) to return to the down and unlocked position. If the master brake cylinder (2) is low in fluid and the brakes cannot be unlocked by applying toe pressure, the following procedure may be used: Open the nose doors and unzip the fuselage curtain which covers the fuselage tub area. Fold the curtain up and secure to the fuselage bulkhead with the two fasteners. Reach into the upper tub area, just inside the bulkhead, and locate the elbow (3) in the left brake line. Disconnect the brake line at the elbow (3) which protrudes through the cockpit floor. Screw a connector (6), P/N AN821-4, into the fitting on the brake line. Attach a pressure source, such as a hand pump, to the AN821-4 connector. Apply pressure to the line until the parking brake handle (5) returns to its down and unlocked position. This method applies pressure directly to the parking brake control valve (4) and simulates left pedal toe pressure with a full master cylinder. Refer to the HMI NAVWEPS 01-260HCA-2-2 for filling and bleeding the main landing gear parking brake system.

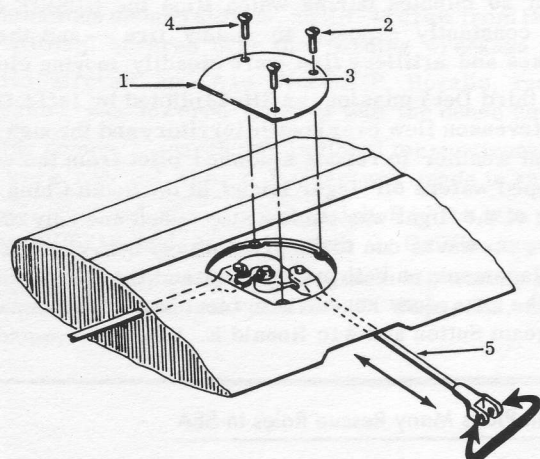
Q. (Applies UH-2) MAY SUBSTITUTE SCREWS BE USED TO INSTALL THE FLAP CONTROL ACCESS COVER ON THE -209 MAIN ROTOR BLADE?

A. No substitutions are allowed. In the illustration, the access box cover (1) is secured in place by two NAS333CPA5 screws (2 and 3) and one NAS333CPA4 screw (4). When screw (2) is installed, it is directly over the path traveled by the flap control rod. If a screw with a greater length is used in place of screw (2), it could protrude enough to prevent the control rod from completing its full travel. To check for clearance, move the short rod to flap (5) in and out while rolling from left to right. IT MUST NOT HANG UP — THE ROD MUST TRAVEL FREELY. If a screw other than the one specified has been installed, interference will most probably occur when the flap rod (5) is rolled to the left while moving the rod in and out. The correct lengths for the specified screws are: NAS333CPA4 - 0.531-inch; NAS333CPA5 - 0.656-inch.

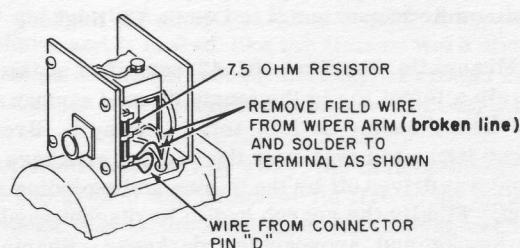
Q. (Applies HH-43B/F) WHAT WIRING CHANGE IS NECESSARY WHEN A 100-FOOT HOIST CABLE IS REPLACED WITH A 200-FOOT CABLE?

A. Reposition the field wire from the 7.5 ohm resistor in the hoist motor relay assembly without disturbing the wiper setting. The illustration shows where the wire (broken line) is connected to the wiper when using the 100-foot cable. Remove the wire from the wiper and resolder it to the base of the resistor (solid line) where the wire from pin D is soldered. Repositioning this wire shunts the resistor. Do not change the wiper setting; in the event a re-conversion back to a 100-foot cable is desired, the wire can be resoldered back to the wiper terminal.

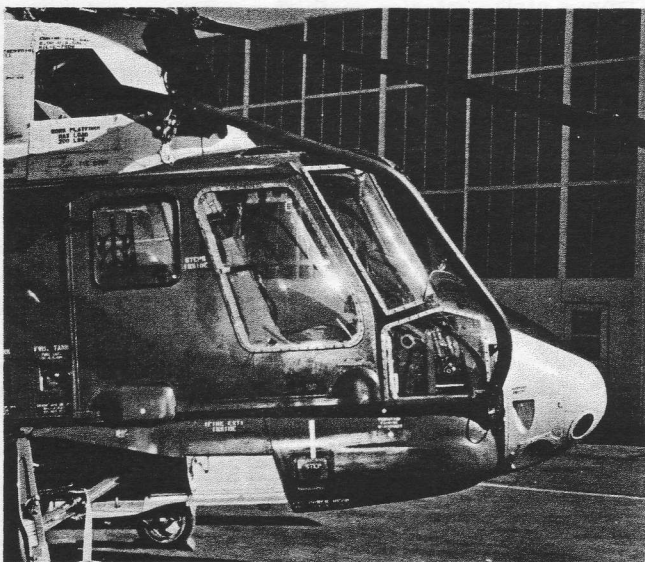
Fishpole Boom — Boom on UH-2 is shown in stowed position with hoist hook suspended over the rescue door.

The open sea rescue boom assembly (fishpole), P/N 683334, is a curved extruded aluminum tube 3 inches in

diameter with a 1/4-inch wall. It is 8-feet, 10-inches long and, like the net, is rated to simultaneously lift two soaking wet, fully-equipped rescuees from the water. The boom is mounted in a socket on the right side of the fuselage, just aft of the nose door hinge line. The rescue hoist cable is threaded over the pulley in the eye at the upper end of the fishpole. When the pole is in the stowed position, the eye is directly under the rescue hoist, suspending the hoist hook over the rescue door. When extended, the pole swings forward about 110 degrees and suspends the hoist cable eight feet outboard of the fuselage thus putting the pickup point within the pilot's line of vision. A series of relays and limit switches interlink the rescue hoist and fishpole control circuits.

Since the fishpole is used in conjunction with the hoist, the crewman or hoist operator threads the hoist cable through the fishpole eye and then notifies the pilot. The pilot places the boom control toggle switch, located on the instrument panel, in the "extend" position. When the pilot or hoist operator places his hoist switch in the "down" position, the boom extends with the cable. Once the boom has reached its fully-extended position it is hydraulically held in place while the hoist cable is lowered with the rescue device — sling, net, or seat. As the cable is reeled in, with the device and rescuee, the hoist bumper assembly contacts the tip-limit switch in the fishpole eye. This reduces hydraulic pressure in the extend circuit by placing the boom actuator in neutral, and allows the hoist cable to return the fishpole to the stow position. When the boom reaches the stowed position, a micro-switch at its base shuts off the hoist motor, hydraulically and mechanically locks the fishpole in place and automatically returns the pilot's boom control switch to the stow position. The hoist hook can then be lowered to bring the rescuee into the cabin. Normally, the boom will not extend unless the hoist bumper maintains contact with the tip-limit switch in the fishpole eye. An emergency extend switch is provided on the boom control panel in the event the boom control switch is accidentally placed in the stow position during a rescue. If the hoist motor is stopped before the fishpole is in the stow position, hydraulic pressure on the boom keeps the cable taut.

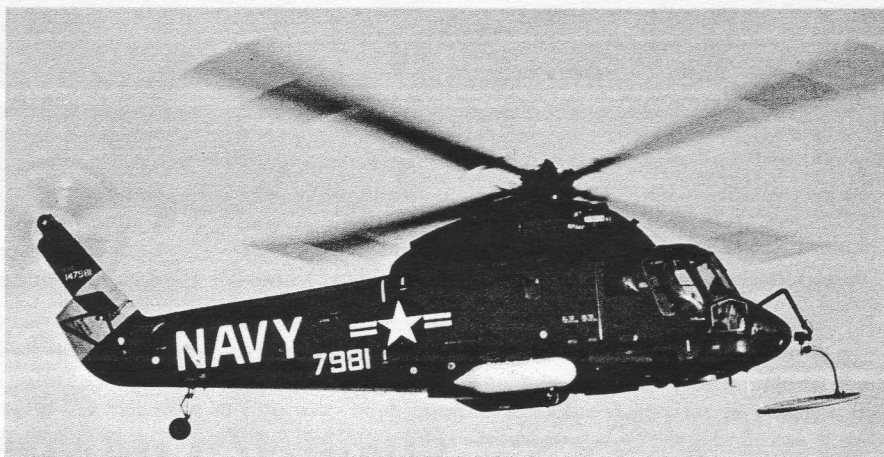
Boom and Net —Twin-engine UH-2C is shown with boom in extended position and rescue net ready for lowering. A rescue sling or seat may also be used with the boom which allows the pilot to keep the survivor in sight at all times.

The delivery of BuWeps P/N 64-A-110H1 rescue nets has added a significant asset to the inventory of specialized helicopter rescue equipment. Although the net may be used for any water rescue, it is particularly adapted for use if the rescuee is injured or unconscious and it is inadvisable to use the sling or seat. The device is often referred to as a "scoop-type" net, however, the term does not properly describe either its primary function or the technique recommended for its operation. The manner in which it is used depends upon the circumstances. Experience has shown that it is best utilized as a platform from which the crewman can, if the situation requires, help the rescuee into the net. The pilot then lifts both men free of the water eliminating any need for leaving a crewman in the water due to lack of space or discomfort of the injured man when using the rescue sling or seat.

The materials used for the net have been chosen for their corrosion resistant properties. The tubing and hinge fittings are extruded from 6061-T6 aluminum and protected by a finish system consisting of MIL-S-4383 sealing compound as well as a multi-coat lacquer finish.

The netting itself is made from high strength nylon chord. Moveable parts at the hinge pins, inherently vulnerable to corrosion by virtue of the relative motion between parts, are easily replaceable aluminum sleeves. The sleeves are made from stock tubing to minimize future maintenance in these areas.

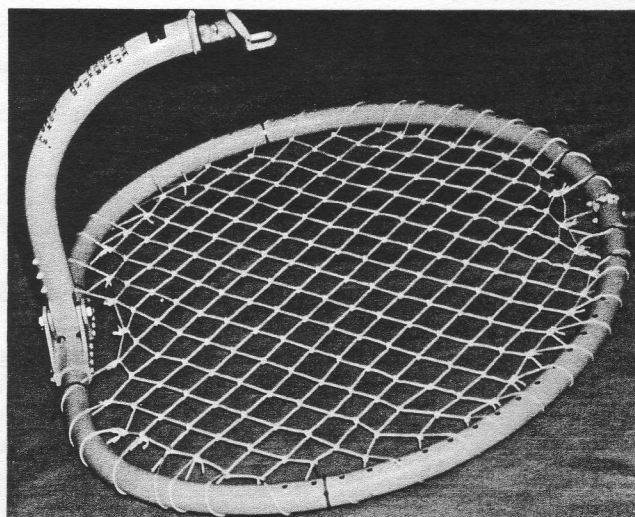
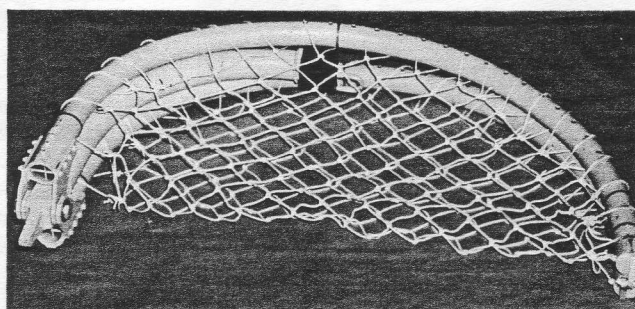
The net face is essentially a five-foot diameter circle supported by two tubes shaped into semi-circles. The tubes are hinged at two points to permit folding and facilitate stowage. A ladle-like handle is mounted at the main hinge point, while the rescue hook receptical, on the opposite end of the handle, is located at a point precisely above the center of the net.

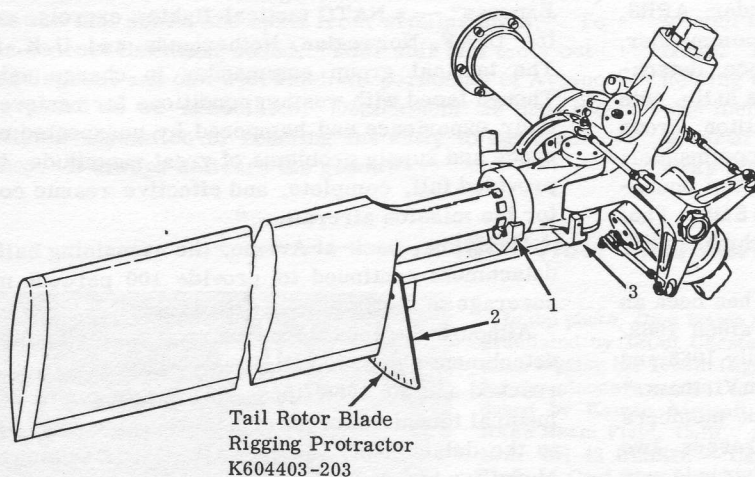
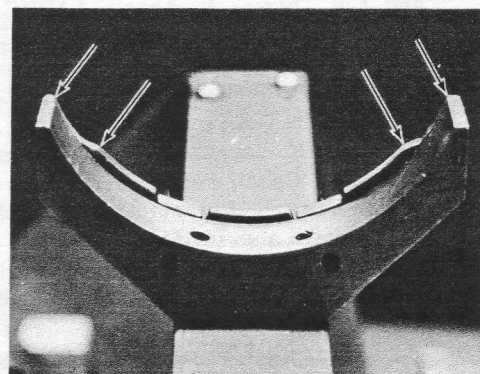
View A

Tail Rotor Blade Rigging Protractor (UH-2)

A minor modification of a support, P/N K604403-47, on the tail rotor rigging protractor, P/N K604403-203 (shown in the illustration), will eliminate the interference occasionally encountered between the protractor and the tail rotor blade lock. The support (1) located between the protractor dial (2) and the rocking pin support (3), has a lip or flange which fits over the outboard edge of the tail rotor blade grip. The modification consists of removing approximately 3/4-inch of the lip from both outboard edges as shown in view A. File the lip flush with the contoured portion or wall of the support (1). If slightly more material is removed from the lip portion of the support no damage will result, but care should be taken not to alter the contour of the support wall.
