# *Rotor Tips*

MARCH-APRIL 1971

Volume VI Number 10

## **THE SH-2D SEASPRITE**

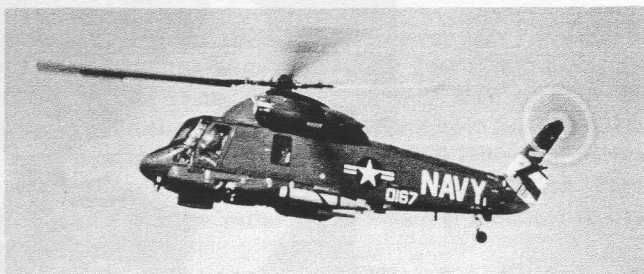
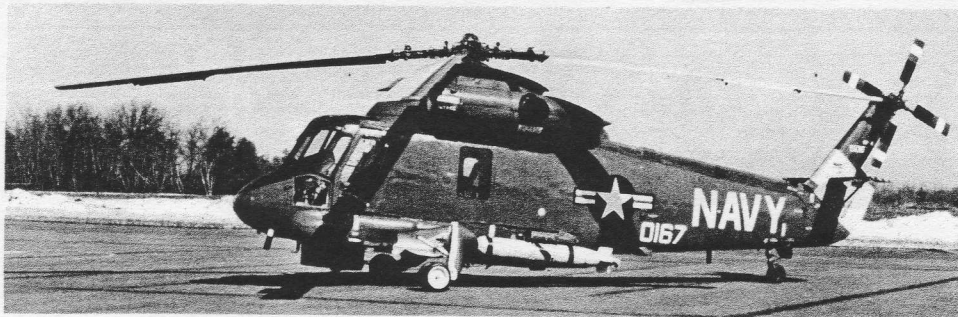
**New Role For SEASPRITE**—Top view shows SH-2D with MAD gear mounted on right side. Note radome under nose of aircraft, just forward of main landing gear. Bottom photo shows helicopter with torpedo installed.

Another torpedo can be carried on the other side....

The copilot in the SH-2D serves as the tactician in charge of launching all stores such as torpedoes, sonobuoys, and smoke markers, extending the Magnetic Anomaly Detector (MAD) gear, and handling navigation, Electronic Counter Measures (ECM) and communications. A sensor operator is seated in the aft cabin on the left, facing forward, and primarily monitors and interprets the displays, such as radar, sonobuoy data, and MAD indications. Most of the avionics is located in equipment modules in the cabin, aft of the cabin, or in the nose. The radar antenna is in a radome under the nose of the aircraft, just forward of the main landing gear. The MAD bird and winch are mounted on a pylon, outboard of the right stores station, as they were in the "Iron Barnacle" operation conducted from the West Coast last fall.

Each of the two stores stations has been moved slightly aft to accommodate a MK-46 torpedo. The left-hand cargo doorway has been replaced with a panel which has a large push-out window and an opening for lateral ejection of sonobuoys. A smoke launcher is mounted on each side of the aircraft in the flotation fairing. Also, added to the outside of the aircraft are the antennas associated with the various avionics equipment. Although Kaman's new "101" rotor system for the SEASPRITE will not be installed when the SH-2D is delivered to the Fleet, this rotor will be retrofitted as the kits become available.

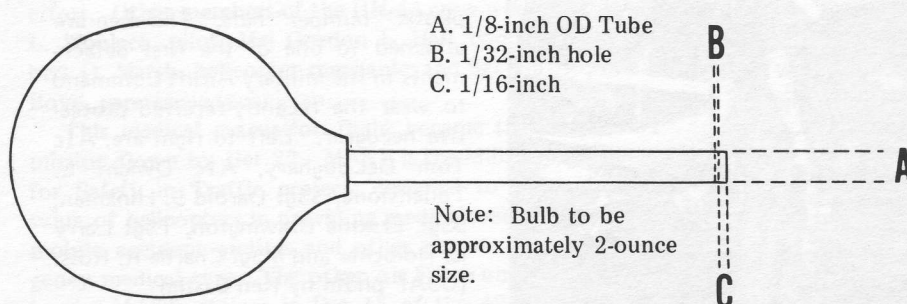
Figure 1. ELECTROLYTE LEVELER

Fill bulb with distilled water. Remove vent plugs. Insert tube into vent hole until tube rests on cell plates. Lightly squeeze bulb, watch for water at vent opening, immediately release bulb; cell fluid will be at the recommended 1/16-inch level. Replace vent plugs.

6. Check electrolyte level; it should be 1/16-inch above plates. Use leveler (Figure 1). Use only pure distilled or de-ionized water. Replace vent plugs and, using a screwdriver, check that all plugs are watertight.

4. Connect battery to charger. It is recommended that the constant current method be used, charge the battery at 0.1 ampere rate for 14 to 15 hours. Remove from charger.
5. Refer to Figure 1 and fabricate the electrolyte leveler. Use the leveler as follows:

Fill bulb with distilled water. Remove vent plugs. Insert tube into vent hole until tube rests on cell plates. Lightly squeeze bulb, watch for water at vent opening, immediately release bulb; cell fluid will be at the recommended 1/16-inch level. Replace vent plugs.

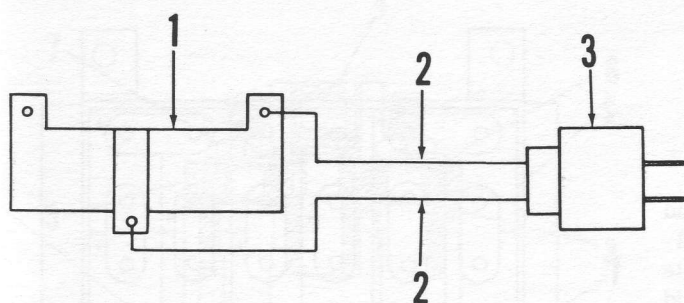
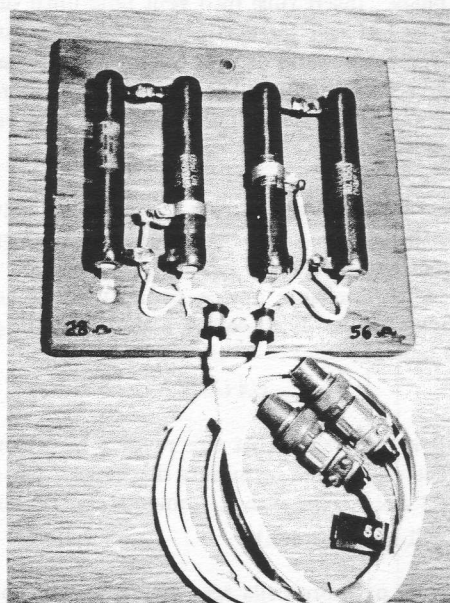
Figure 2. DISCHARGE DEVICE FABRICATION

1. 40-watt, wire wound resistor
2. 18-gauge wire
3. Connector, P/N 696R12S-3P100

NOTE: 14-day check use 56-ohm resistor

56-day check use 28-ohm resistor

(Equivalent part substitutions allowed)

7. Check load voltage. (Figure 2) Connect discharge device for 5 minutes, then read cell voltage under load—each cell should be at or above 1.2 volts. A reading below 1.2 volts is cause for induction of battery into reconditioning cycle. Remove discharge device.

Be certain battery is completely discharged prior to disassembly. Attach discharge device (Figure 2) until total battery voltage is 5-6 volts.

6. Fabricate discharge device described in Figure 2, and connect to battery. Accomplish battery discharge (at 0.8 - 1.0 ampere rate) for 55 minutes. At end of 55 minute period with discharge device connected, all cells should read above 1-volt. If all cells are above 1 volt, proceed to Steps 9 and 11.

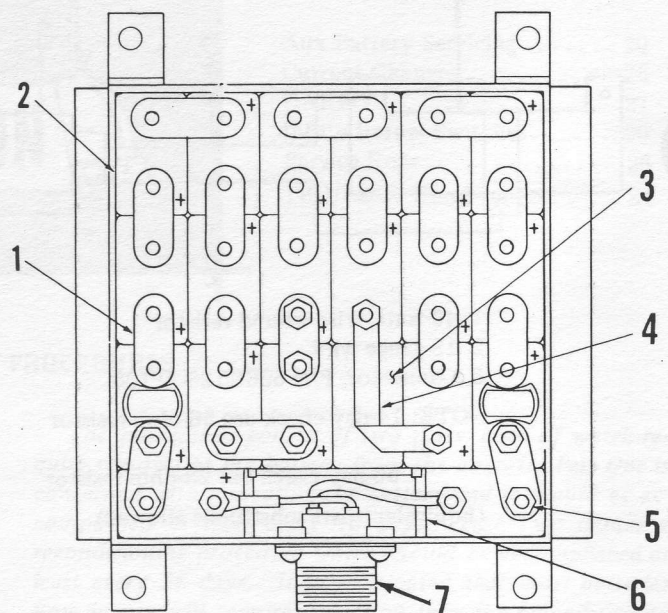
View A. Non-coated battery

1. Intercell connector
2. Cell assembly
3. Dummy cell
4. Connector
5. Nut
6. Baffle (not removable)
7. Case-mounted connector
8. Gasket

Figure 3. BATTERY ASSEMBLY

3. Reinstall cells and case-mounted connector, Figure 3. When replacement cells are installed, torque lower terminal nuts to 6-8 inch-pounds. Install the intercell connectors and torque the upper nuts to 6-8 inch-pounds.

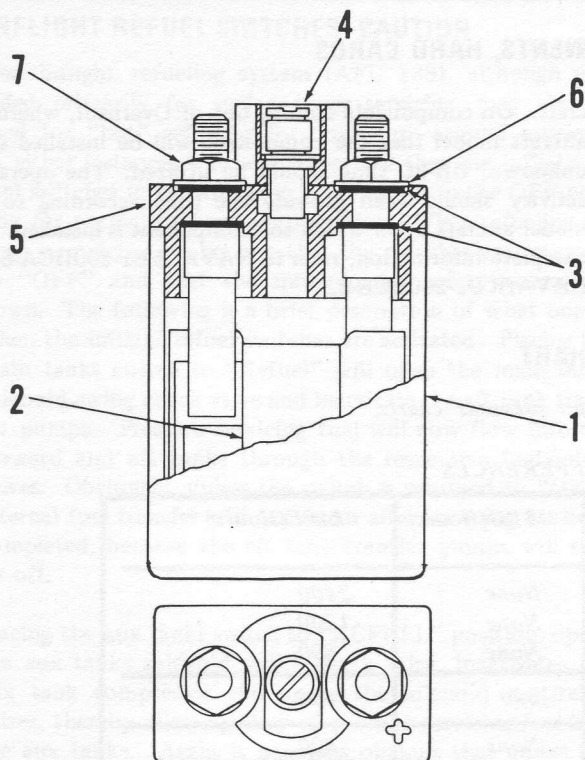
| 1. Case | 5. Cover |

2b. Tighten lower terminal nuts to 6-8 inch-pounds. Check cells for electrolyte leakage. Pay particular attention to: case-to-cover seal, cracks and area around terminals. Any leakage is cause for cell replacement. If grey or brown accumulations are noted within the cell, replace cell. Look for crossed threads on nuts and terminals, check for damaged cell connectors. Install new parts as required. See Figure 4.

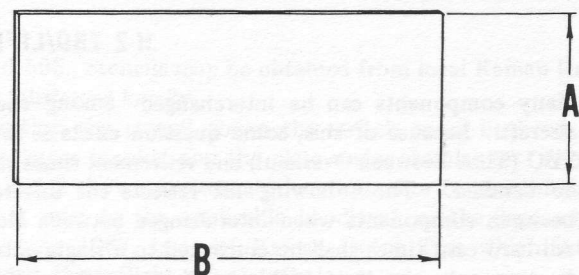
**View A. Case Walls and Bottom Liners**

A	B	NOTE: All dimensions in inches.	
4.0	4-1/8	C. 3-9/16	J. 1/8
4.0	2-5/16	D. 4-3/16	K. 1-5/8
4-1/8	2-5/16	E. 3-11/16	L. 1/8
1-1/8	2-5/16	F. 4-5/16	M. 1-5/8
		G. 1/32	N. 2.0
		H. 15/32	P. 2-11/16

- 2e. Thoroughly wash liner, case and cover in a solution of (5%) boric acid and fresh water. Remove corrosion by brushing with a stiff fiber brush. Dry thoroughly. Inspect liner for damage (tears, gouges, etc). If necessary, replace per Figure 5, using neoprene-base rubber cement.

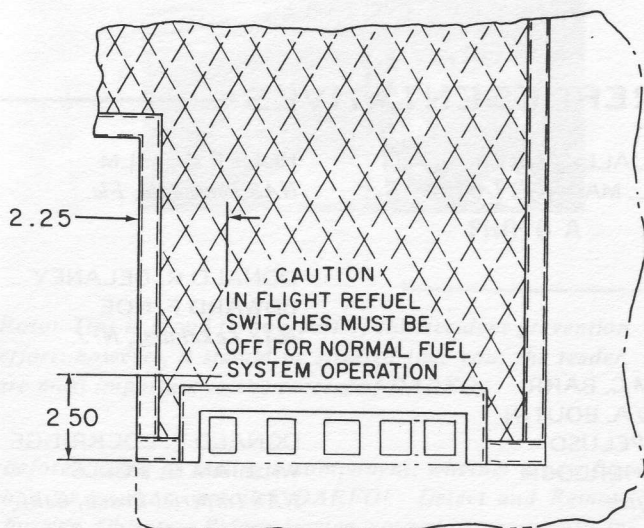
Illustration 1

(See Illustration 1.) Aircraft currently at Kaman for PAR/MOD rework will have this marking added prior to delivery. It is recommended that service aircraft which have Airframe Change 138 incorporated, have the markings applied as soon as practical. Use Black, Color No. 17038, Per Fed

Placing the aux tanks switch to "REFUEL" position, opens the aux tanks solenoid swing check valve, inactivates the aux tank compressor and opens the solenoid vent/relief valves, thereby allowing flow of pressure servicing fuel into the aux tanks. Again it becomes obvious that unless the aux tanks switch is returned to "OFF" after refueling has been completed, aux fuel transfer will not occur since the pressurization system is still inoperative. Because switch position is so important, a drawing change has been accomplished adding a "CAUTION" marking (1/4 inch letters) to the acoustical blanket just above the switch panel and to a metal plate, under the acoustical blanket, also above the switch panel.
