ISSUE NO. 5

THE KAMAN AIRCRAFT CORPORATION

# Rotor Tips

AUGUST, 1960

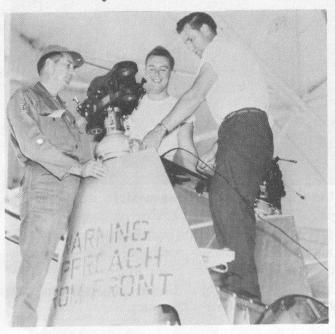
ASSEMBLYING H-43B newly arrived at Cannon Air Force Base are, left to right, TSgt. Charles P. Clark, A2C William Burks, both of Base Flight, and Stanley Balcezak, Kaman tech rep. (U.S. Air Force Photo by 1st Lt Carl R. Balduf)

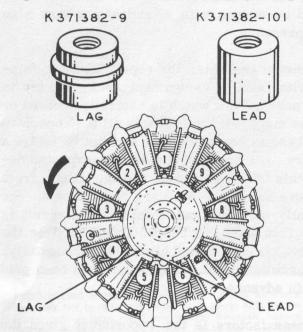
There are two clutch bumpers, or torque stops, in each HOK, HUK and H-43A which are mounted on the engine thrust bearing cover plate studs in such manner as to keep the clutch rear hub from turning. These bumpers look like several layers of friction tape wrapped around the stud; <u>BUT</u>, the lead bumper is not the same as the lag bumper.

The lead bumper is a solid cylinder; whereas the lag bumper has had the two ends of the

cylinder turned down, leaving a much narrower ring to contact the clutch torque stop. This was found necessary in early tests in order to prevent the clutch hub from resonating and bouncing back and forth between the bumpers at an amazingly high frequency, wearing out the bumpers in short order, and sometimes even damaging the clutch torque stop.

Therefore, when a clutch is installed, be sure one bumper is a solid cylinder and one is narrowed down by undercutting. Be sure too, that they are in the proper positions.

When the engine is viewed from the nose, and number 1 cylinder is at the 12:00 o'clock position, the solid bumper should be at about 7:30 o'clock and the undercut bumper at about 8:45 o'clock. (See illustration)

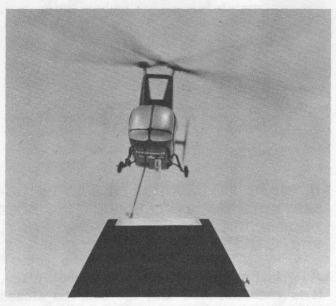
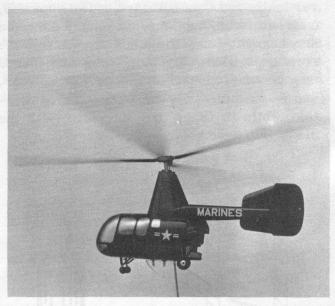
**ED WHITE, KAMAN FIELD SERVICE REPRESENTATIVE IN JAPAN,** uses this "energized" model of an HOK-1 while explaining how the synchropter design works. White used a small, battery-operated motor working through the transmission from a child's toy to power the rotors.

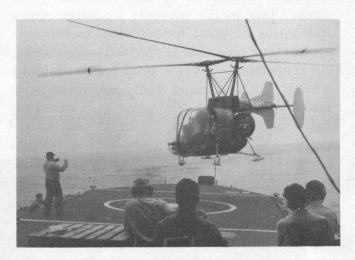
HTK-Drone Helicopter

This helicopter has landed on the Hazel-wood in a sea state of "5", a 35-knot wind, and with the deck rolling 25° port and star-board. The HTK-1 has made 446 shipboard landings, of which 57 were droned. It came through the latest series of test with 100 per cent availability (six weeks of flying.) This included a trip to Key West, Fla., and back.

The DASH concept calls for the helicopter to fly unmanned from the deck of a destroyer with a drone operator on the ship having full control over cyclic, rudder, and collective controls. Power is automatically regulated to the proper rpm. The operator can also set the altitude and heading of the machine from his location in CIC. This, coupled with sonar information, allows him to successfully attack submerged submarines with homing torpedos during night and IFR conditions, as well as during a day VFR situation. Kaman has been successfully demonstrating this capability for a period of years.
