# KAMAN *Rotor Tips*

**KAMAN AIRCRAFT CORPORATION**

**JUNE-JULY, 1963**

# UH2A/B FUEL QUANTITY MEASURING SYSTEM

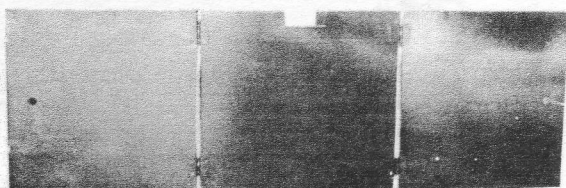
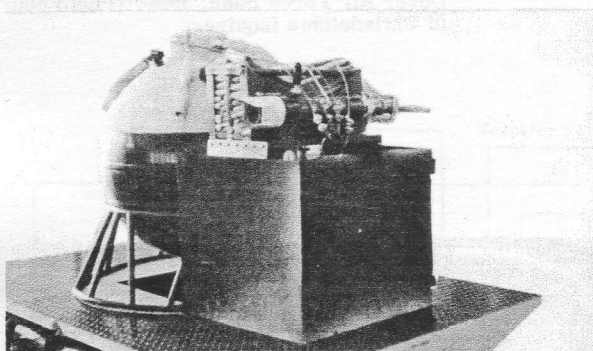
TSgt Edward I. Cambio of Det 30, CARC, Cannon AFB, N.M.; devised this safety shield of 1/16" steel plate to protect personnel while the air bottle on the fire suppression kit is being recharged. The two side portions of the shield are 24" x 24" and the center section, which is 24" high and 26" wide, has an opening at the top to accommodate the recharging hose. Straps are passed through holes in the shield to secure it to the FSK frame.

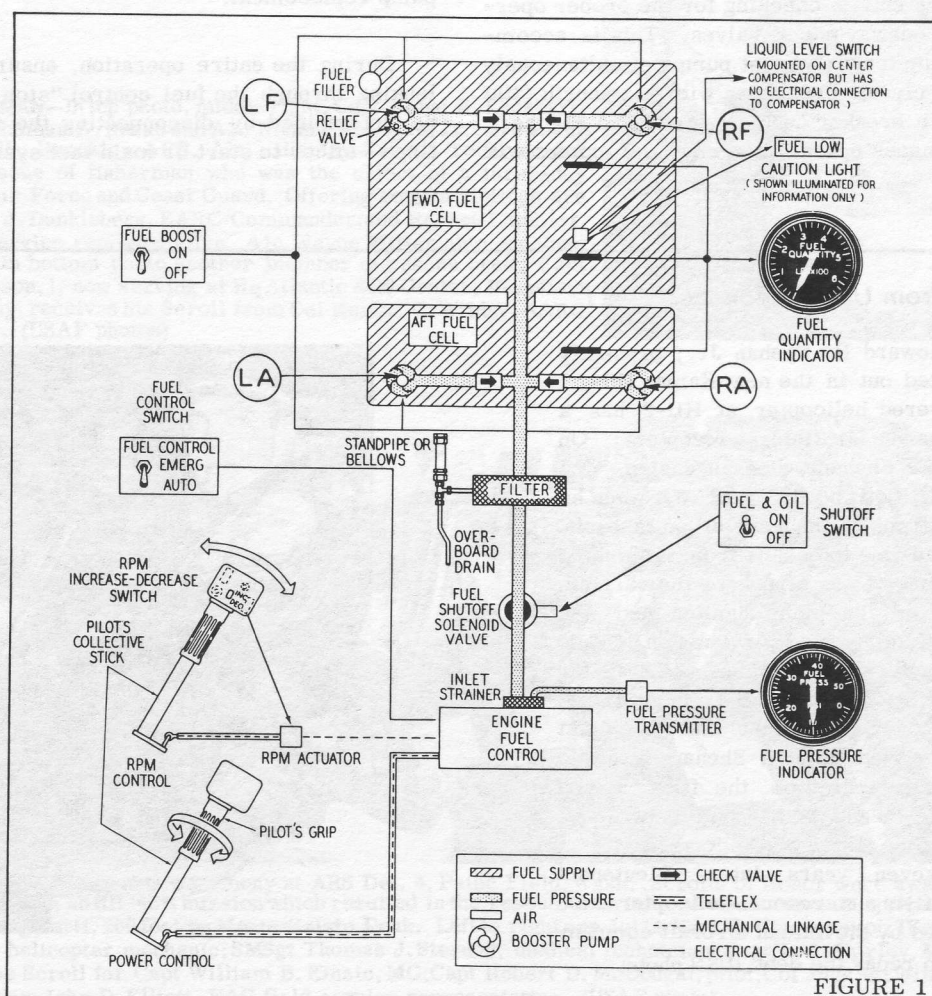
FIGURE 1

malfunctioning and the third shows which, if any, check valve is leaking. The four boost pumps are operated simultaneously by a single fuel boost "on-off" switch through their respective circuit breakers as shown in Figure 1. Each pump will be referred to according to the installed position as depicted in the drawing: Forward fuel cell—Left forward pump (LF); Right forward pump (RF). Aft fuel cell—Left aft pump (LA); Right aft pump (RA).

shutoff valve ON, throttle in CUTOFF position. Allow boost pumps to operate for approximately one minute. Pressure should stabilize at some point between 7 and 11 psi. Shut boost pumps off and observe fuel pressure gage. If gage is steady no leakage exists in fuel system. Proceed with boost pump test in part two (2). If, however, a pressure dropoff occurs, proceed with test procedures outlined in part two (2) and part three (3).

This procedure entails checking for the proper operation of the four oneway check valves. This is accomplished by actuating three (3) boost pumps simultaneously by means of the circuit breakers, with the fourth (4th) boost pump circuit breaker OFF. Referring to Figure 1, note that simultaneous operation of any three pumps will

cause fuel pressure to be exerted against the check valve in question. Should leakage past this check valve occur, low fuel pressure or fluctuation of pressure will exist. Ensure that the pilot's throttle is properly rigged and in the "Cut-Off" position.

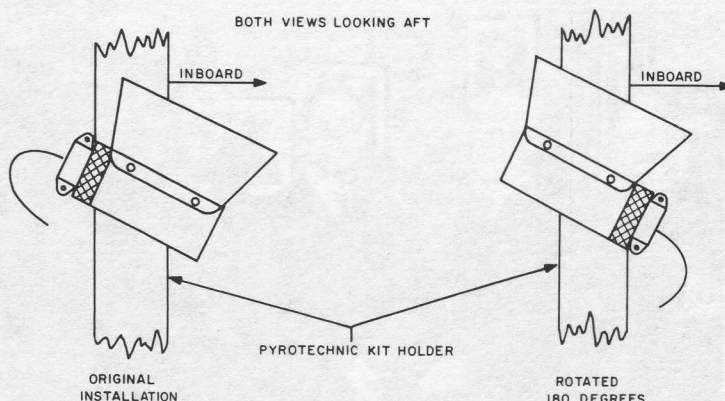
If the UH-2A instrument floodlight, P/N A-4255A, on the pyrotechnic kit holder behind the pilot tends to loosen, reverse the bracket holding the light 180 degrees (see illustration). The shade should also be reversed. This is done by removing the four screws holding the shade and name plate, reversing the shade and re-installing the four holding screws. The holes in the bracket will match the holes in the pyrotechnic kit holder after it has been reversed. This change has been incorporated in later production aircraft.

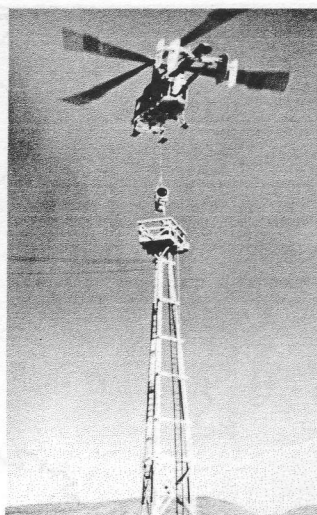
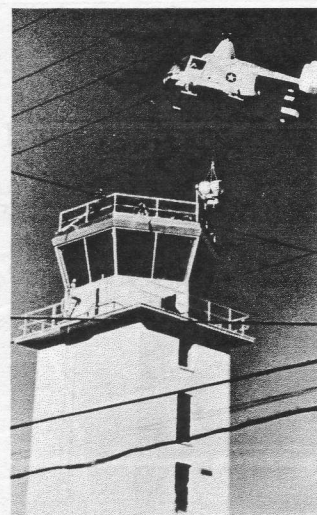
**HERE TO THERE**—Civil Engineering, Maintenance and Supply Groups teamed up with an HH-43B crew at Stead AFB, Nev.; in placing this 700-pound beacon atop the new control tower so the light would be back in operation by nightfall. Aboard the HUSKIE were Maj Harold Wheeler, pilot; Capt William L. Henderson, copilot; and SSgt Roger Winkle, crewman. (USAF photos)

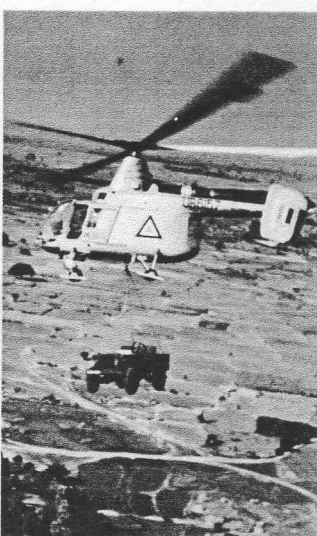
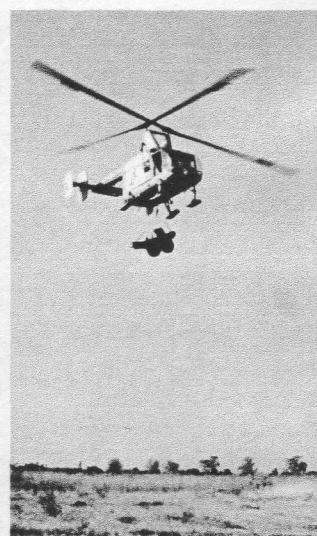
**AERIAL DELIVERY**—HH-43B's of the Burmese Air Force practice cargo hook utilization with jeep and field gun. Transporting of these and similar loads are a daily occurrence in Burma despite high ambient temperatures and elevations.
