# KAMAN Rotor Tips

KAMAN AIRCRAFT CORPORATION  
PIONEERS IN TURBINE POWERED HELICOPTERS

Volume III Number 6

December-January, 1963/64

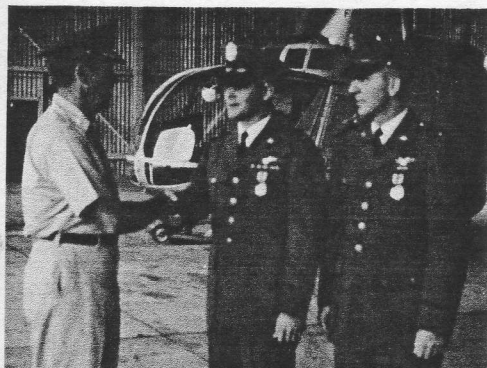
**COMMENDATION**—BrigGen A. N. Williams, left, ARS commander, presents Air Force Commendation Medals to Capt R. E. Lee, commander of Det 9, AARC, Moron AB, Spain, and Capt O. A. Heeter, operations officer, for their part in Moroccan flood relief mission last January. Over 50 survivors were rescued and 4200 pounds of food airlifted to stranded Moroccans. Recently, while on the same flight, Captain Lee and Captain Heeter each logged their 500th hour in the HH-43B. (USAF photo)
