**KAMAN**

# *Rotor Tips*

KAMAN AIRCRAFT CORPORATION

OCTOBER - NOVEMBER

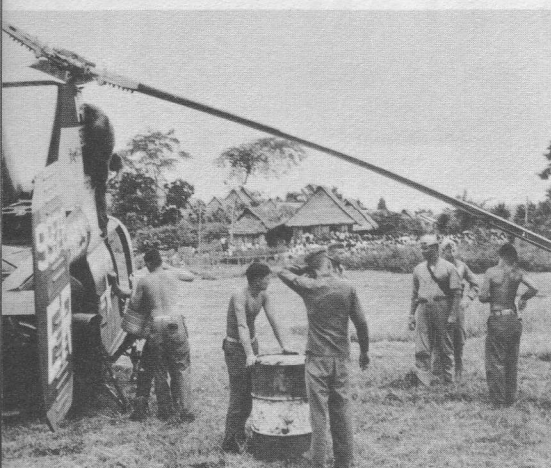
**WORK AND HEAT**—OH-43D tail is unloaded from C-130 at Iquitos. Aircraft is refueled "jungle style" at Requena. (USMC photos)

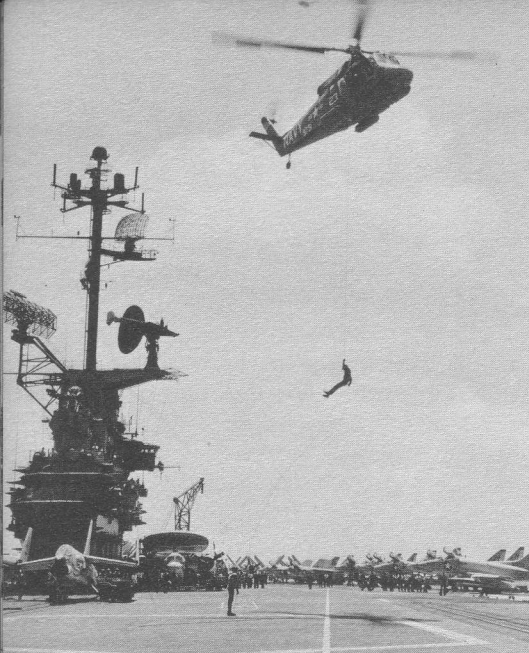
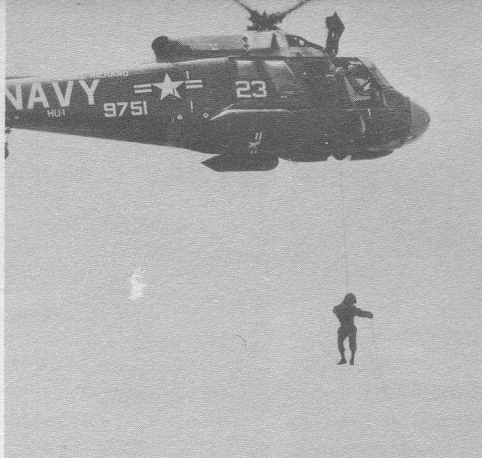
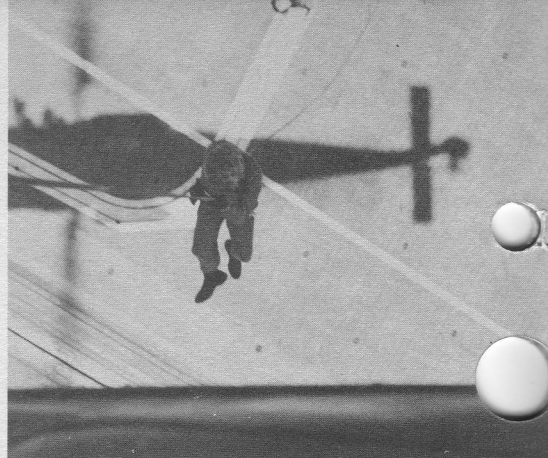
**MARINE LANDING**—Capt P. J. Ryan, commanding officer of the marine detachment on board the carrier Bon Homme Richard, uses mountain climbing technique and rappels from UH-2 SEASPRITE 120 feet above deck of the moving ship. The helicopter rappel permits marines to quickly land on a moving ship or in the jungle. Piloting the UH-2, flown and maintained by HU-1's detachment Echo, are Lt(jg) Andrews and Lt(jg) Griffith. (USN photos)

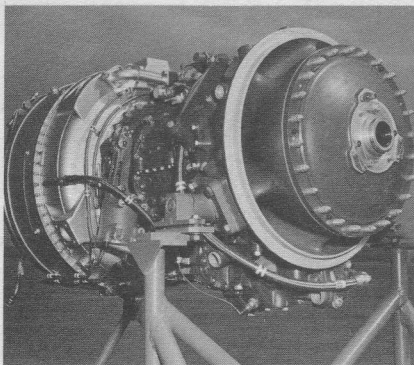
# KAMAN INTRODUCES HH-43F

The Kaman HH-43 HUSKIE helicopter now in production by Kaman Aircraft Corporation, Bloomfield, Conn., has a new, more powerful turbine engine which will add to the aircraft's already outstanding altitude and payload performance.

Kaman announced that current and future deliveries of the HH-43, now in production for the United States Air Force, are being powered by the Lycoming T53-L-11A gas turbine engine in place of the T53-L-1B used in earlier models. The new engine has 1100 horsepower in place of the 860 horsepower of the previous engine.

The unique intermeshing rotor system of the HUSKIE means that it needs no tail rotor and makes possible the efficient Kaman "unitized" drive system. All drive system gearing and rotating controls are in a single assembly. In 1962 the Air Force approved the HUSKIE drive system for unlimited life, and last year increased the rating of the transmission to 1000 horsepower.

The advantages of the T53-11 engine installation are to be found in superior performance at increased altitudes and during hot day operating conditions. This approximates an 800-pound advantage in payload or a 3000/4000 foot altitude advantage. Additionally, the -11 engine displays much better fuel economy.

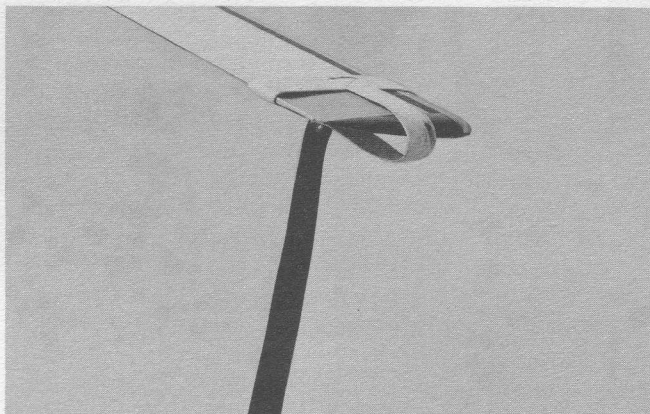
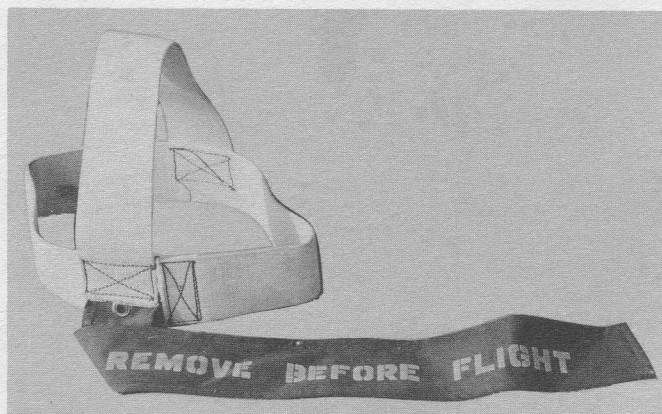
## Timely Tip

The blade warning streamer above was designed by A1c Hubert O. Marsh of this unit. They are slipped onto the blade tips whenever the HH-43B is parked in a congested area and are especially valuable when installed on aircraft in a hangar where there is other maintenance activity.

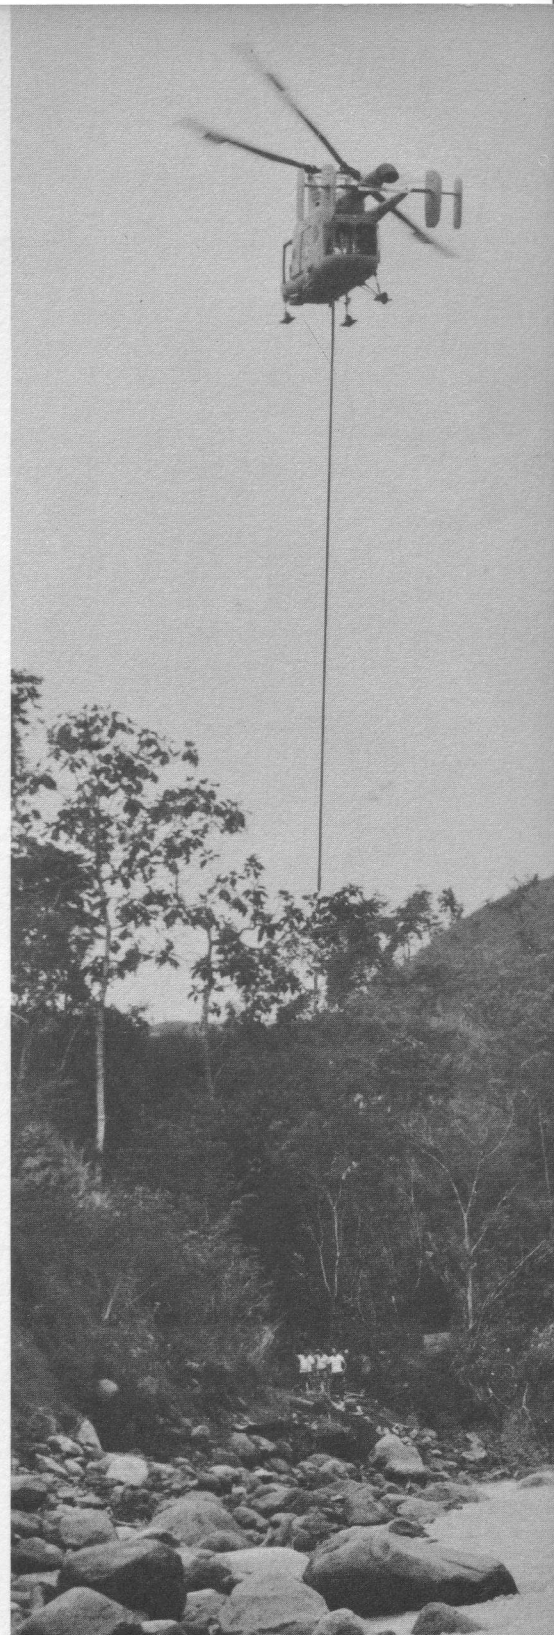
**ARS AIDS BASE**—HH-43B crew from 31st ARS, Clark AB, P. I., delivers one of several 700-pound water pipes to almost inaccessible ledge at bottom of cliff in rugged Zambales mountains. The pipe lengths were attached to a 150-foot cable, lifted vertically, to the small ledge. The HUSKIE was called on after pipes supplying base housing were broken by a landslide during typhoon "Winnie." A critical water shortage developed and the road leading to the water reservoir had been washed out. Aboard the helicopter were Capt David J. Wege, pilot; Capt Marvin L. Palmer, copilot; Capt David E. Allen, observer; and TSgt David D. Dere, helicopter mechanic. (USAF photo)
